PAMPIERSTAD LANDFILL SITE

Site Photos taken in September 2015

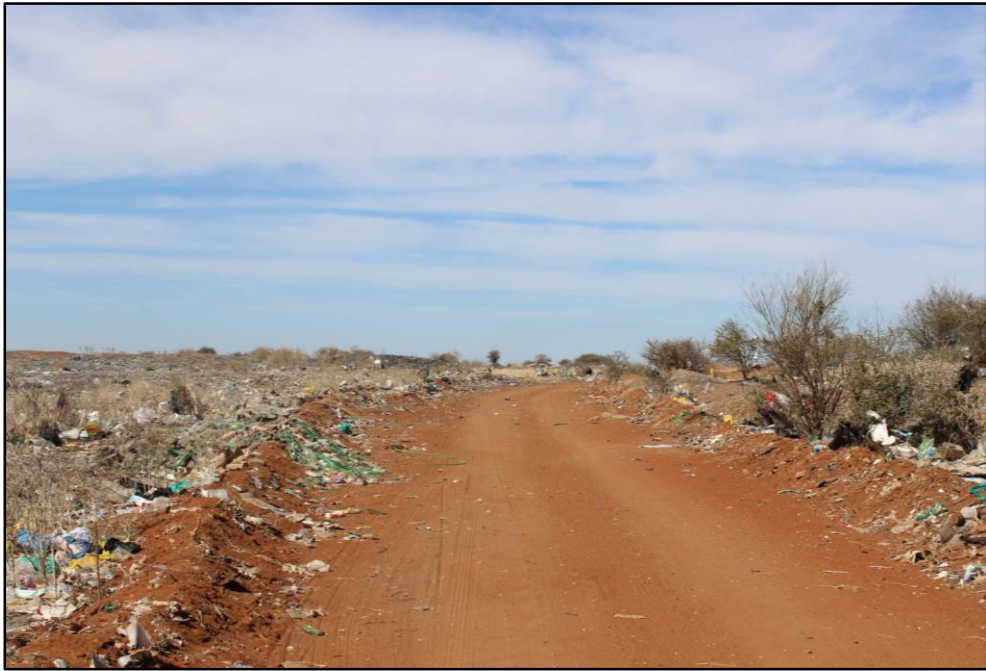
Figure 1: Landfill is transacted by an access road from the centre. Picture show a view towards the south showing the access road to the site

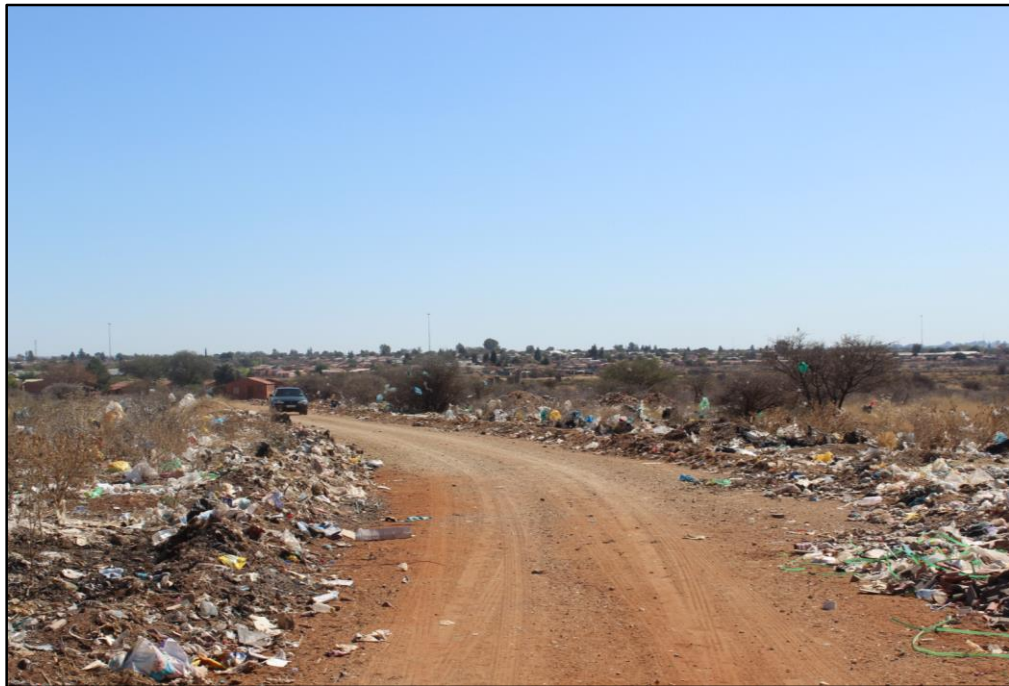
Figure 2: Site is located nearby a residential development (in the background) View towards the north showing the access road from the site and the

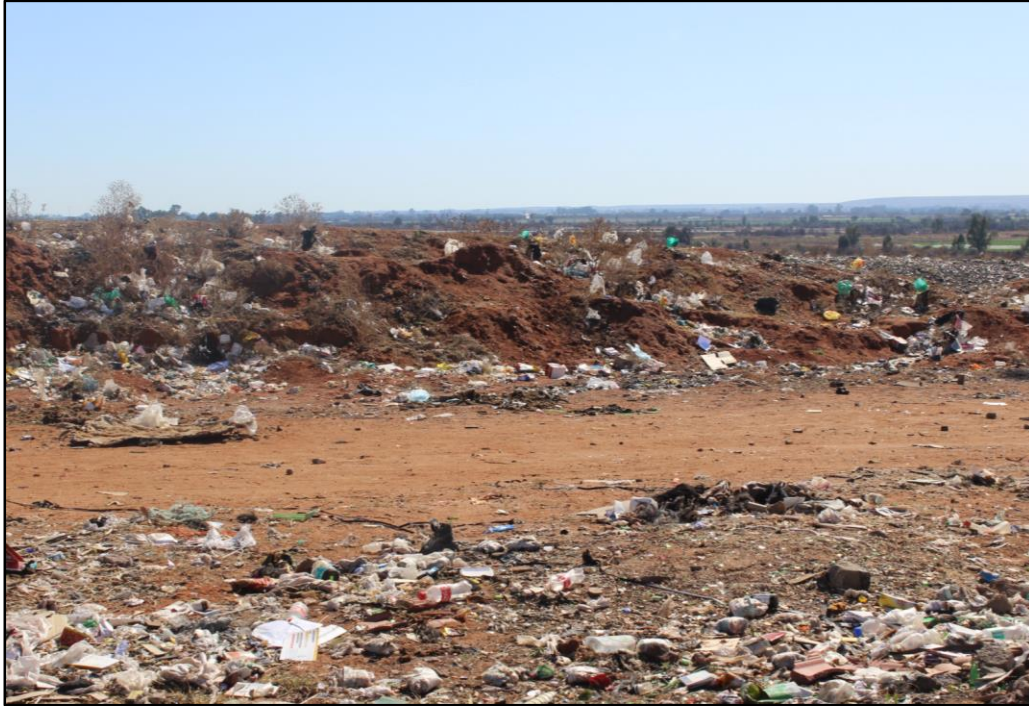
Figure 3: The Pampierstad landfill viewed from the south

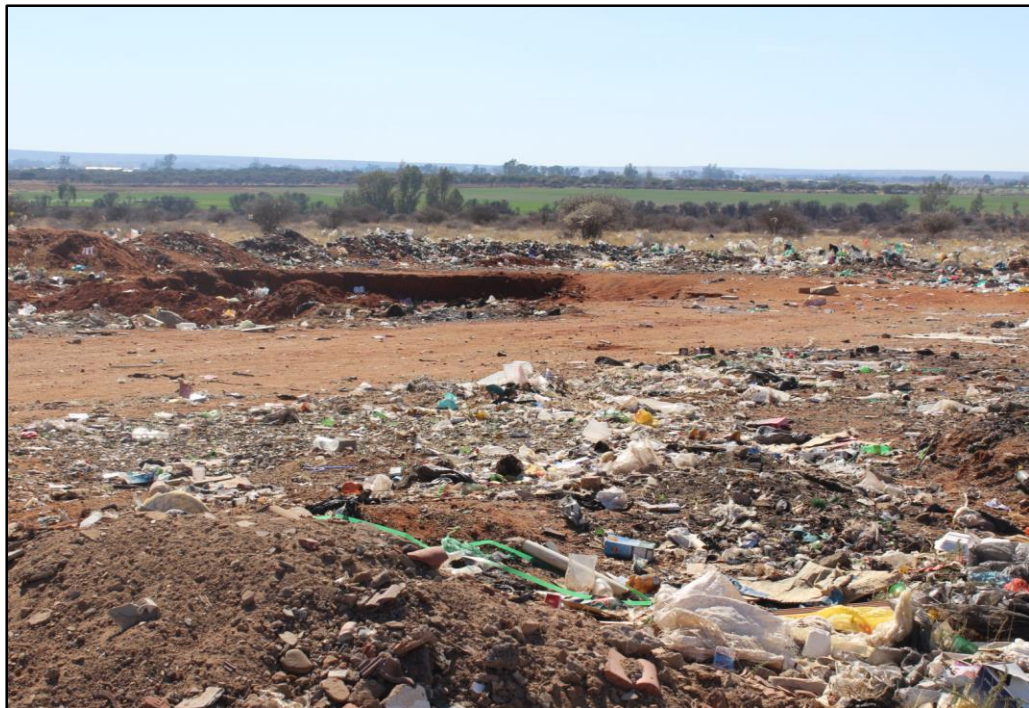
Figure 4: Agricultural farmlands (in the background) located to the north east of the site. Note excavation in the foreground
Picture taken from the south.

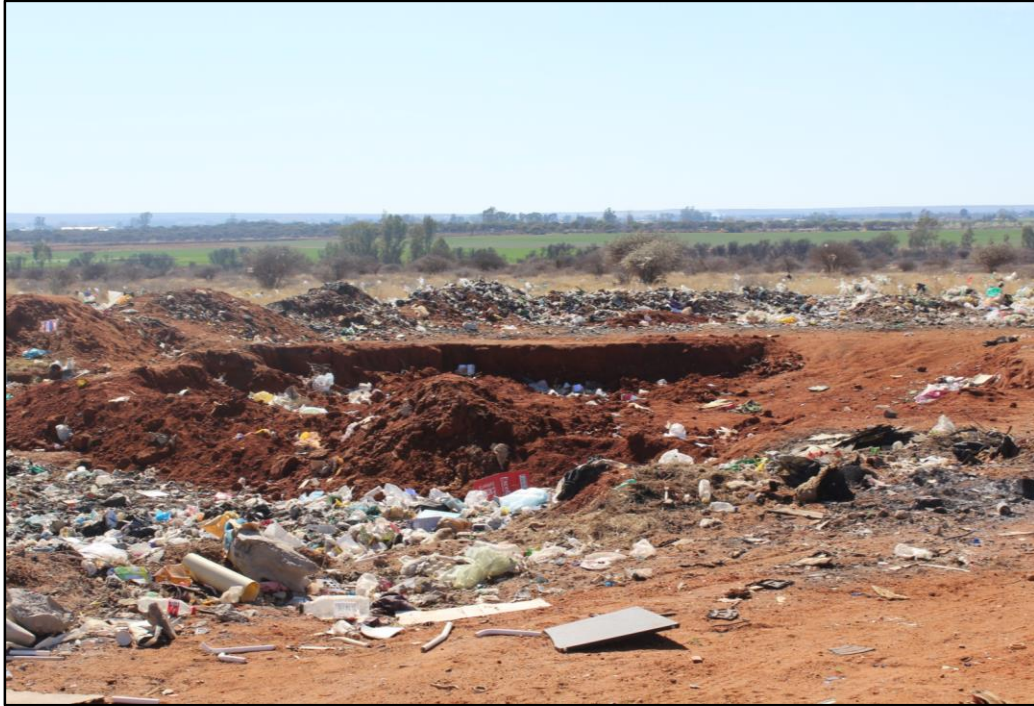
Figure 5: Close up view of the excavation in **Figure 4**

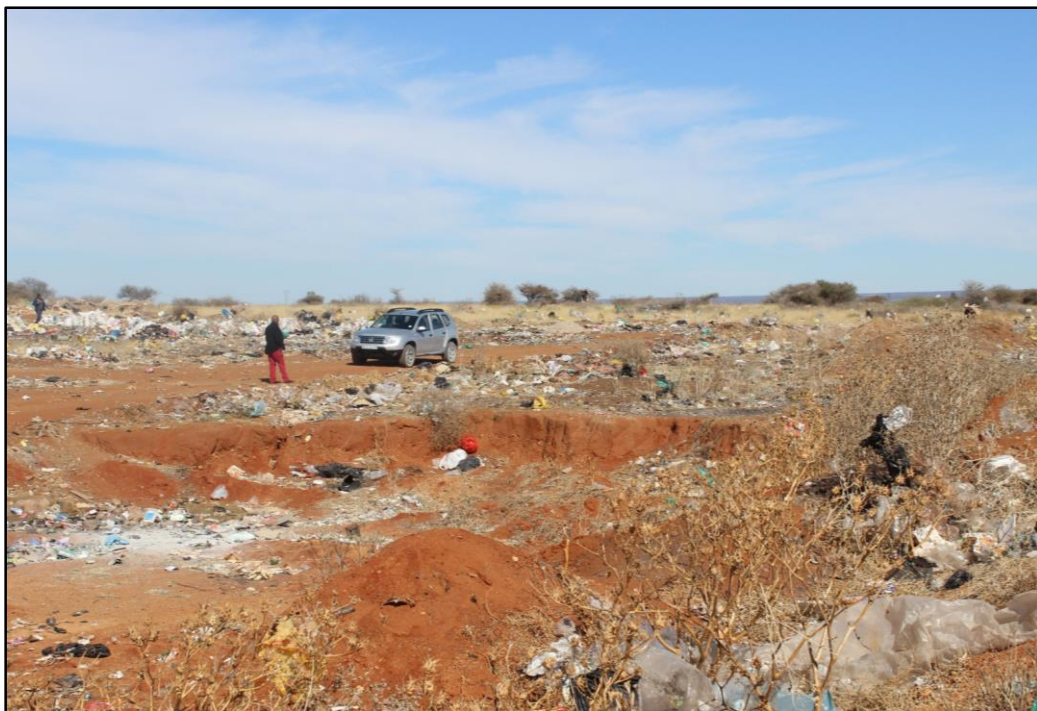
Figure 6: View towards the west showing an alternative view of other excavations on the site

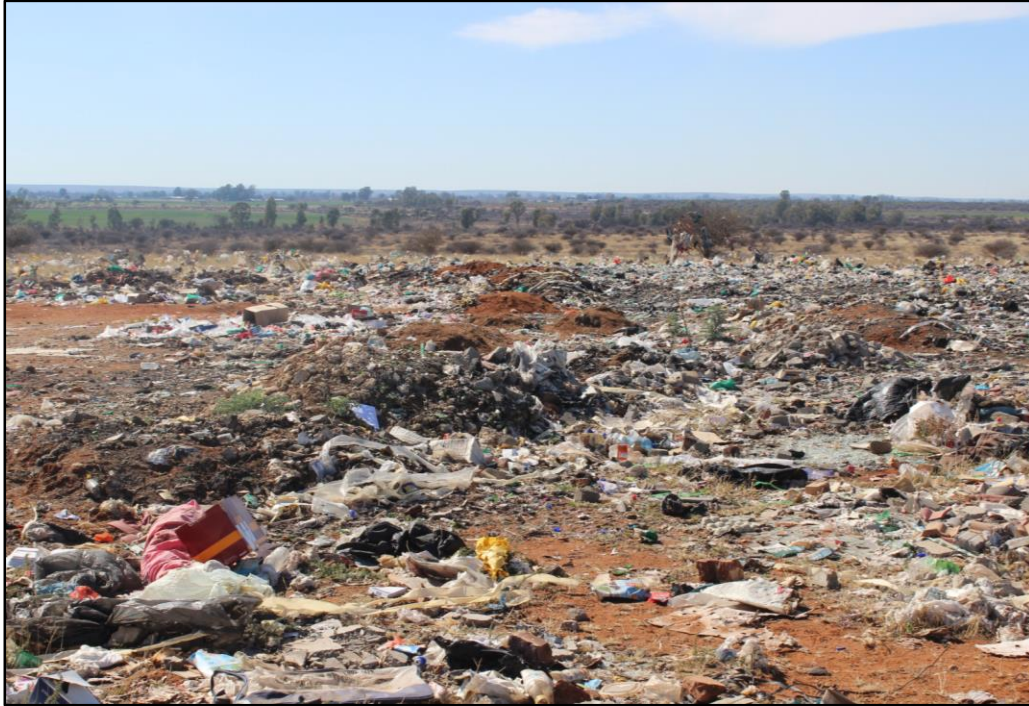
Figure 7: The eastern portion of the landfill viewed from the west, note the extent of visual impact emanating from the dumping of waste

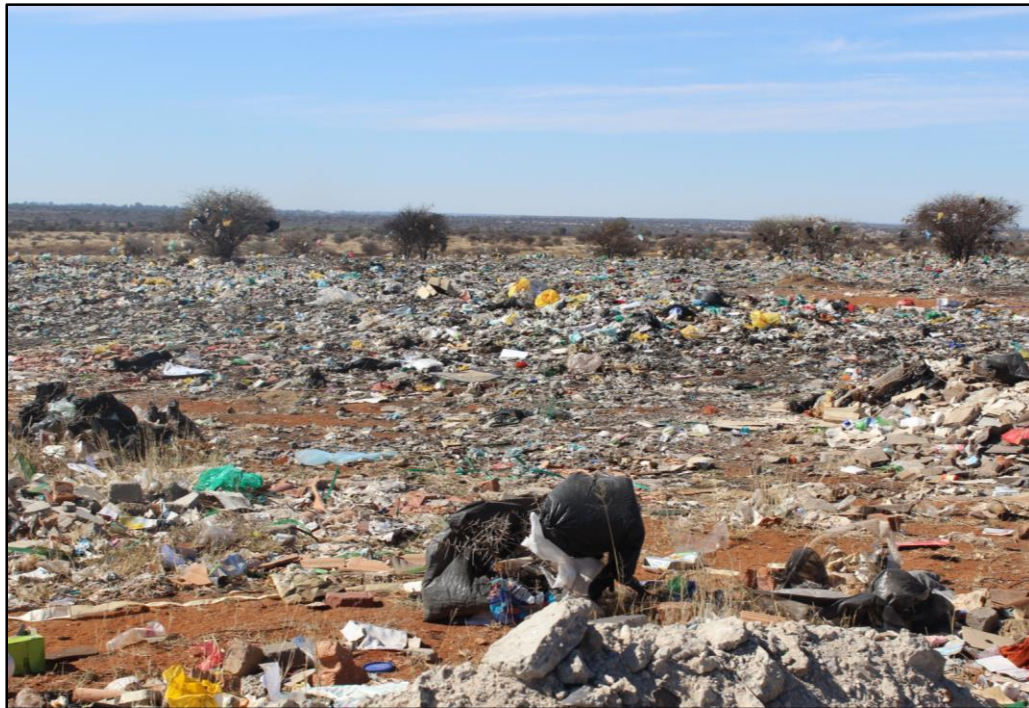
Figure 8: View of the south eastern part of the landfill. Note the extent of waste dumped on the site

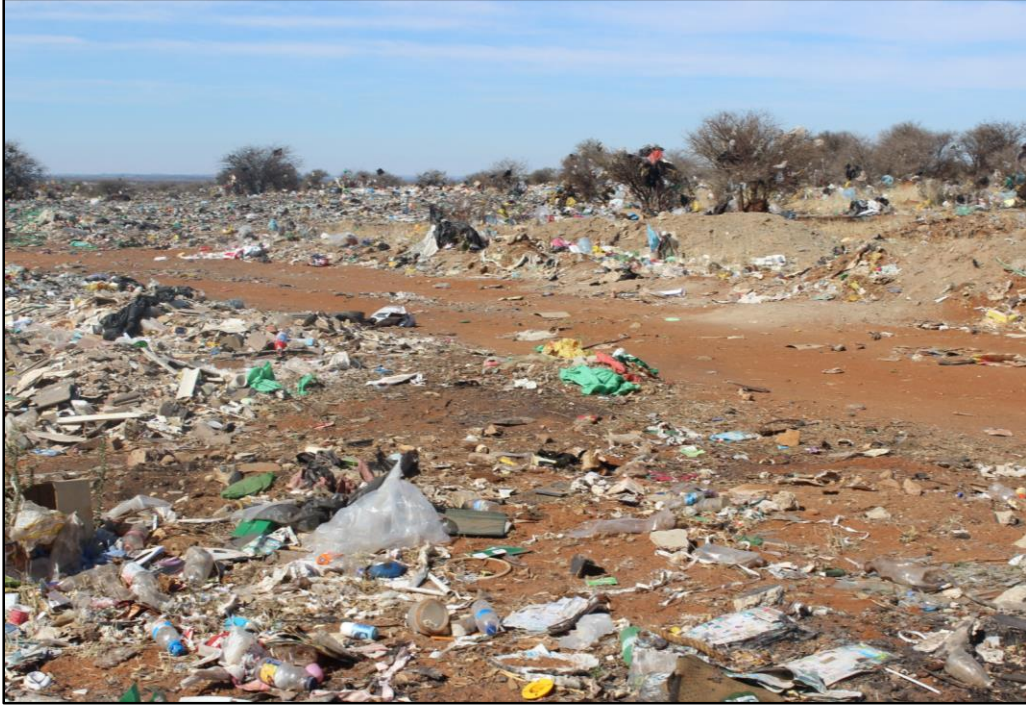
Figure 9: View of the southern portion of the landfill, note the litter trap on existing trees

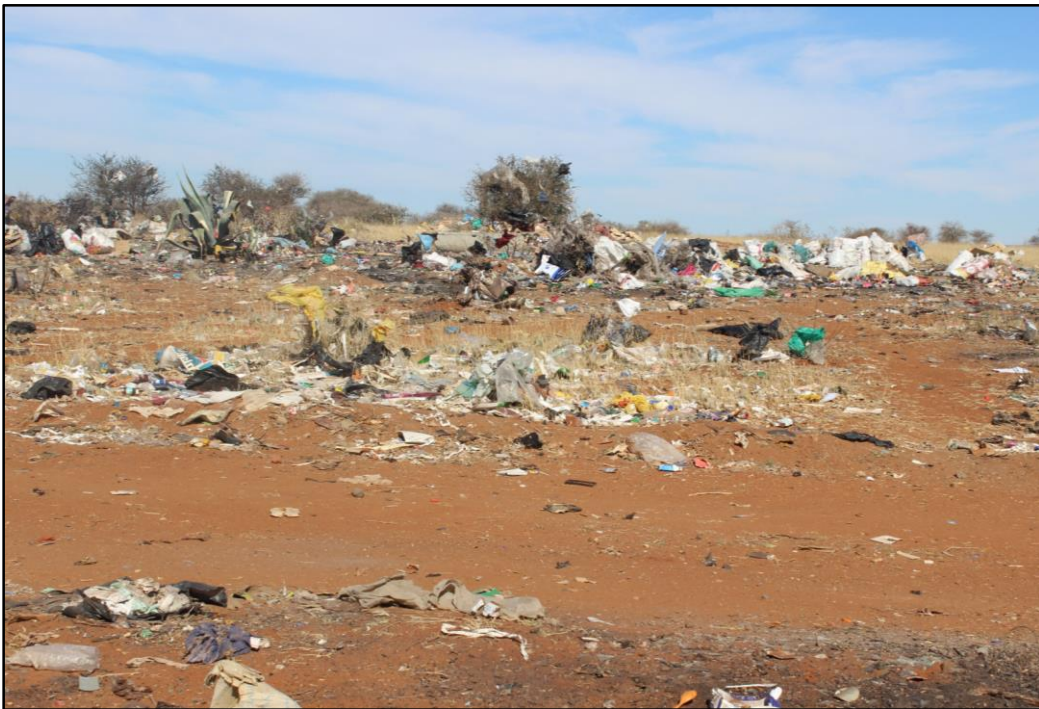
Figure 10: The south west portion of the Pampierstad landfill currently used for dumping of waste and reclamation

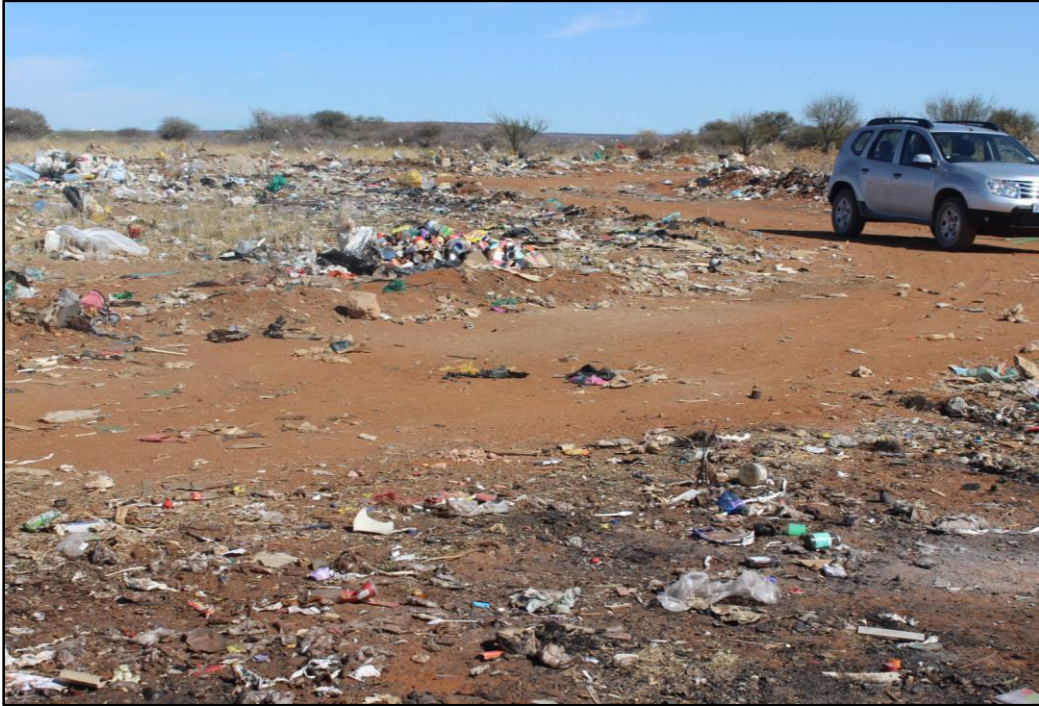
Figure 11: Picture shows the western portion of the Pampierstad landfill

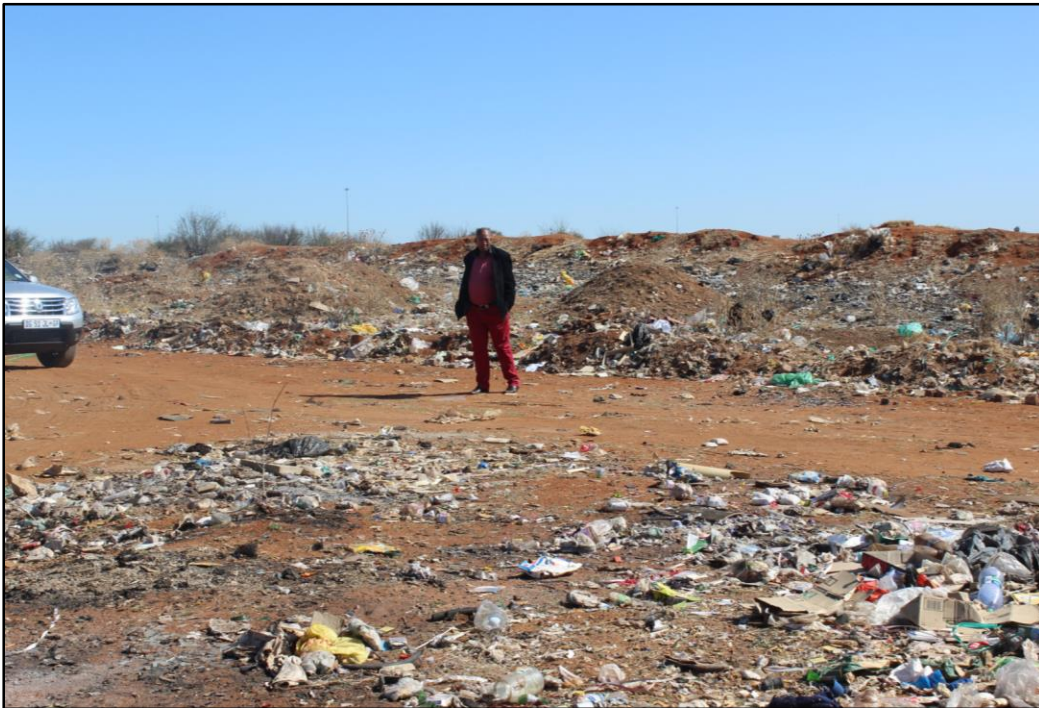
Figure 12: The North west portion of the landfill is dominantly characterised by soil heaps

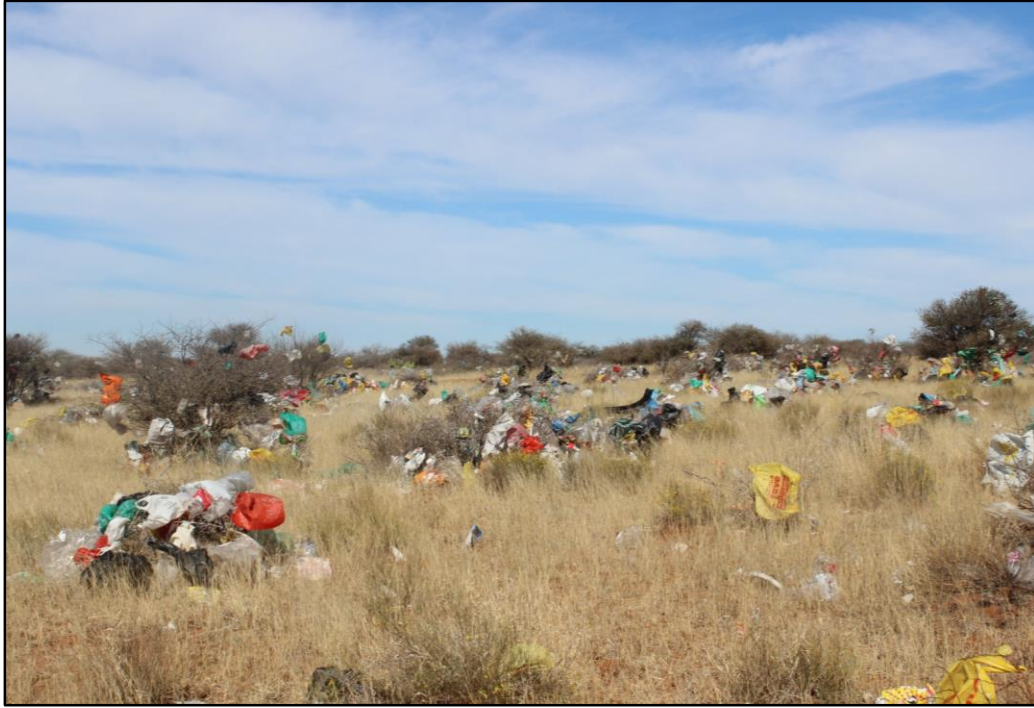
Figure 13: Windblown litter trapped on trees and grass surrounding the site, causing immense visual impacts

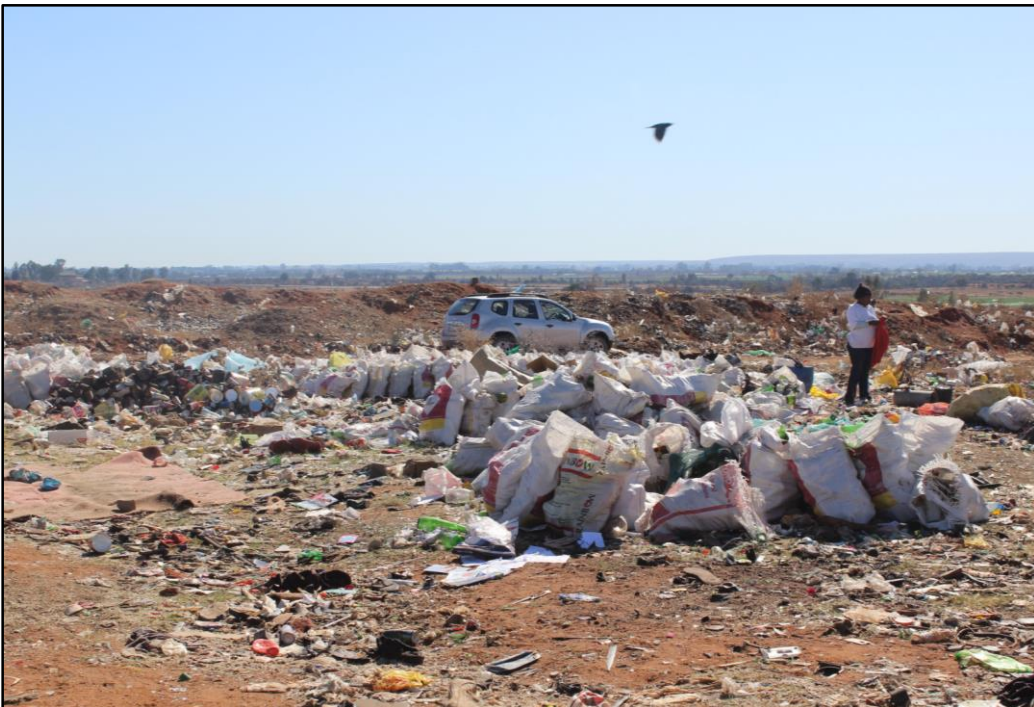
Figure 14: An example of the recycling initiatives taking place at the landfill
