HERITAGE ASSESSMENT OF HISTORIC FARM DWELLING KURUMAN (NORTHERN CAPE PROVINCE)

Date: February 2013 Report: April 2013

Project by: M. Naudé

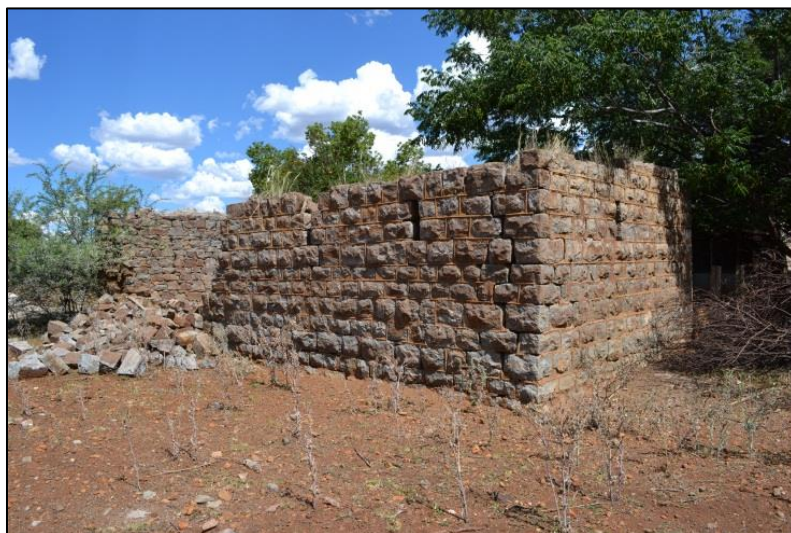
This structure has no roof and its original function is unknown. It is not possible to determine function as it consist only of four walls and has no roof. Its main characteristic is the construction materials: dolomite stone masonry.

Figure 2. Exterior of the remains of a stone outbuilding

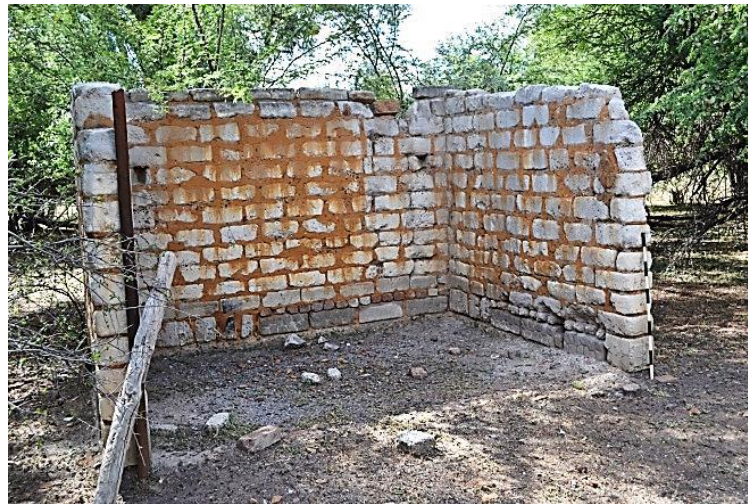
Structure of uncertain function of which only three walls have remained. It is impossible to determine the function of the structure due to the almost complete lack of clues in the remaining built fabric.

Figure 6. Ruin of what seems to be an unfinished or vandalized outbuilding constructed with clay bricks

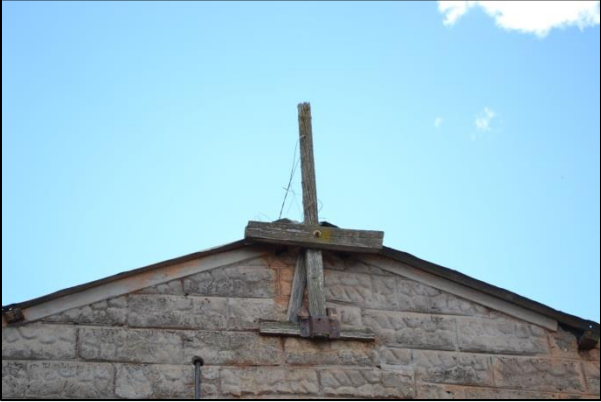
<p data-bbox="321 1829 1097 1885">Figure 25. Top of the gable of the dwelling indicating the installation of a primitive wooden cross or maybe supporting a radio aerial</p>	<p data-bbox="1133 506 1211 533"><i>Rating</i></p> <p data-bbox="1133 596 1195 623"><i>High</i></p>

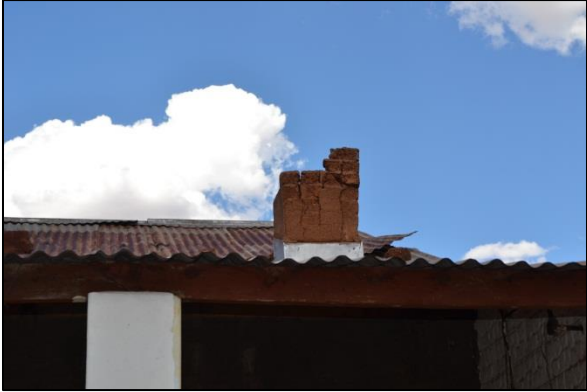
<p>Figure 34. Deteriorated chimney stack constructed with sundried bricks (Photograph: M. Naude 2013)</p> <p>Roof: As the site is located in area not known for its extensive rainfall roof constructions and coverings are not significant elements on buildings in the region, this building is no exception. The roof sheets have not been painted and rust has had a major negative impact on the corrugated iron sheeting. The sheeting is also not properly secured to the roof structure and brandering anymore and sheets have lifted. The roof structure of the entire building needs a thorough investigation and those parts that were added when the extensions were done seem to be in poor condition.</p>	<p>Rating</p> <p><i>Medium to high</i></p>

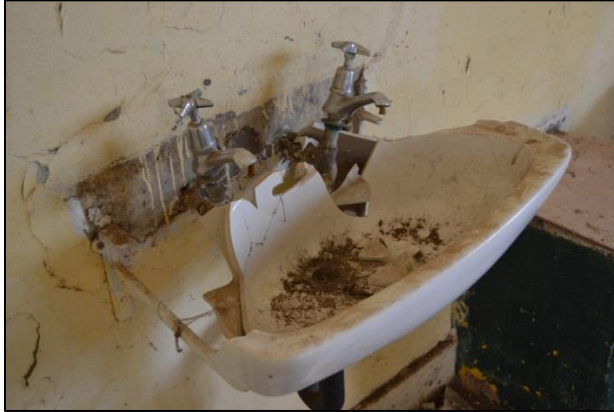
**Figure 35. Vandalized porcelain wash basin in the bath room
(Photograph: M. Naude 2013)**

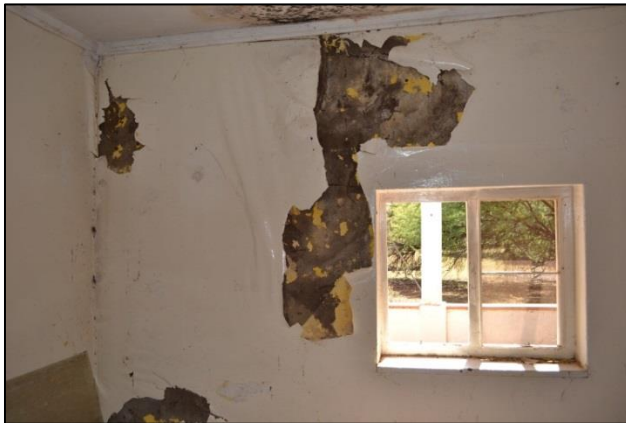
Walls: Due to the poor condition of the roof sheeting water has penetrated into the dwelling at various points causing damaged – however the damage can be mitigated and reversed by replacing the roof sheeting.

The part worst impacted on by moist penetration are the sections that were added to the core building at a later stage.

Moist has penetrated the walls impacting on wall paint, plaster and probably also structural integrity of the walls themselves.

Figure 36. Large areas of the walls of the later additions have been penetrated by rain water due to bad drainage, guttering and roof problems (Photograph: M. Naude 2013).

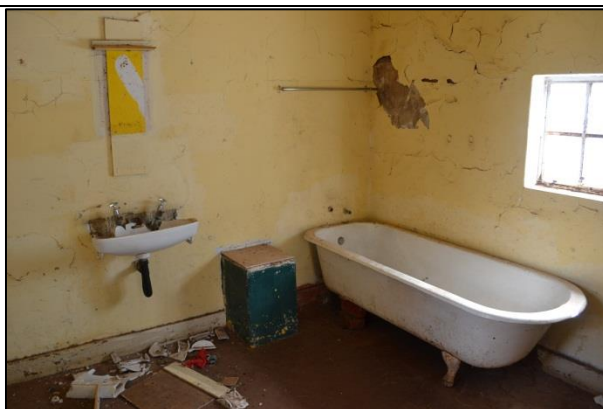
Figure 37. Moist problems are indicated in the plaster and paint of the exterior walls (Photograph: M. Naude 2013)

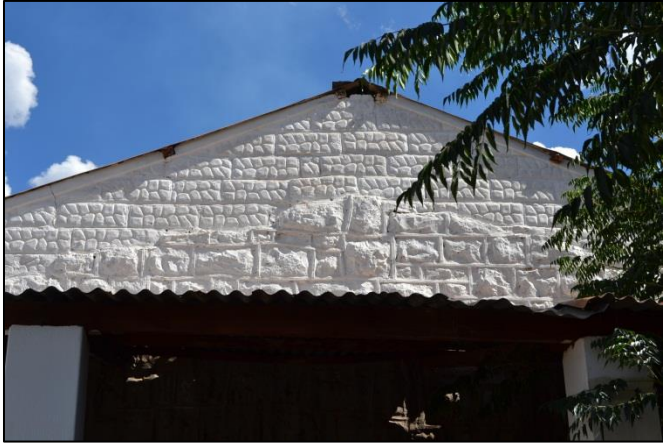
<p>Figure 39. Indication of the elevated gable when the stoepkamers were added - a defined line indicates where the original stone masonry gable ended and the more recent material was added on top (photograph: M. Naude 2013)</p>	<p><i>Rating</i></p> <p><i>Original design still relatively intact</i></p>
