# Atmautluak

## Energy Action Plan

Atmautluak Energy Efficiency Project

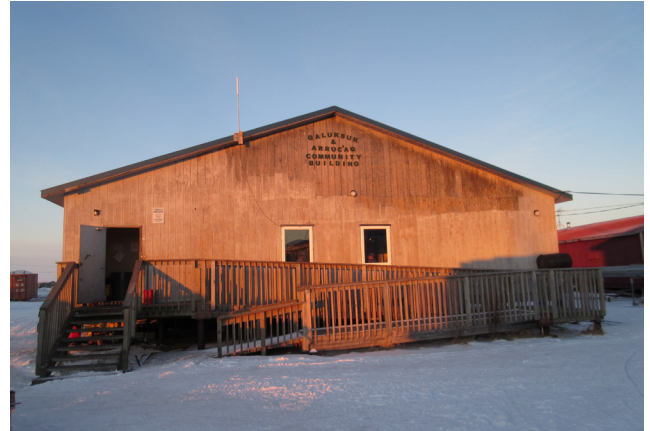
The 3,500 square-foot building sits on a steel piling foundation with wood siding. The building shell is in poor condition with some of the windows experiencing disrepair. A hydronic unit heater that utilizes the waste heat system provides heat. Secondary heating is supplied by an oil-fired, direct vent Toyotomi heater. There is no domestic hot water or plumbing in the building. The exterior lighting is comprised of incandescent lamps. The interior lighting consists of fluorescent and compact fluorescent lamp (CFL) fixtures. Plug loads for the facility are moderately high due to the high volume of daily visitors and use of the space as an office. The ATC is hoping to reduce the energy use of this building in a future energy retrofit project.

The ATC office is, along with the school, one of the most used buildings in the community. It is both a hub for decision making and a gathering place for the community.

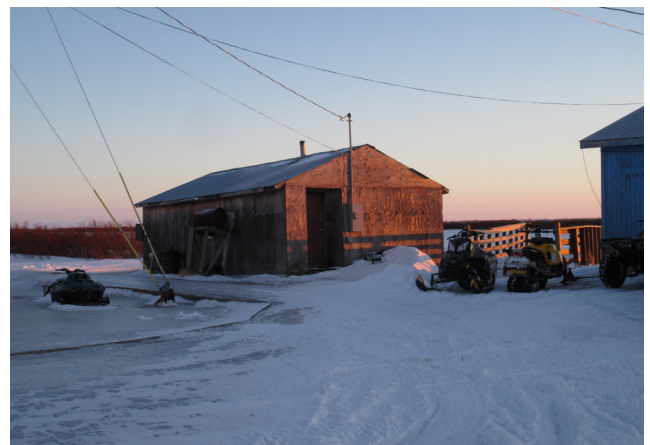
The 576 square-foot building was constructed in the 1970s. The structure does not have a foundation and is in direct contact with the ground. The building shell is in poor condition. There is no potable water or domestic hot water plumbing in the home. An oil-fired, direct vent Toyotomi heater provides primary heating, with a wood stove as a secondary heat source. There is no exterior lighting and the interior lighting is a mix of fluorescent, CFL, and incandescent lamps. The ATC is hoping to reduce the energy use of this building in a future energy retrofit project.

The ATC rental house is traditionally reserved for the janitor position at the community hall and tribal office.

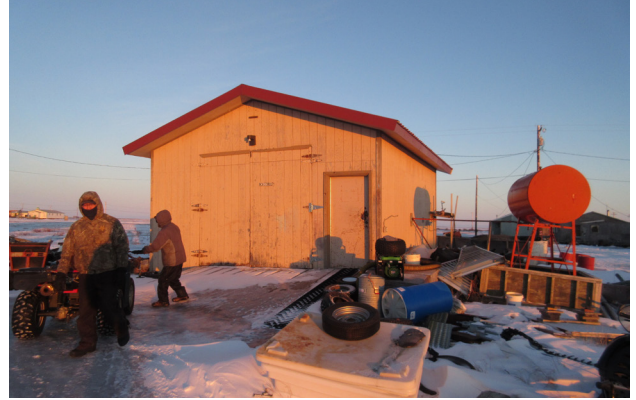
The 480 square foot building sits on grade with wooden planks covering the dirt floor. The building shell is in poor condition. There is no plumbing in the building. Exterior lighting is comprised of a single screw-in fixture. The interior lighting consists of high pressure sodium (HPS) fixtures and several incandescent lamps. Plug loads for the facility are negligible. The ATC is hoping to reduce the energy use of this building in a future energy retrofit project.

The ATC Shop is used periodically and seasonally but is not occupied by permanent staff.

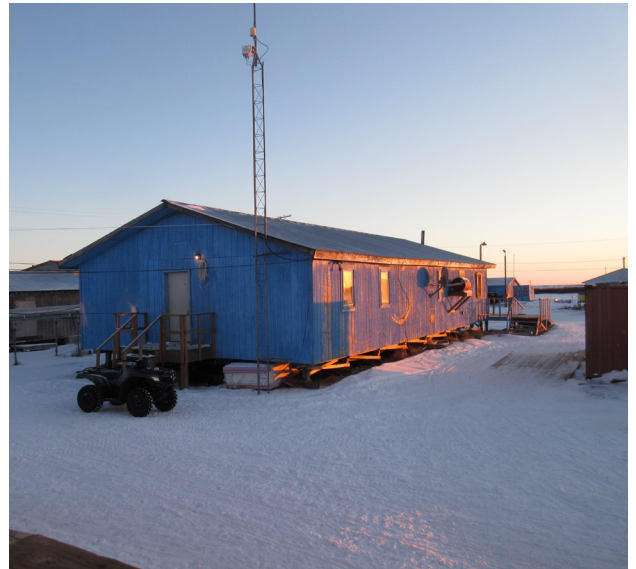
The 1,680 square-foot building was constructed in the mid-1970s on an elevated pier foundation. The building shell is in poor condition with about half of the windows experiencing disrepair. The waste heat system distributes heat from the power plant to the building via unit heaters. There are manual thermostats for controlling the unit heaters. There is no plumbing in the building. The exterior lighting is mostly incandescent lamps, and the interior lighting is a mixture of fluorescent, CFL, and incandescent lamps. Plug loads are low in this building. There is a PC/cash register, an ATM machine, a small refrigerator, and a bingo display board. The ATC is hoping to reduce the energy use of this building in a future energy retrofit project.

The gaming office's bingo hall takes up half of a repurposed building that sees great changes in occupant load based over the course of a typical week. The other half of the building is taken up by the post office.

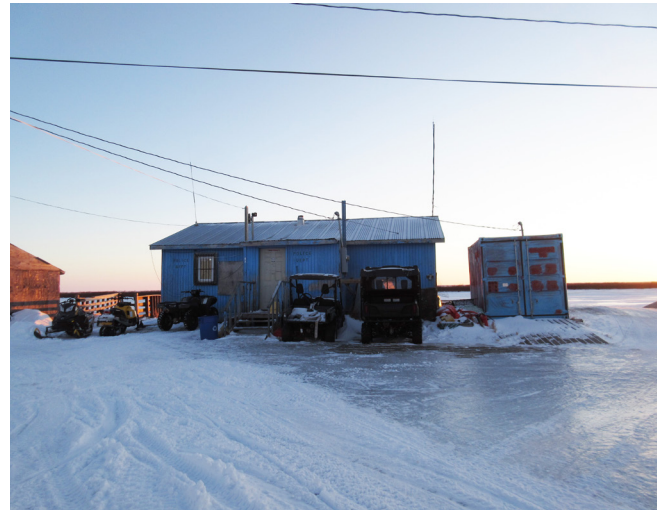
The 768 square-foot building is situated on a wooden pad foundation. The building shell is in poor condition with the roof showing signs of disrepair. An oil-fired, direct vent Toyotomi heater provides heat. There is no potable or domestic hot water plumbing in the building. There is no exterior lighting. The interior lighting consists of a mix of CFL and incandescent lamps. Plug loads are negligible for the facility. The ATC is hoping to reduce the energy use of this building in a future energy retrofit project.

The police station in Atmautluak contains both an office and a jail cell.

Police station	This building is in extremely poor condition. The roof leaks, and there is water damage in the attic. The building is cold due to drafts from cracks in the envelope; in the winter the jail cell is too cold to house inmates. The building has mold, and lacks ventilation.
Washeteria	This building is in poor condition. It lacks plumbing, so staff need to haul water. The building is also not always warm.

1. Repair the foundation of the building.
2. Repair or replace the roof to prevent further water damage.
3. Treat and paint the building exterior to preserve the remaining life left in the T1-11 siding.

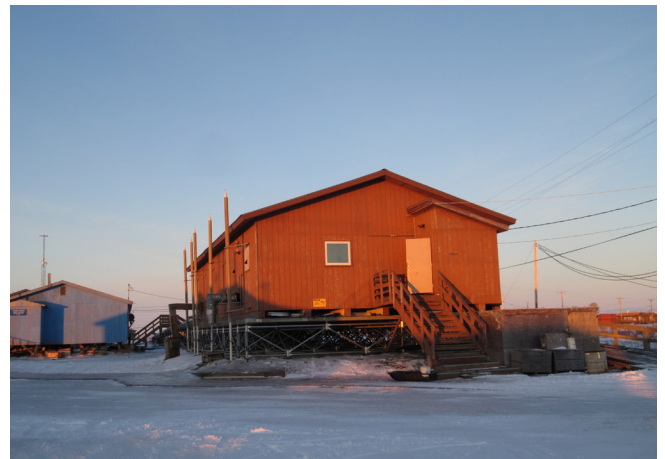
The 2,048 square-foot building sits on a triodetic foundation. The building receives waste heat from the power plant. Oil-fired boilers supplement the waste heat. The facility has two top loading washers and two front loading washers. There are four stackable dryers and three commercial dryers. The ATC is hoping to reduce the energy use of this building in a future energy retrofit project.

Waste heat from the power plant is utilized by numerous public buildings in the community, including the washeteria.

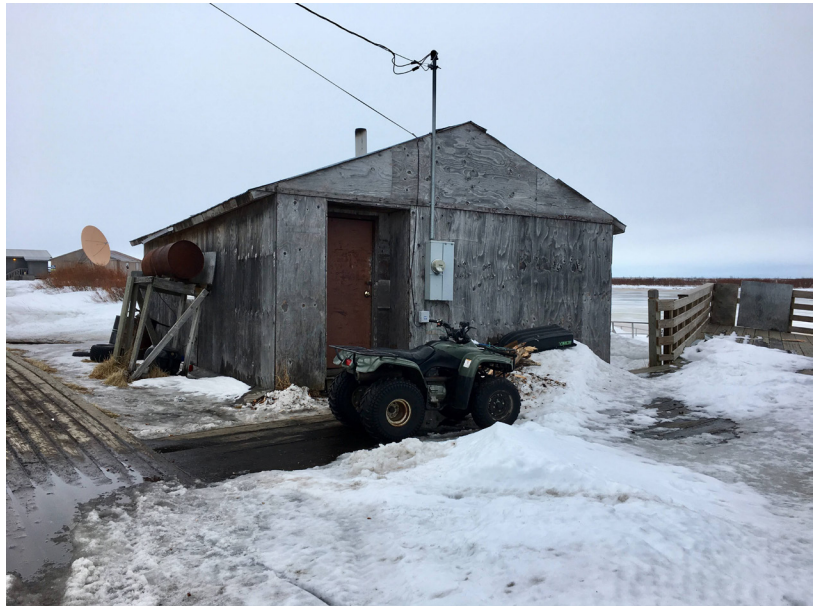
The Tribe's rental house has safety concerns that should be addressed immediately, including the need for a proper foundation, ventilation, roof repair, and a multi-wall flue for the wood stove.

1. Lift and stabilize the building and install a proper foundation to remove it from ground contact and insulate the floor.
2. Install an ERV to improve indoor air quality.
3. Repair or replace the roof to prevent further water damage.
4. Install rain shield and weather proof siding on the building.
5. Install vapor barriers.
6. If the wood stove is being used, it appears to have a single wall flue exiting the attic. **This is a safety issue** and the current flue should be replaced with a multi-wall flue to prevent fire danger.

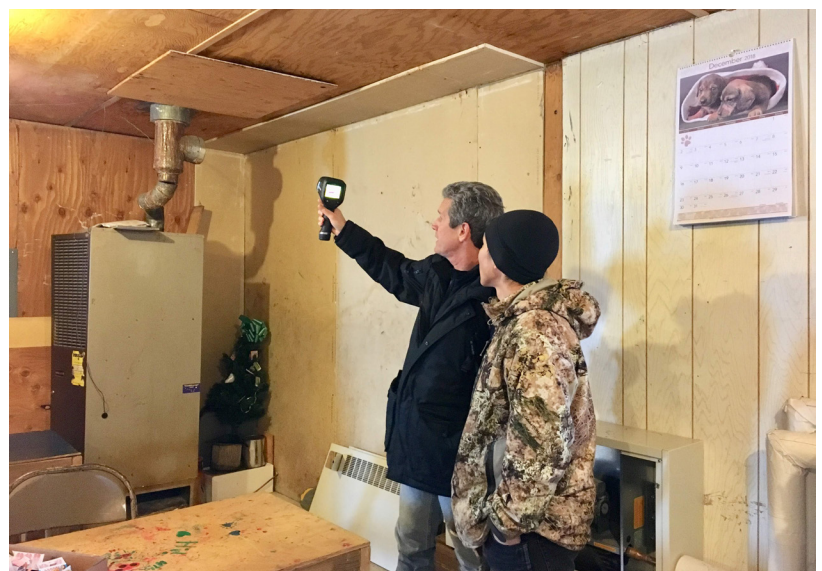
The energy auditor and Atmautluak's tribal administrator use a thermal camera to examine the building envelope of the gaming office.

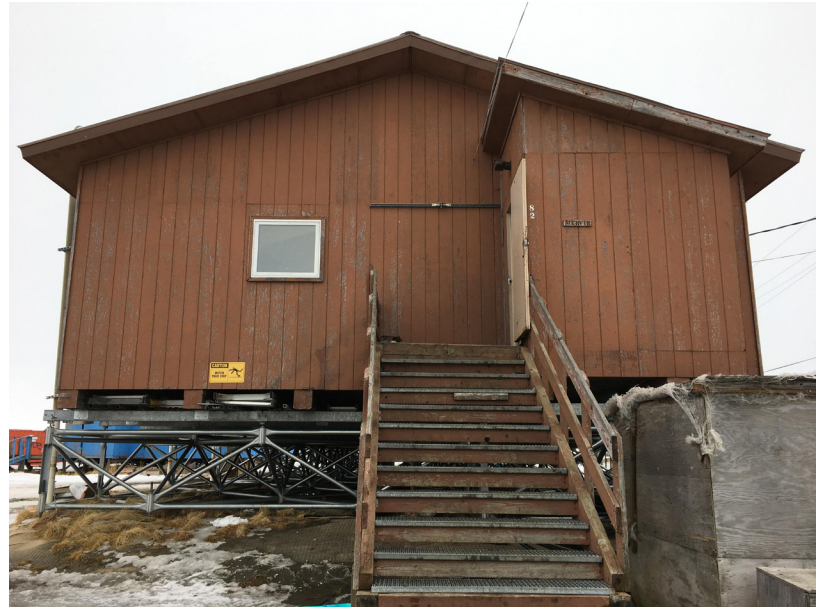
The Alaska Native Tribal Health Consortium (ANTHC) previously audited the washeteria in 2016. That audit recommended several EEMs, including a lighting upgrade to LED bulbs, using temperature setbacks in both the washeteria and the water treatment portions of the building, replacing lift pumps with more efficient models, replacing windows with triple pane versions, air-tightening the building, replacing electric dryers with hydronic versions, and only using the heat trace on the water lines for emergency purposes. Since 2016, the lighting has been upgraded to LEDs. For this current project, the energy auditor surveyed the building and determined that the remaining recommendations from the 2016 audit are still valid and could be included in any future retrofit project.

An audit update for the washeteria's 2016 report revealed that while lighting has been upgraded, many of the other recommendations are still valid.

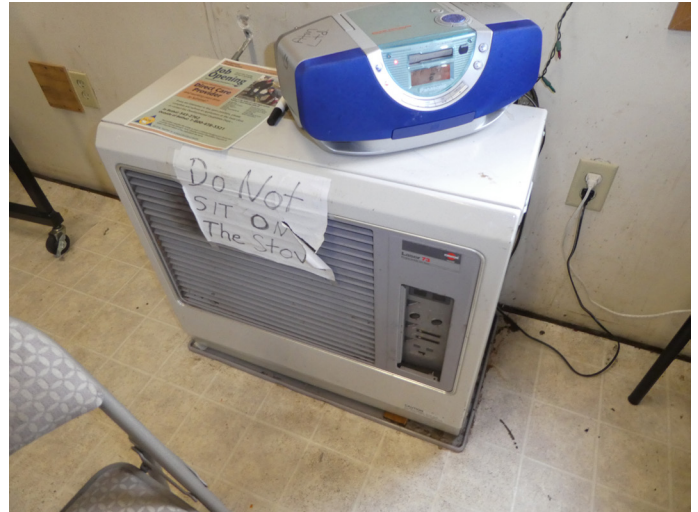
Check on the Toyotomi stoves periodically to ensure that the programmable thermostat is set to reduce the temperature at night.

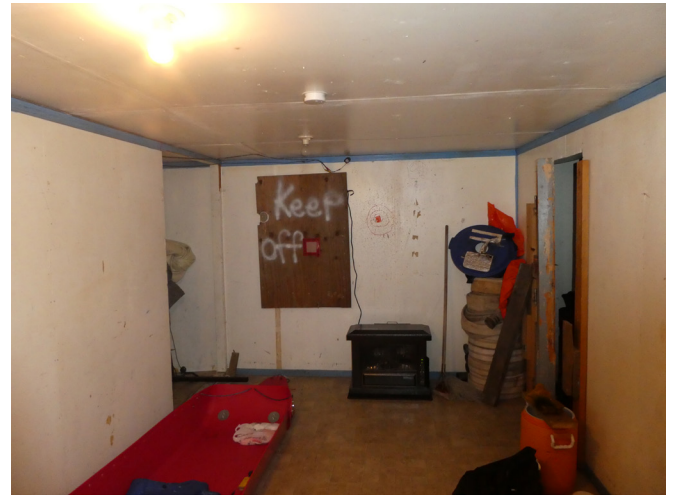
The Toyotomi stove in the police station should be checked on periodically to ensure that the programmable thermostat is set.

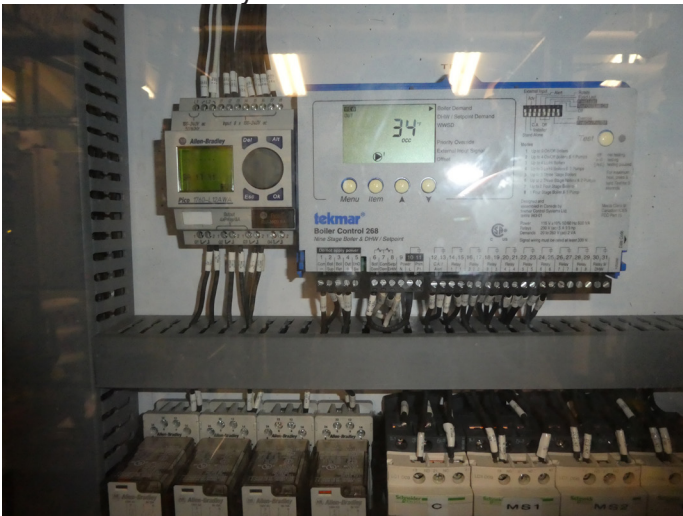
Ensure that the thermostat for the boiler is programmed to run at lower temperatures when there is no one in the building.

- Heating: Check that the programmable thermostat for the boiler is configured. If it is not, it will need to be reprogrammed to run at lower temperatures when there is no one in the building.
- Lighting: Ensure all lighting fixtures are operating and document any failed fixtures. Ensure replacements are LED.
- Health and safety: Check the smoke alarm and CO detector to make sure they have power and the batteries are full.
- Envelope/Structure: Walk around the exterior of the building and document any damage, such as cracked windows, shifting foundation, or damage to the siding.
- Occupants: Talk to the building occupants. Have they noticed anything that is making the building unsafe or uncomfortable? Document their comments in the maintenance notebook, and follow up with any concerns.

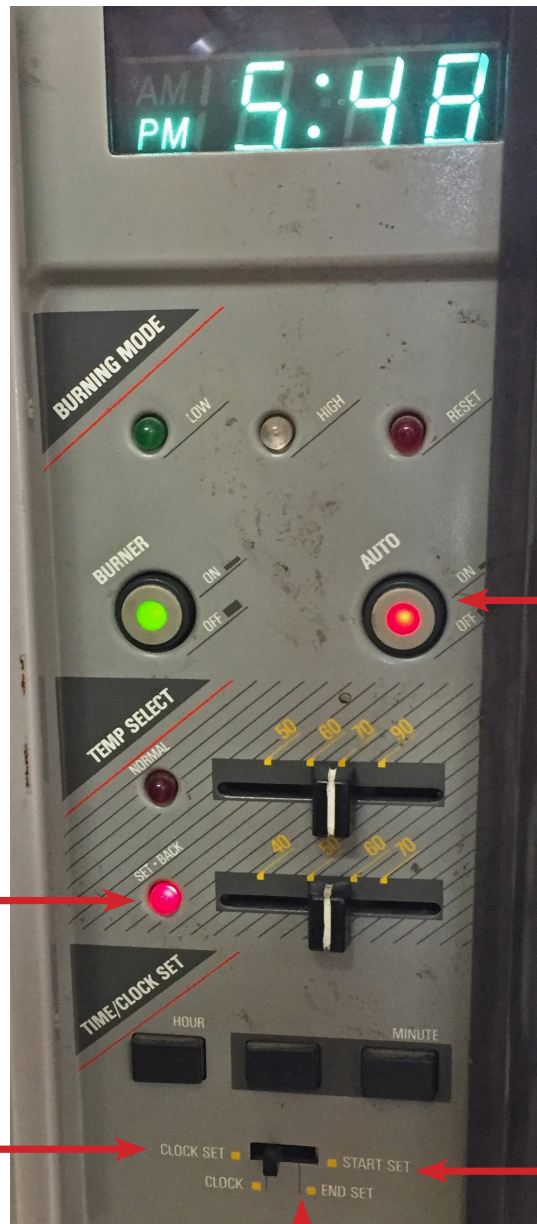
# TOYO SET BACK INSTRUCTIONS

\*  
IF CLOCK IS FLASHING,  
TOYO NEEDS TO BE  
RESET

Auto Mode **5**
