Outbuilding NW of Tannington Hall

HERITAGE IMPACT ASSESSMENT

Jane Blanchflower

June 2021

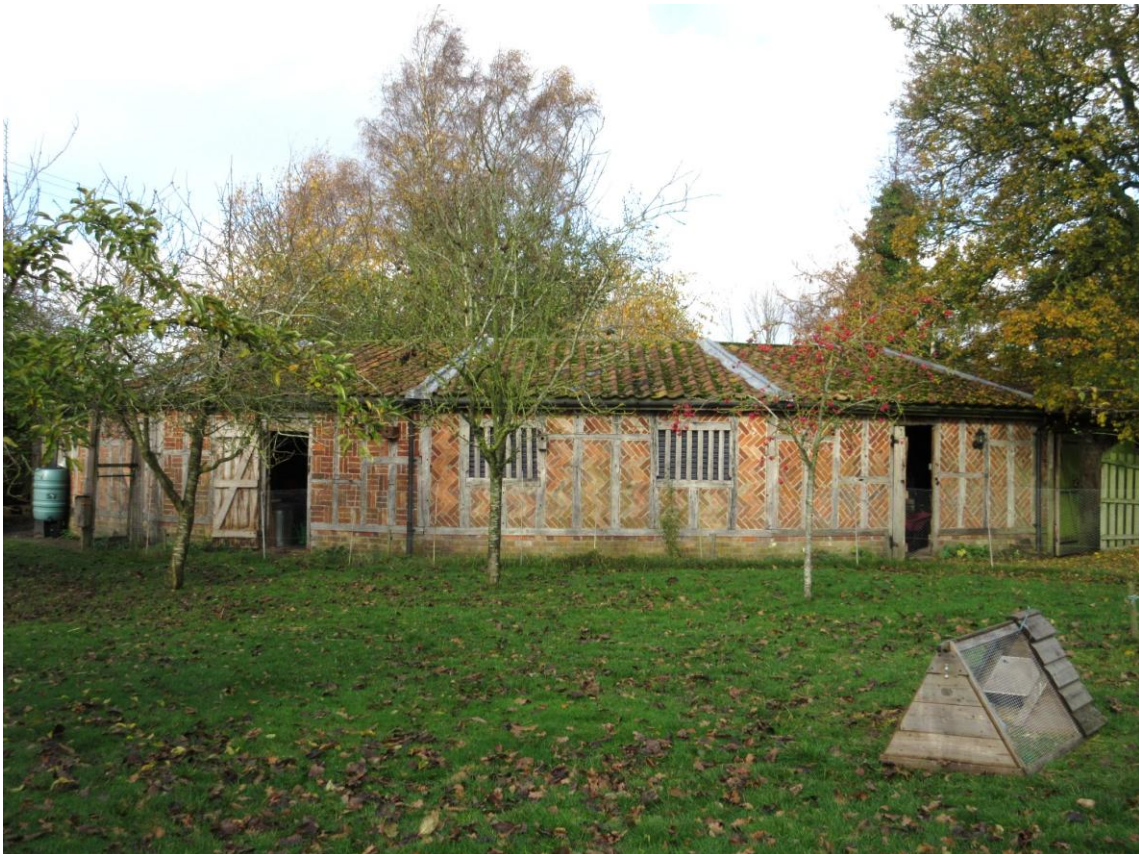
Outbuilding at Tannington Hall, looking N

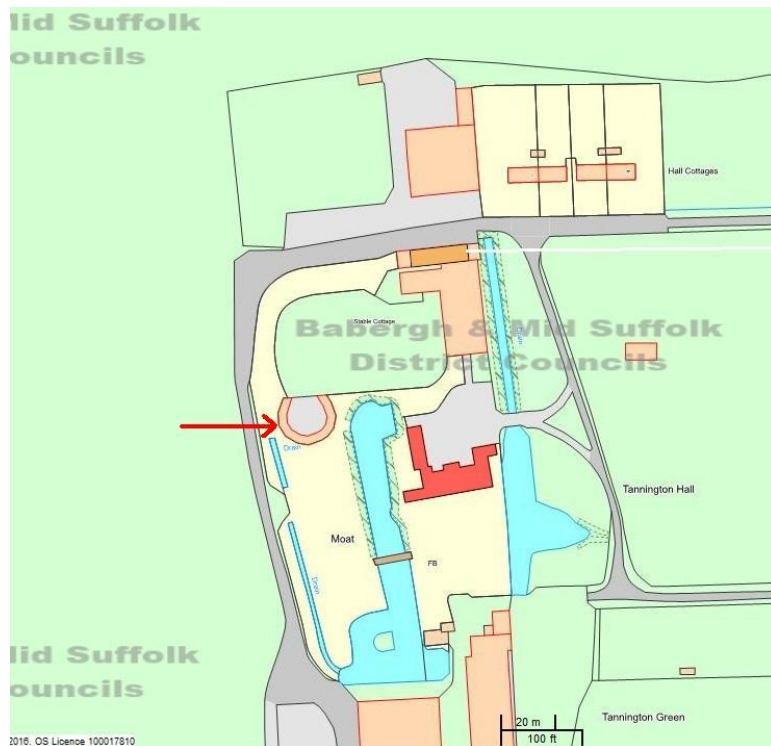
2016 BDC & MSDC SDP OS site plan. Tannington Hall (Grade II*) shown in red; the red arrow indicates the outbuilding and lunging ring

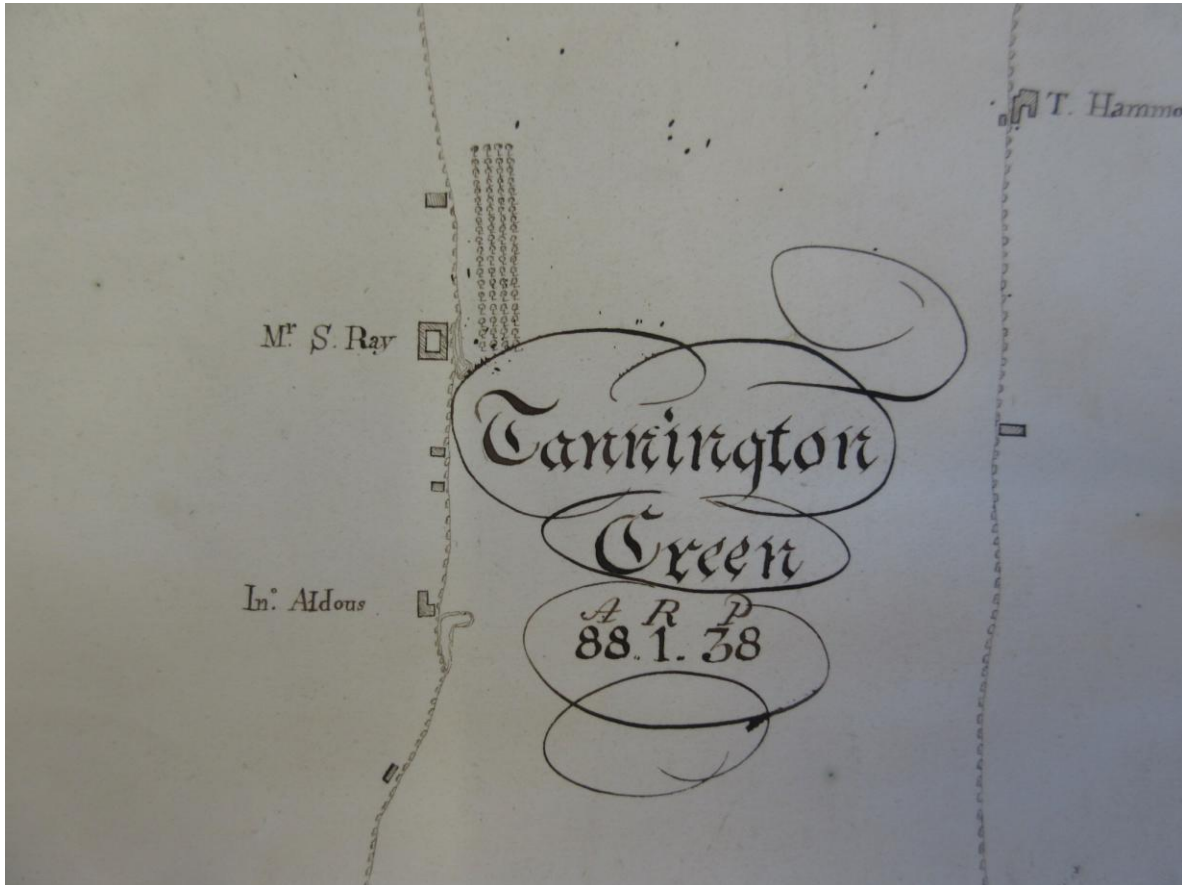
Late 18th century plan of Tannington Green, no scale (SROI fc 93/L1/24 13.95) Tannington Hall shown with a rectangular plan around a central courtyard, occupied by Mr S Ray

The earliest map in the Suffolk Record Office (SROI) showing the site is an undated late 18th century plan which shows the Hall as a rectangular building with central courtyard, partially moated. To the E, on the Green, are four rows of formally planted trees on a N/S axis. Tannington Hall was the estate of Humphrey Wingfield until he died in 1587 when it passed to the Dade family. The Hall was formerly their seat until they moved to Flixton Hall.

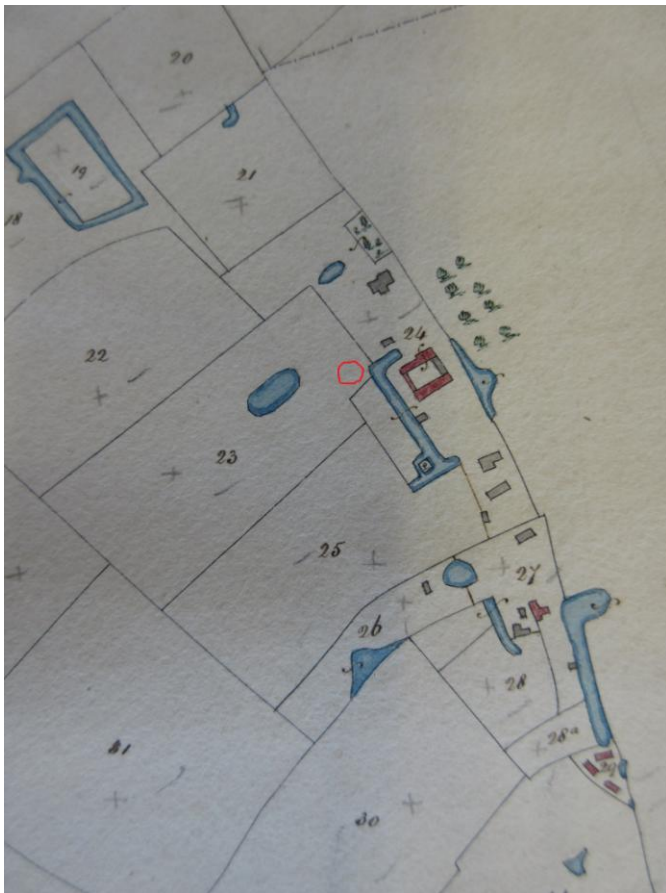
1842 Tithe Map, scale 6 chains : 1 inch (SROI FDA 251/A1/1b). Approximate site of outbuilding marked in red in enclosure 23

The 1842 Tithe Map shows outbuilding site in enclosure 23 described as *Pasture Park* in the Tithe Apportionment. There is a small outbuilding in enclosure 24 to the N of the moat. The footprint of the Hall is similar to that depicted on the late 18th century plan but the moat to the W is shown, with a small island at the S end. The section of moat to the E is shown and the remains of the lines of trees to the E. Garnham's Farmhouse, also partly moated, is shown on enclosure 27 to the S. There is a further moat to the NW on enclosure 19.

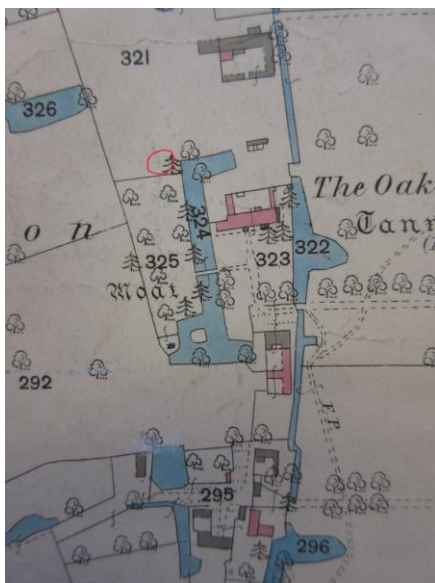
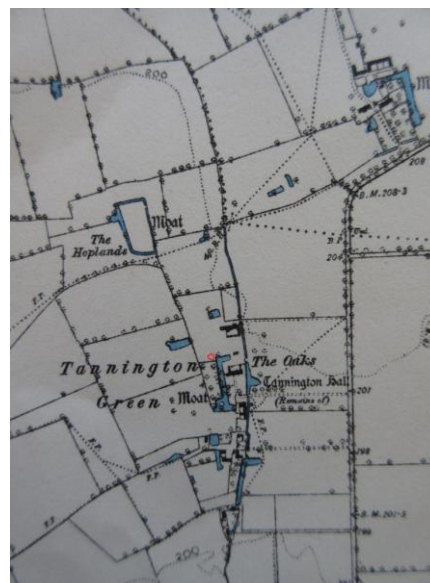
Left: 1885 1st edition OS, scale 25in : 1mile (SROI 37/15); Right: 1891 1st edition OS 6in (SROI TM 37 SE) site marked in red on both maps

The 1885 and 1891 OS maps show no building on the site. The 1885 map shows that the N part of the Hall had been demolished and most of the trees, named as 'The Oaks', have gone and the Green has been enclosed.

The 1891 six inch map shows less detail but the extract includes the hinterland, showing the site within its wider context. The field next to the moat to the NW of the site is named as 'The Hoplands'. Hops were grown as part of the mixed farming economy in this wood-pasture region of High Suffolk. The highway now known as Tannington Long Road is shown running in a straight N/S direction to the E of the site through what was formerly common land until the Green was enclosed.

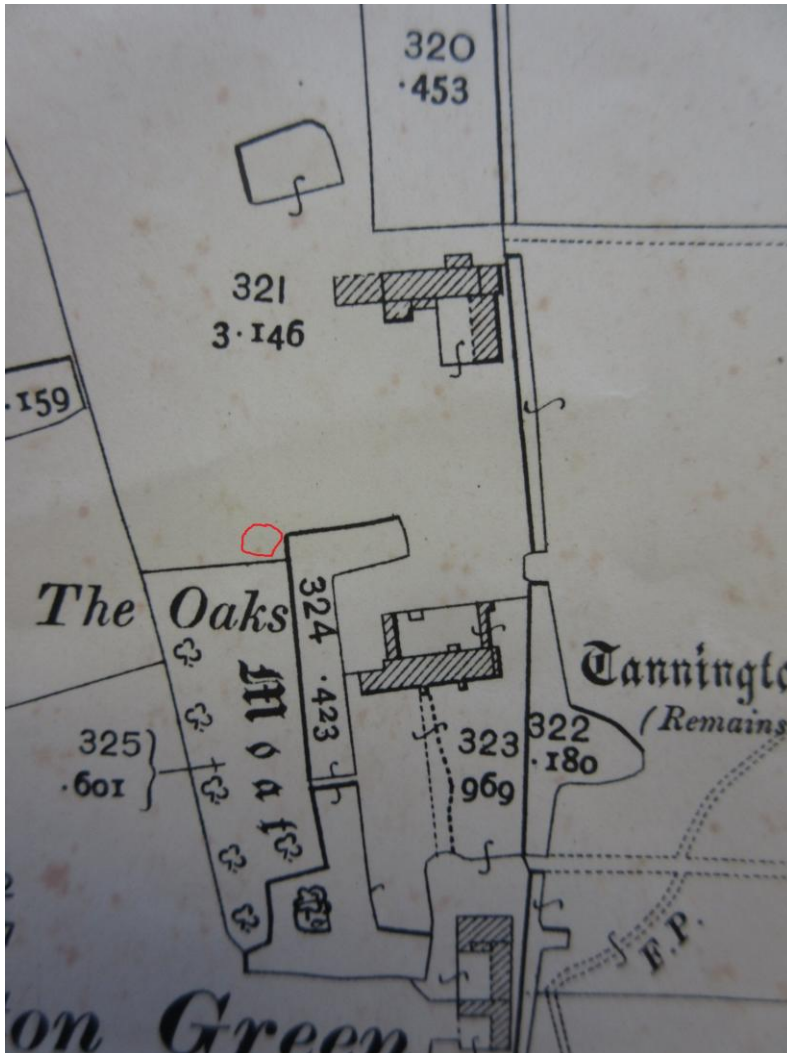
1904 2nd edition OS, scale 25in : 1 mile (SROI 37/15), site marked in red

By 1904 there are no trees shown to the E of the Hall but the small enclosure to the W of the moat has a line of trees and is named 'The Oaks'. The small outbuilding with attached yards or courts (probably a piggery), to the N of the Hall has gone.

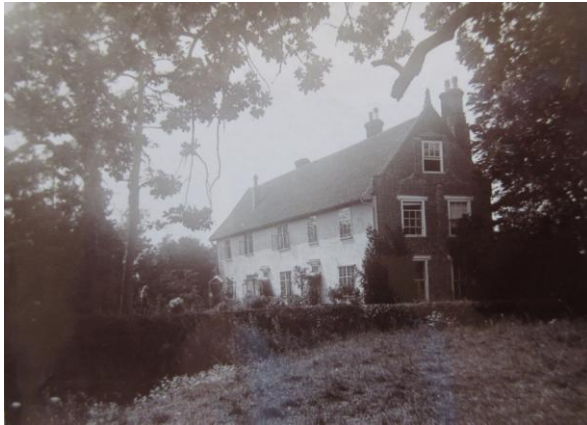
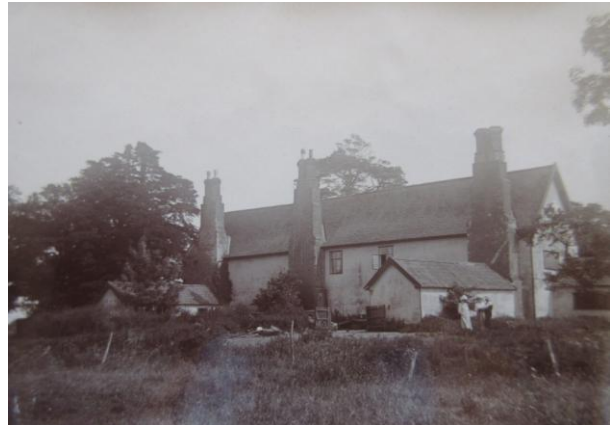
Early 20th century photographs of Tannington Hall; Left: S & E elevations; Right: N (former rear) elevation (SROI) photograph taken looking SE from near site of the outbuilding

retained and the elevations within view looking NW from the Hall will remain as existing. The building is only visible across the moat from the W elevation of the W wing of the Hall. This wing was substantially re-modelled during the mid-20th century from a single storey domestic wing (shown in the historic photograph on page 9) to a one and a half storey annexe with a lean to single-storey extension (shown on page 20) facing the W arm of the moat. The extension faces W and there are no direct views across the moat towards the outbuilding therefore there would be no appreciable overlooking.

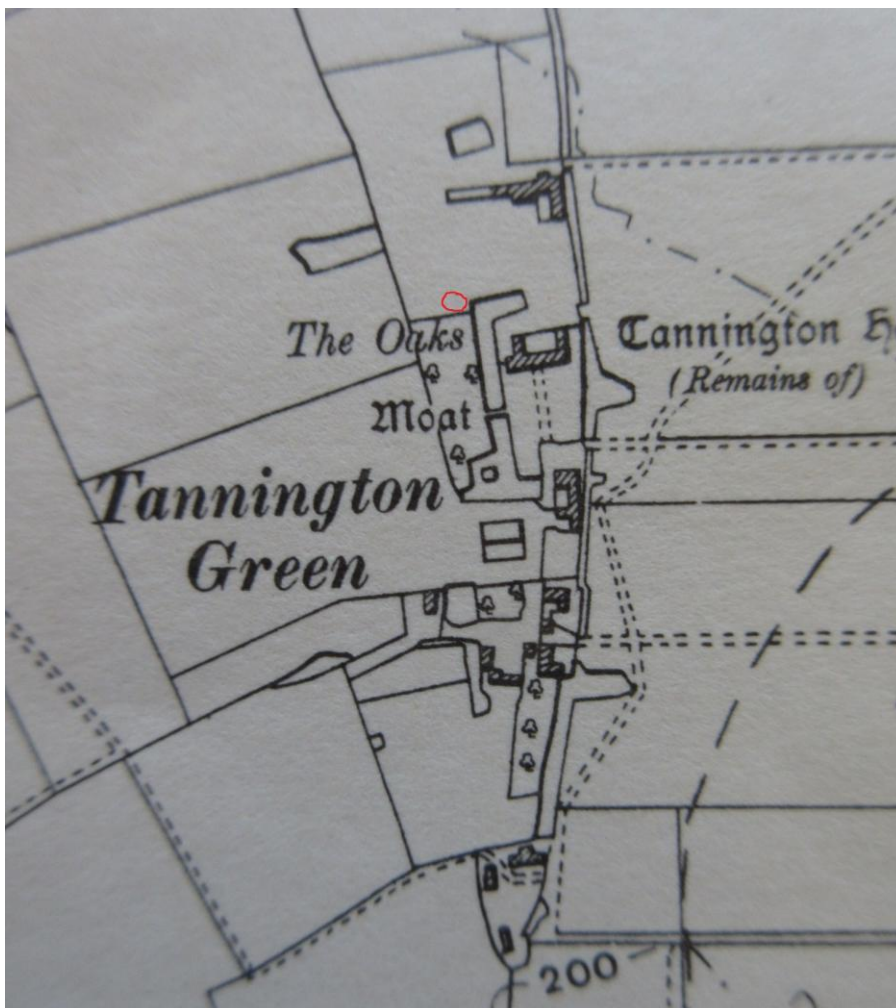
1947 Provisional OS, scale 6in : 1 mile (SROI TM 37SE) site marked in red

The 1947 six inch map shows no building on the site.

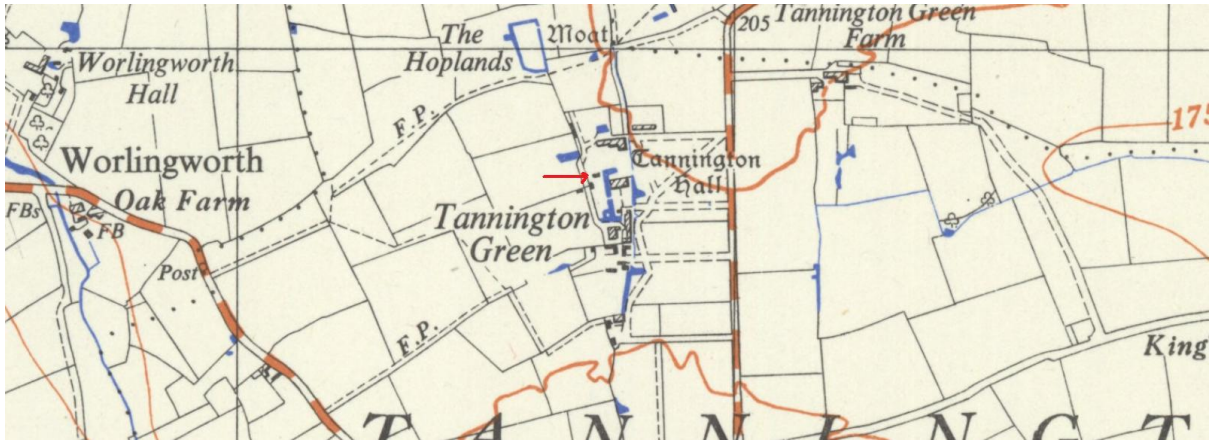
1956 OS TM 26C, scale 1 : 25,000 (National Library of Scotland website) red arrow indicates building

The 1956 1 : 25,000 OS map shows the outbuilding immediately W of the NW corner of the moat.

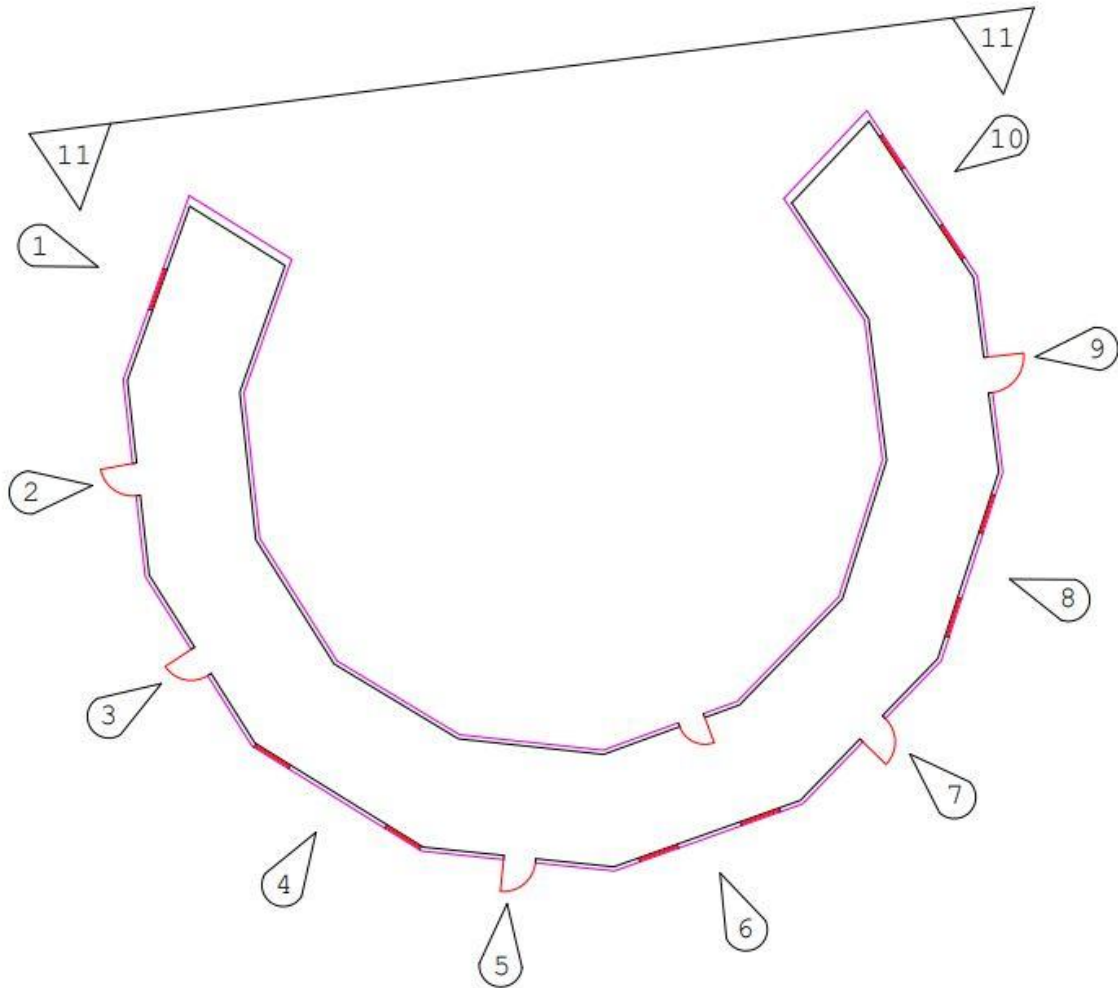
ELEVATION LOCATION PLAN

Elevation location plan, scale 1 : 50 (S J Geomatics drawing SJG3506)

The building itself has 10 elevations (numbered on the elevation location plan) which have single skin, red brick walls, laid in a variety of bonds, set on a red brick plinth with a timber sole plate. The bricks are set within timber studs and cross members to resemble the brick nogging used as infill in some timber framed buildings. There are five planked timber doors giving access to the internal compartments and nine timber mullion windows replicating those found in 16th century timber framed buildings. The roof is red clay pantiles with leaded seams and exposed rafter feet.

The elevations and internal compartments are referred to as numbered on the elevation location plan i.e. elevation 1 forms the exterior wall of compartment 1.

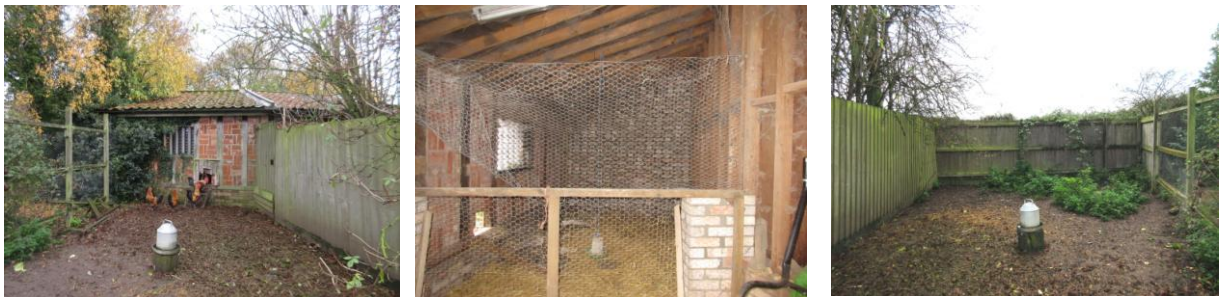
Compartment 1: Left: external elevation looking SE; Centre: interior looking NE; Right: associated enclosure looking NW

Elevation 1 has no exterior door and can only be accessed from inside the adjacent compartment 2. There is a temporary wire netting division between the two compartments and compartment 1 currently houses bantams which have a small opening with ramp leading into a fenced area outside the building. This area is enclosed by a boarded fence on the S and NW sides with a tall post, rail and netting fence on the NE side. There is a boarded gate in the S fence, giving access to the enclosure. Elevation 1 has a timber mullion window (with corrugated perspex sheet inside) and the red bricks (set in cement mortar) are arranged vertically and horizontally between the timber studs. The NE wall is of common brick, laid in cement mortar in Flemish bond. The floor is concrete and the SE wall facing into the lunging ring is constructed from plywood on sawn softwood framing. The gently sloping, monopitch, pantiled roof is lined and has closely spaced softwood rafters.

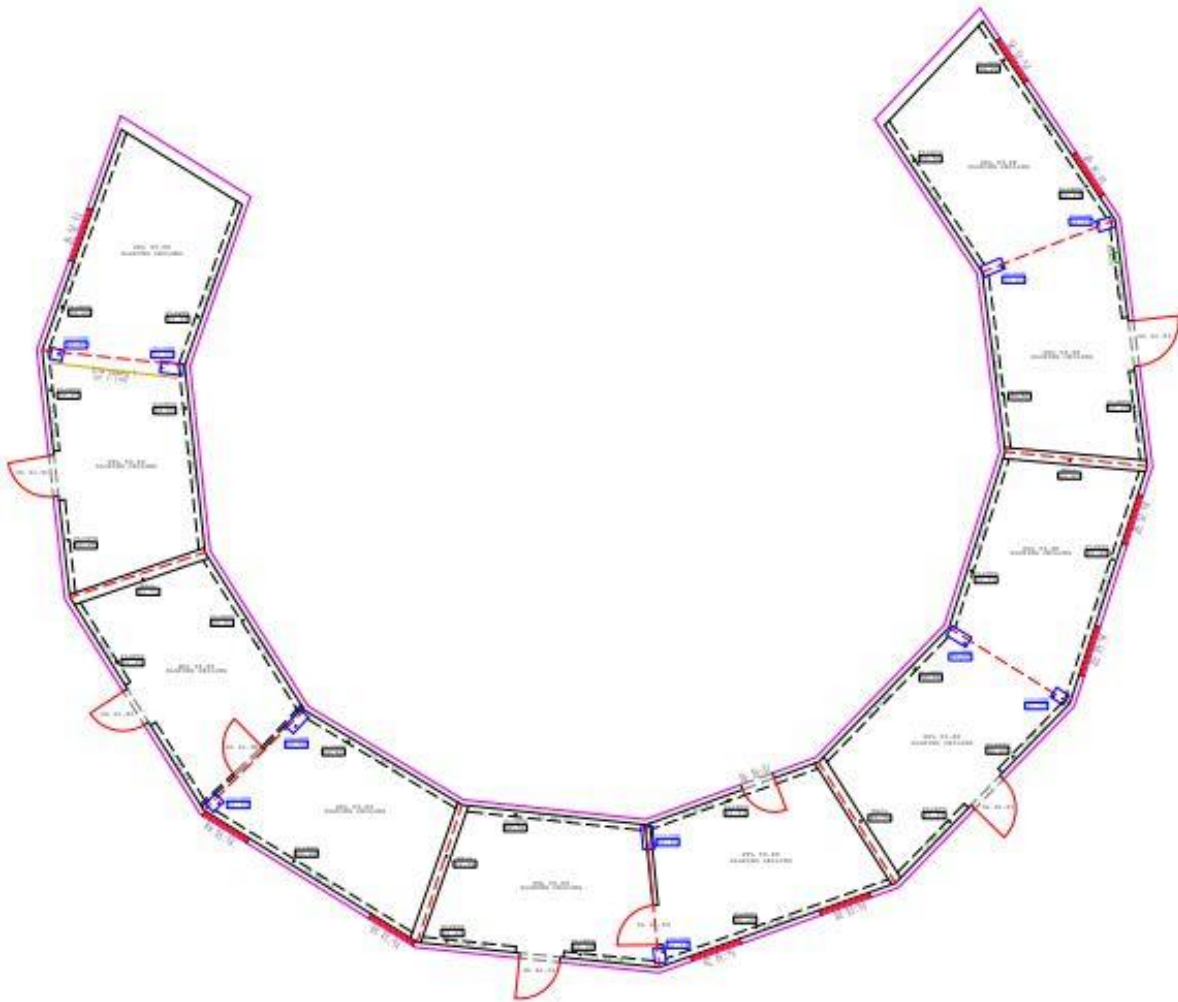
FLOORPLAN

Floor Plan, scale 1 : 50 (S J Geomatics drawing SJG3506)

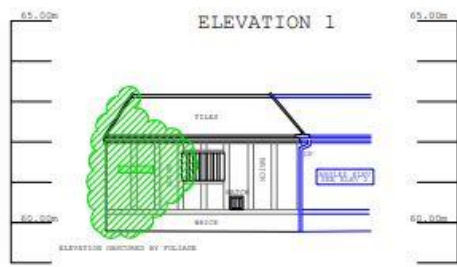
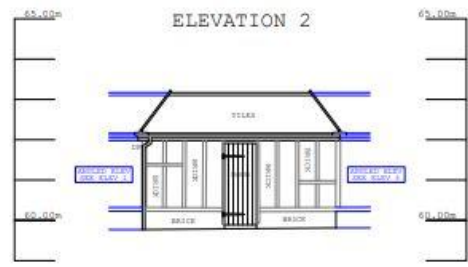
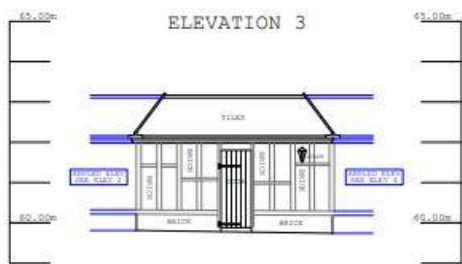
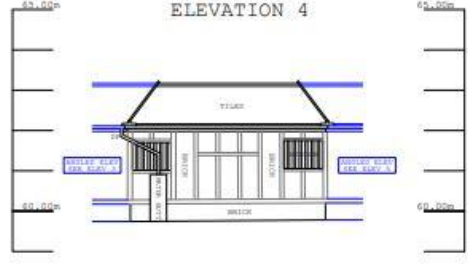
Elevations 1, 2, 3 & 4, scale 1 : 50 (S J Geomatics drawing SJG3506)

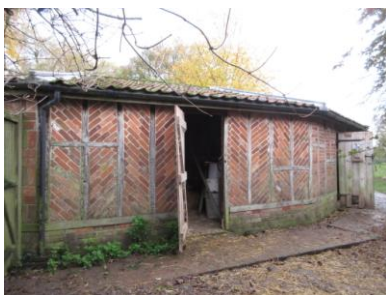
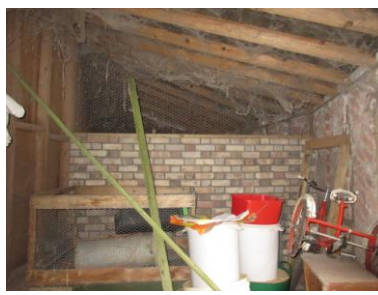
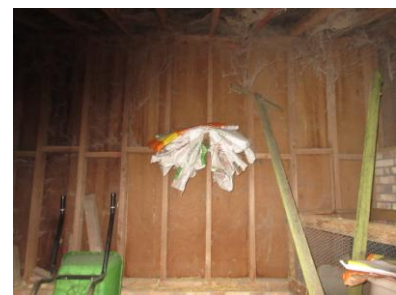
Compartment 2: Left: external W elevation; Centre: interior looking S; Right: E plywood wall

This compartment has no windows in the external wall and access is via a centrally placed battened and braced door. The panels above the sole plate and plinth have red brick nogging laid in herring bone pattern. The common brick S interior wall terminates below eaves level. The roof construction and plywood E wall are of the same construction as compartment 1.

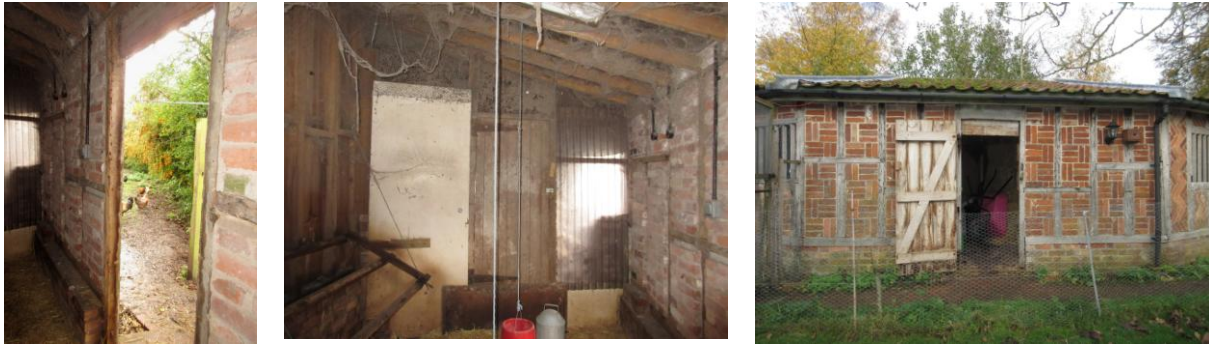
Compartment 3: Left: doorway showing single skin brick exterior wall; Centre: interior looking SE; Right: external SW elevation

This section contains nesting boxes and feeders for the bantams. There are no windows in the SW external wall and the door is battened and braced. The brick nogging is laid in a 'woven' pattern of alternating verticals and horizontals. There is a SE partition wall with a central planked door with a polypropylene corrugated sheet beside it.

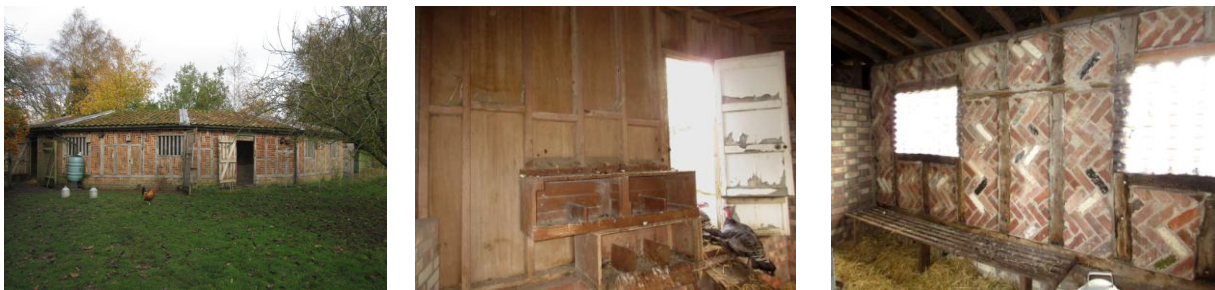
Left: elevations 4, 5 & 6; Centre: NW wall of compartment 6; Right: SE wall of compartment 6

Compartment 4 has two windows, herring bone pattern nogging and no door in the SW elevation; it is accessed via an internal door from compartment 3 and is used for straw storage. Compartment 5 faces S and has a central battened and braced door but no windows. The E internal partition wall has a door leading to compartment 6 which accommodates the turkeys. Compartment 6 has two mullion windows, herring bone nogging and a door with ramp leading into the former lunging ring.

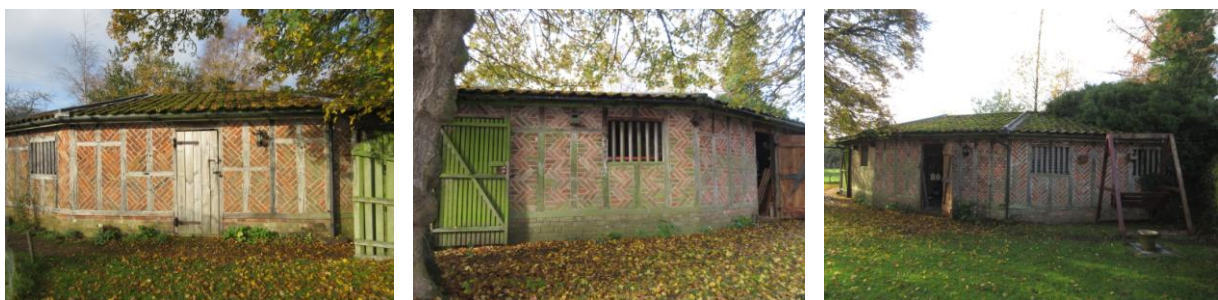
Left: elevation 7; Centre: elevation 8 (mullion window hidden behind green gate; Right: elevation 9 & 10)

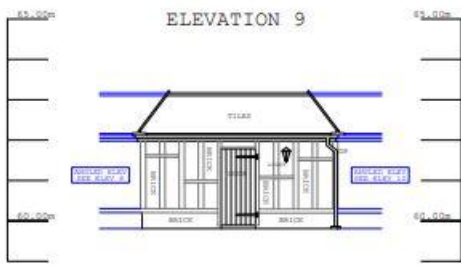
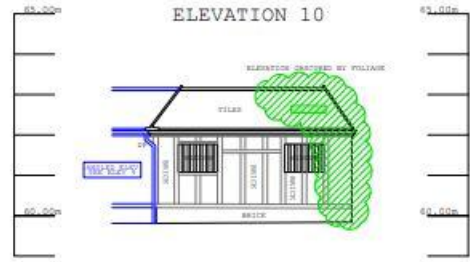
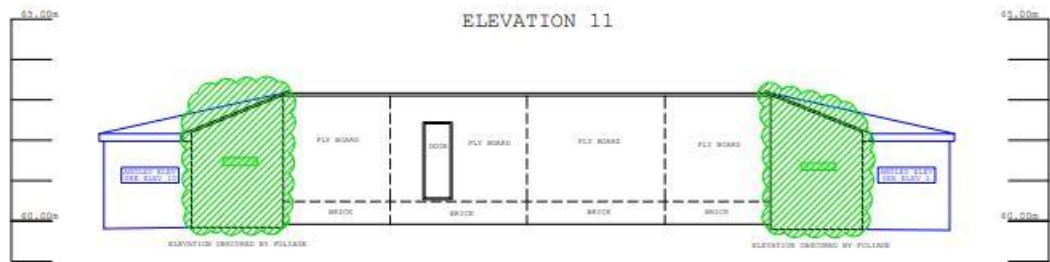
Elevations 9, 10 & 11, scale 1 : 50 (S J Geomatics drawing SJG3506)

The drawing shows this elevation looking due S into the horseshoe-shaped lunging ring, therefore not all of the plywood clad elevations are visible in the drawing. All 10 of these angled elevations (forming the sides of the lunging ring) are of plywood on an inner timber frame. The only variation is in compartment 6, just E of the central axis, which has a narrow doorway with ramp leading into the lunging ring which now serves as a turkey enclosure. The 'open' side of the horseshoe shape is aligned with the boundary of an open area of lawn

(a former field in which the farm buildings stand) to the N. The two ends of the horseshoe are linked by a fence with a gate through which horses entered the lunging ring but this is now closed to contain the turkeys.

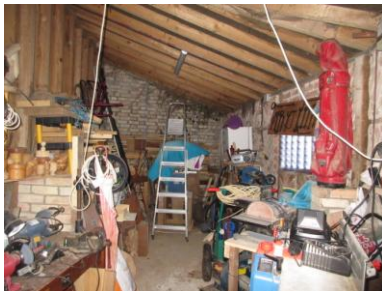
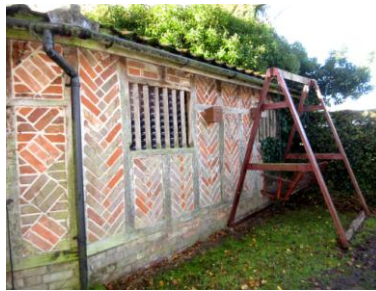
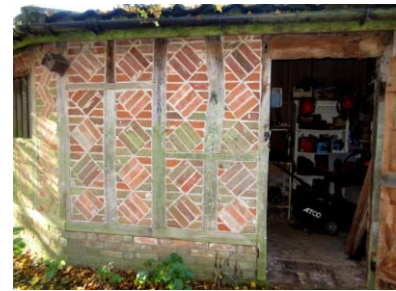
Left: interior looking NW; Centre: NE elevation of compartment 10; Right: doorway and diamond pattern brick nogging of E elevation of compartment 9

There is no internal division between these two compartments which are used as a workshop and garden equipment store. Access is via a single battened and braced door in elevation 9. This elevation has no windows but elevation 10 has two mullion windows. The construction is the same as in the other elements with variations in the ornamental brick nogging, the bricks laid in diamond and herring bone patterns. The NW end wall of compartment 10 has a wall of common brick, laid in Flemish bond with a plywood section above. The floor is concrete as is the case throughout the building.

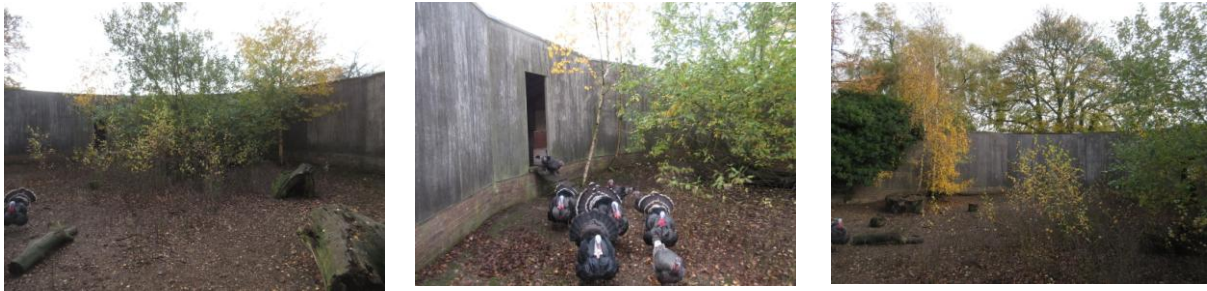
Interior of Lunging Ring: Left: looking N showing silver birch trees; Centre: looking SW showing doorway and ramp in N elevation of compartment 6; Right: looking NE

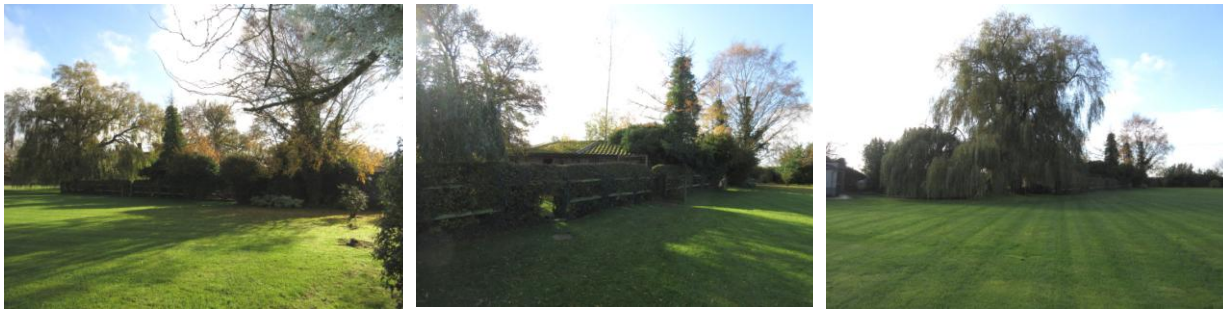
Left: looking SE towards lunging ring from lawned area to N; Centre: looking SW showing hedge to E of outbuilding; Right: looking S from lawned area towards N end of moat, outbuilding obscured by trees

The outbuilding stands behind a hedge and post and rail fence on the S boundary of a large lawned area to the SW of a former livestock building which is now in use as a wedding venue. It is screened by the hedge and some mature trees. Horses entered the lunging ring via a gate in the fence on the N side but the lunging ring became disused when the family ceased to keep horses some years ago. The horseshoe shaped building was used for keeping tack and general storage and was subsequently adapted for domestic fowl.

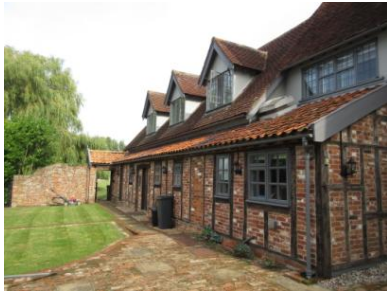
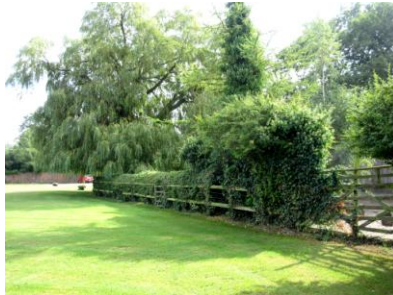
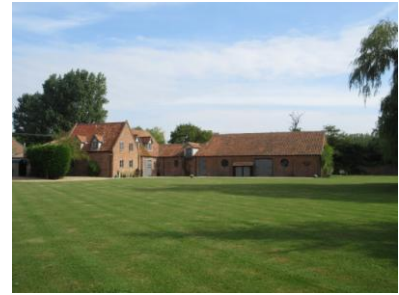
Left: single storey lean to on W side of W rear wing of Hall; Centre: boundary fence and gate on N side of lunging ring; Right: looking NE from outbuilding across lawned area towards wedding reception barn (all photographs 19.9.16)

To the SE of the building is the W arm of the moat which terminates approximately level with elevation 10 of the outbuilding. There are several mature trees to the N of the moat which screen the moat and building looking SW from the wedding reception barn. To the S of the outbuilding is a meadow in which the bantams spend the day before returning to the outbuilding at night. To the E of the meadow is the moat and the W rear wing of the Hall. This wing was re-built in the 1950s at approximately the same time as the outbuilding. The single storey lean to on the W side of this rear wing is of similar construction using re-claimed bricks and timber.

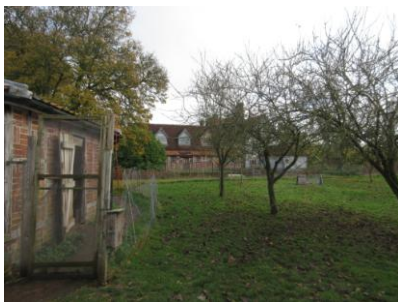
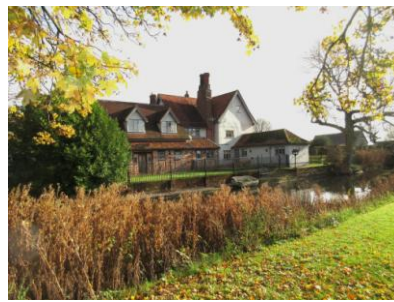
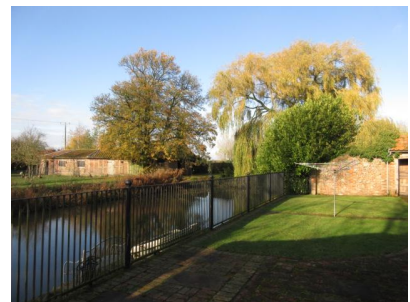
Left: looking E from S side of outbuilding; Centre: the Hall viewed from the meadow S of the outbuilding; Right: looking NW from the moat platform to the outbuilding

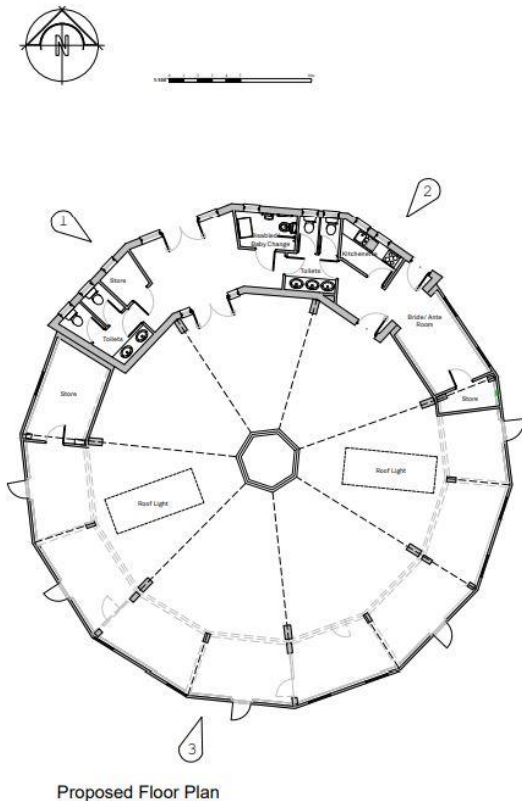
Left: Proposed floor plan, scale 1:100 @ A1 (Patrick Allen Architects drawing 4171 04 D)

The proposed floor plan and elevations (4171 04 D) show that the polygonal form of the building will be replicated on the NW, N and NE aspects but clad in contrasting natural timber vertical boarding. This new construction will replace the existing timber boarding and railed fencing on the perimeter of the lunging ring. The proposed site plan (drawing 4171 06) shows that three trees will be removed. The ones in the centre of the ring are self-seeded and have grown since the ring was no longer in use for lunging (ref. photographs on page 19); their removal is necessary for the building to be put to viable re-use.

It is proposed to remove the internal partitions in the southern, roofed part of the building. These compartments are described on pages 13-18 and are of no architectural significance. They are constructed from a combination of common brick, plywood, polypropylene sheeting and soft wood studs. The removal of these partitions will have a positive impact on the building. The existing walls of the lunging circle are of plywood on a softwood frame; their removal will enhance the setting and enable re-modelling to form a building of quality which incorporates the mid-20th century elevations facing towards the Hall.

It is proposed to create a bridal/ante room, WCs, kitchenette and store rooms in an annular form in the N half of new addition, leaving an open central space for the wedding ceremony or other events such as conferences. The design respects the circular form of the original building making reference to its former function as a lunging ring whilst also reading externally as an agricultural roundhouse housing a horse-driven engine sometimes found on Suffolk farmsteads before mechanisation.

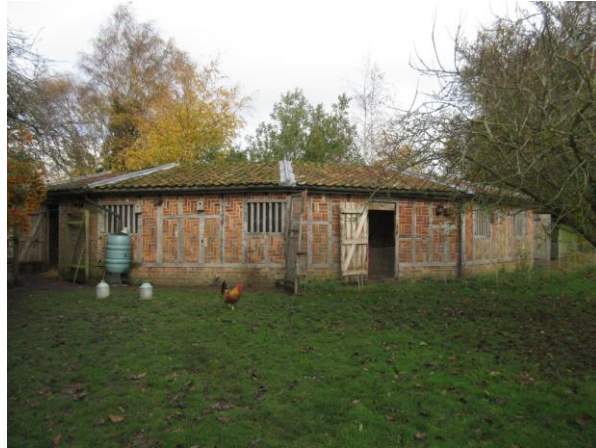
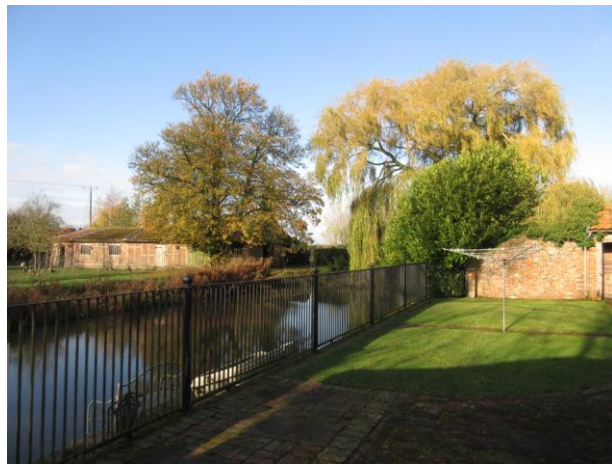
Right: Top: looking N from grassland to S of outbuilding; Bottom: looking NW towards outbuilding from moat platform on W side of W wing of Hall

The bottom right photograph shows the view across the moat from outside the W wing of the Hall. The existing walls and openings will remain and the pantiles will be replaced with a grey zinc roof which will be partly obscured by the tree immediately SE of the outbuilding. The existing brick wall at the NW corner of the W wing will ensure privacy for occupants of the annexe and its lawned area (shown in the left hand photograph on page 23) when guests are moving between the ceremony venue and the reception barn.

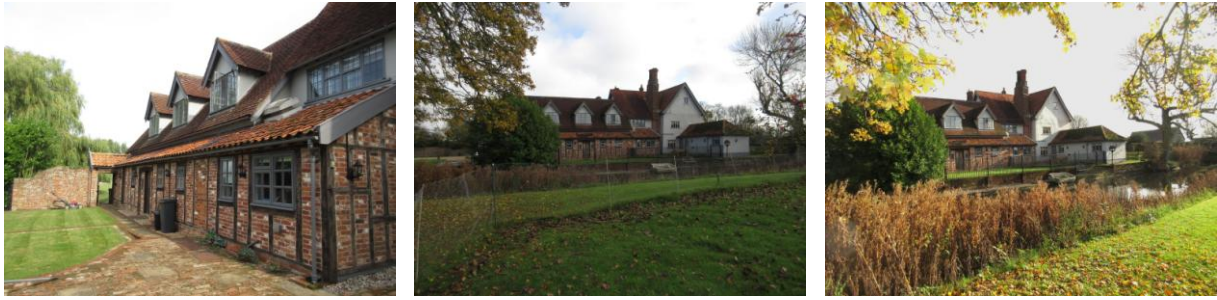
Left: W elevation of W wing showing brick nogging similar to the outbuilding; Centre: looking SE from grassland to S of outbuilding; Right: looking SE from outbuilding towards the Hall

Although the outbuilding is approximately 40m from the nearest NW corner of the W wing of the Hall, the visual relationship will remain relatively unchanged since the timber framed elevations with ornamental brick nogging (which mirror those in the lean to extension to the Hall wing) will be retained. The only visual change will be in the roofline which will be raised with a central lantern and the pantiles replaced with zinc cladding. The roof has been designed in two tiers with a gentle pitch and a low level lantern to reflect the annular form of the lunging ring and to avoid dominance and competition with the designated asset.

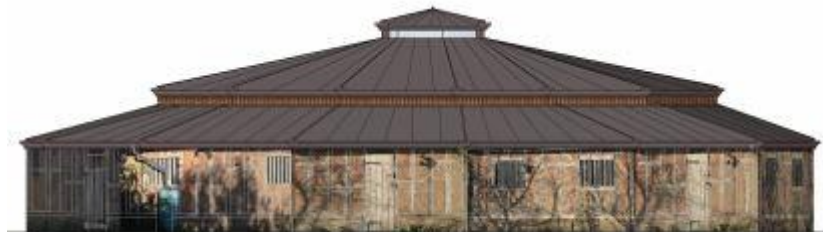
**Proposed Elevation (Natural Cladding)
"3"**

Proposed Elevation 3 (numbered on proposed floor plan), scale 1 : 100 @ A1 (Patrick Allen Architects drawing 4171 04 D)

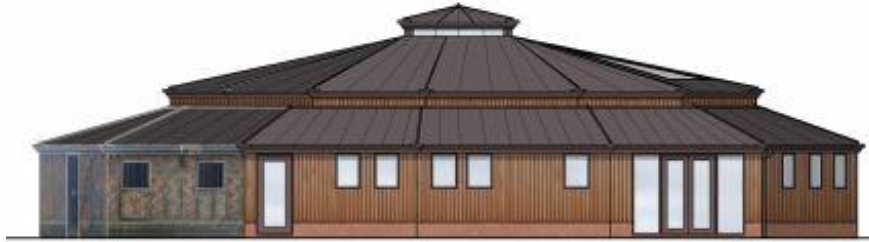
Proposed Elevation (Natural Cladding)
"2"

Proposed Elevation 2 (numbered on proposed floor plan), scale 1 : 100 @ A1 (Patrick Allen Architects drawing 4171 04 D)

The proposed windows and doors are of simple design without glazing bars, giving a vertical emphasis in a contemporary style which contrasts with the Neo-Tudor appearance of the southern elevations. The northern elevations face away from the listed building and will not compete with it or detract from its significance.

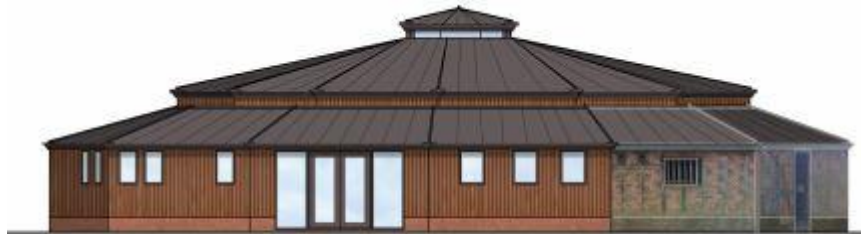
Proposed Elevation (Natural Cladding)
"1"

Proposed Elevation 1 (numbered on proposed floor plan), scale 1 : 100 @ A1 (Patrick Allen Architects drawing 4171 04 D)

The outbuilding cannot be seen from the N elevation of the Hall. This has become the main front with an entrance from the driveway although the S garden elevation was originally the principal facade as shown on the historic photographs on page 9. Hard landscaping will be minimal. Access to the wedding ceremony building will be via a red brick pathway from the driveway and it is proposed to lay a red brick path round the perimeter of the building giving access to the various entrances. The bricks will be laid in herringbone pattern to mirror the brick nogging in the existing walls. The low rise glazed lantern provides natural light and is a distinctive but low key central feature at the apex of the roof. Two roof lights are proposed; the W one is on a roof slope away from the Hall and the E one will be obscured from view by the mature tree immediately SE of the building when looking NW from the Hall. The shallow pitch of the roof prevents a direct view of the roof lights from ground level in any direction as shown in the elevational drawings (4171 04 D).

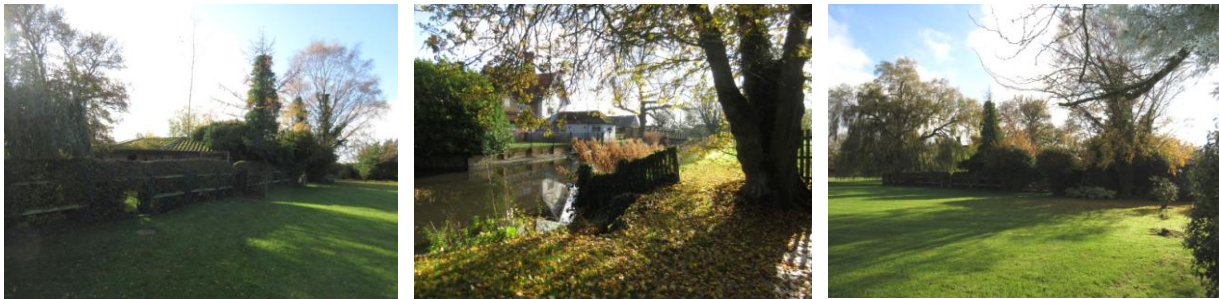
Left: looking SW towards outbuilding from lawned area; Centre: looking SE across the moat from the outbuilding; Right: looking S towards the outbuilding from the lawned area NW of the Hall

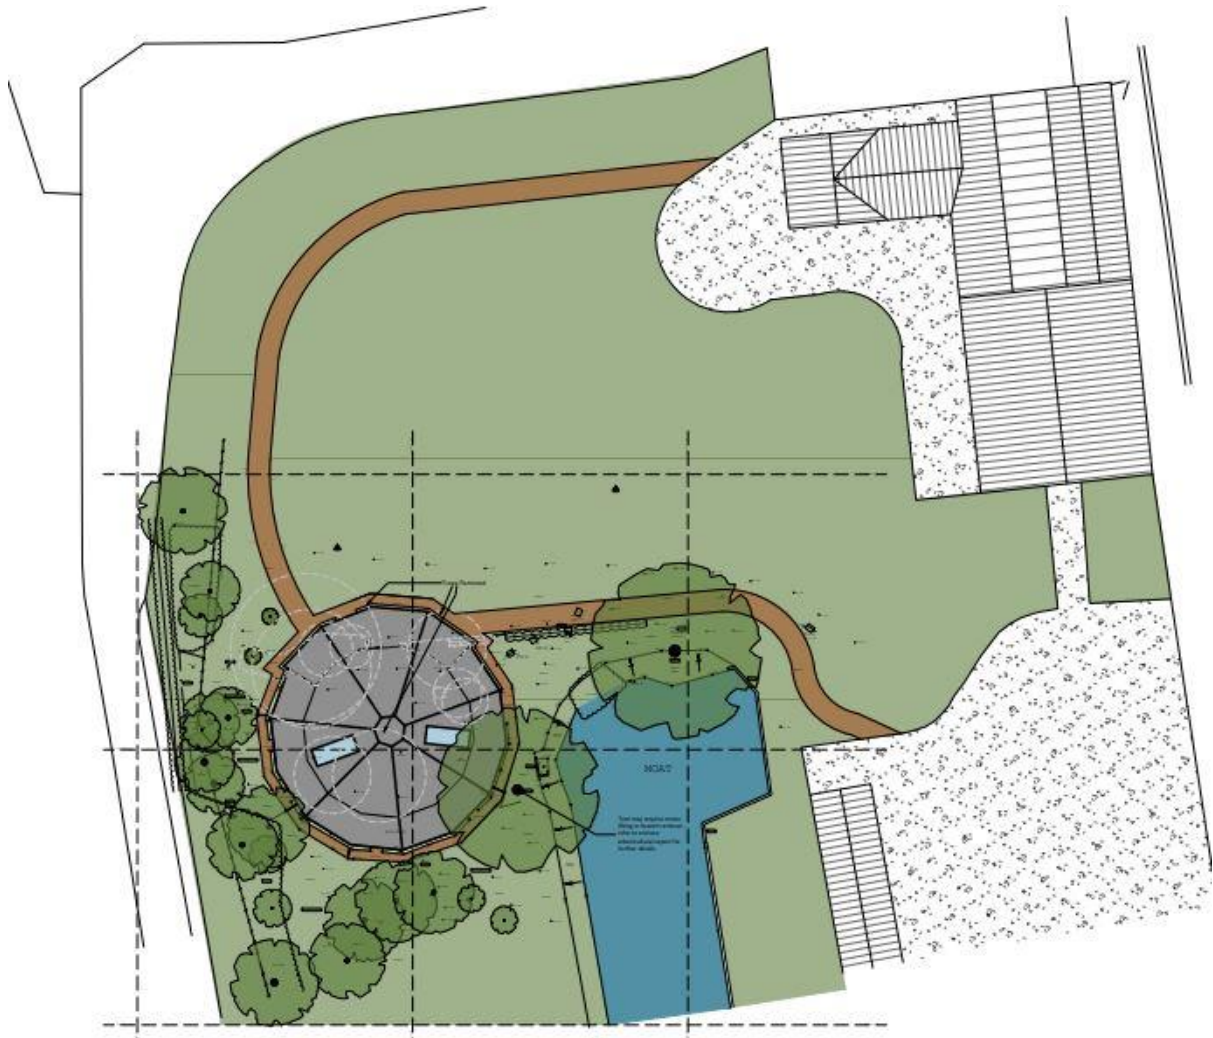
Proposed Site Plan, scale 1 : 200 @ A1 (Patrick Allen Architects drawing 4171 06)

The existing informal parking area for 100 cars (marked on the location plan on page 21) can be used in conjunction with the proposal. This is sited in a field some distance SE of the Hall and accessed via the existing surface driveway from the public highway. This car park has been approved and it removes the need for guests to park within the immediate setting of the Hall.
