# Provincial Flood Damage Assessment Study – Town of Millet: Damage Estimates

Submitted to Alberta Environment and Parks  
by IBI Group and Golder Associates Ltd.  
March 2019

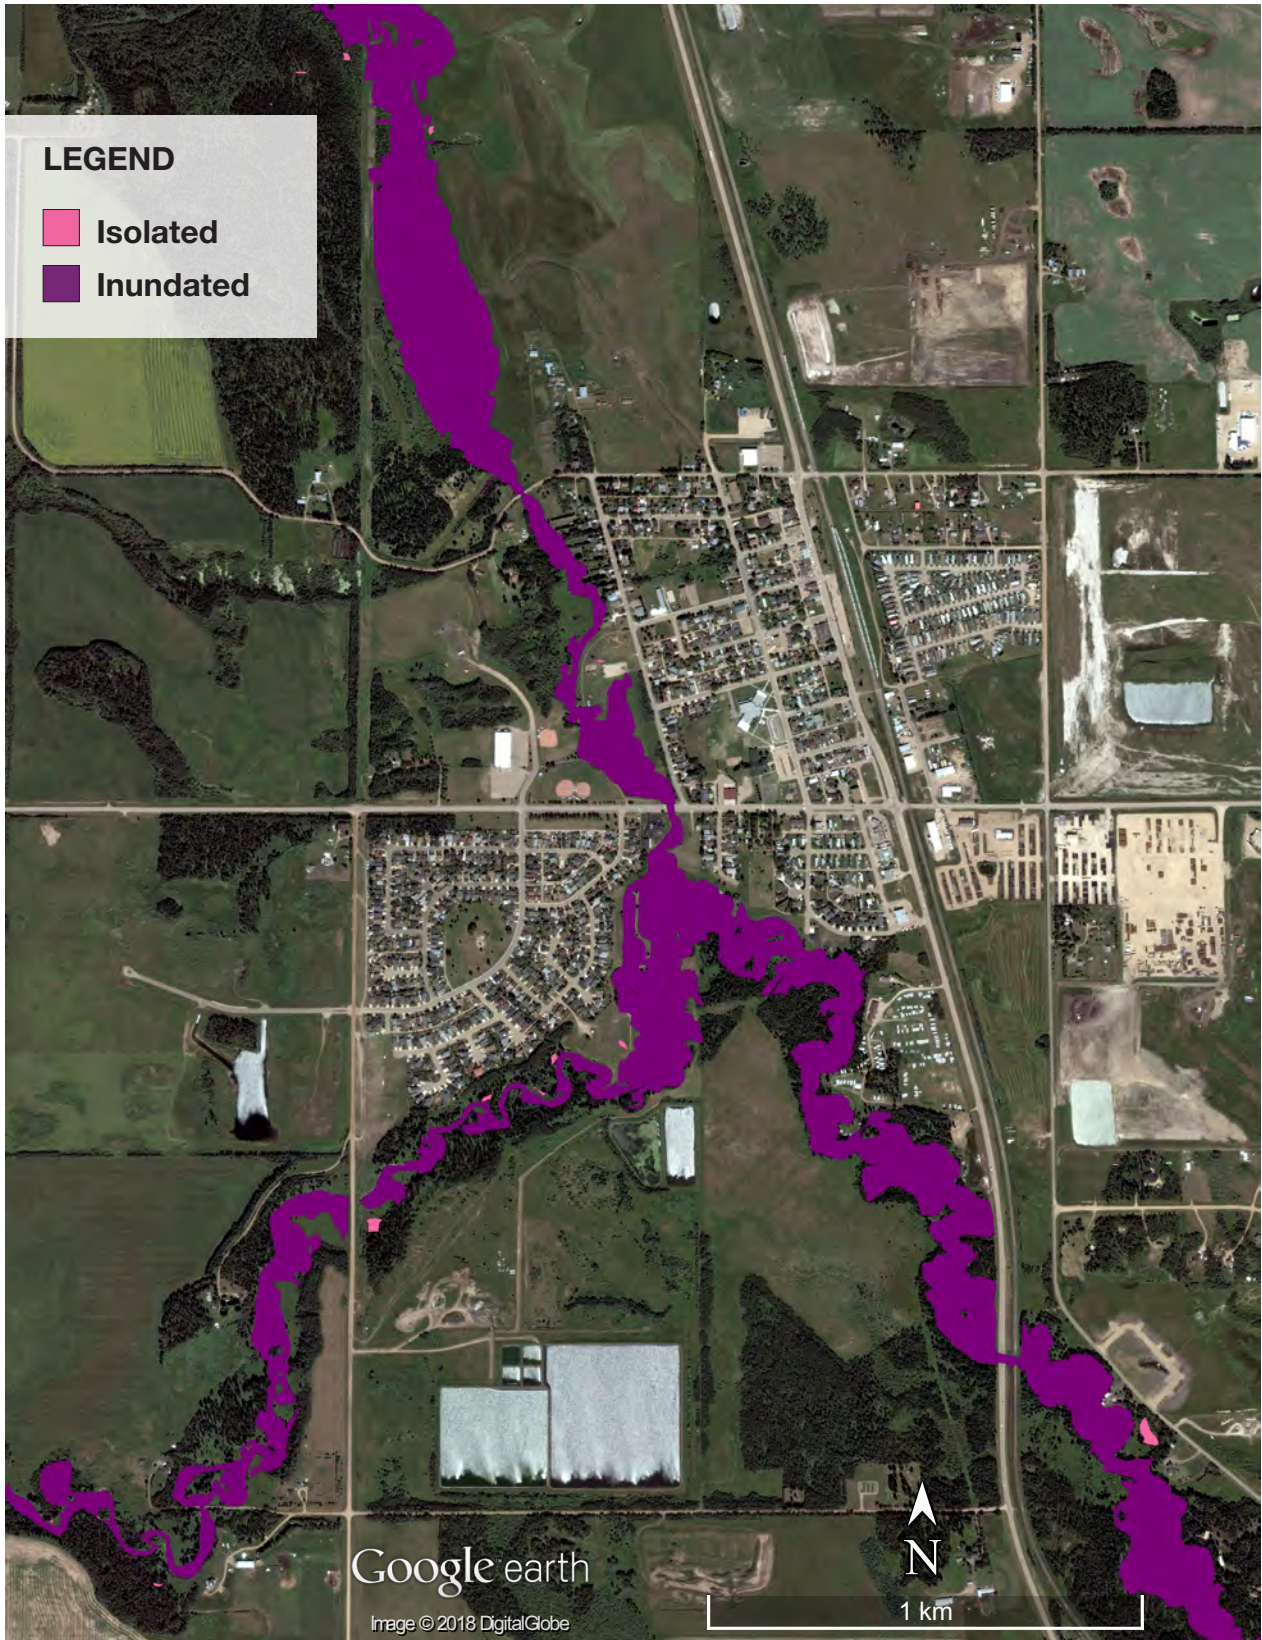
# Appendix D - Town of Millet Flood Elevation Mapping - 1:100 Year Flood

Areas of natural and maintained park, including pathways and a playing field are shown as inundated during the 1:100-year flood. Applying typical remediation costs per square metre for this type of landscaping indicates that the damage to public greenspace would be approximately \$5 million.
