How to Deal with Halen Estate

BY BERNHARD FURRER

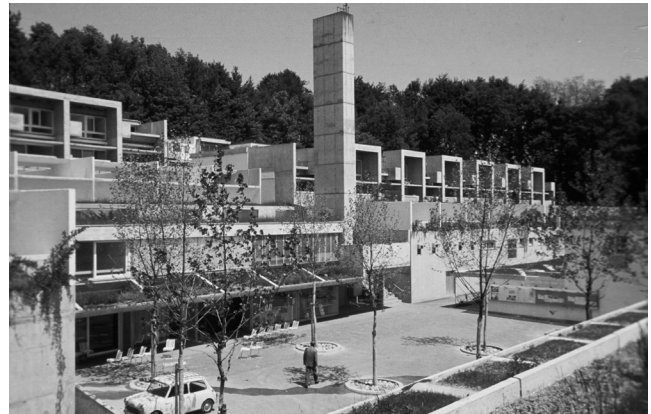
03 Central square immediately after completion. The horizontal streets and pathways and the perpendicular stairs lead up to it; they all lead to the square tangentially, not axially. The shop, the club-room and the laundries are directly connected to the square. On their way to the public transport stations or to the parking garage most of the inhabitants cross the square. © Archive *Atelier 5*. Photo by Albert Winkler, 1960s.

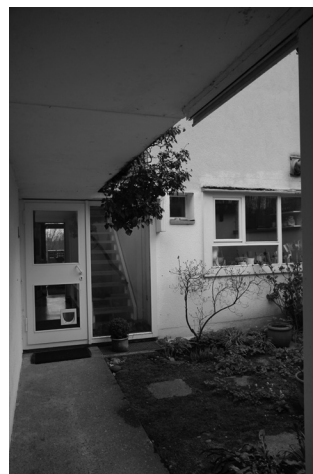
05 Courtyard of the broad type of houses. It is private, but orientated to the pathway, the public space. Beyond the outside door (many inhabitants normally leave it open) the view opens onto the courtyard and to the northern façade. A covered path leads to the entrance. Note the differentiated manners of mounting the windows (from outside, flush mounted, from inside). © Bernhard Furrer, 2012.

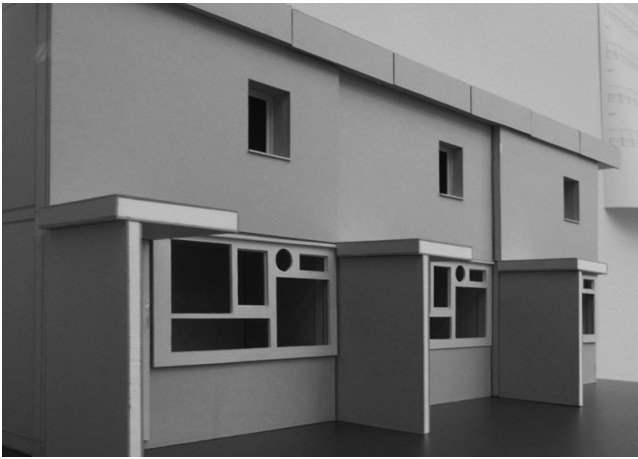
06 Model showing the effects of outside insulation of rear facades. Insulation would have required new concrete elements of the roof fascia mounted towards the outside. The differentiation of the mounting of windows would have been essentially harmed. © Suter + Partner architects, 2012.

From the outside, the success of the efforts towards adequate projects will mainly be discernible on the façades towards the north. As in many similar cases, improving the insulation of the façades is most delicate. A first intention with an external insulation of 12, 8 or 6 centimetres, covered by plaster, was abandoned, as it would have greatly altered the expression of the facades in relation to the intelligently differentiated position of the openings and windows. As every owner of a row would have been free to decide whether to insulate or not, the aspect of the façade would have become irregular for decades. Currently, proposals with 2,00 cm of extra thickness and/or a system of wall tempering (drying the wall increases its insulation capacity and assures comfort with lower ambient temperature) are being discussed.

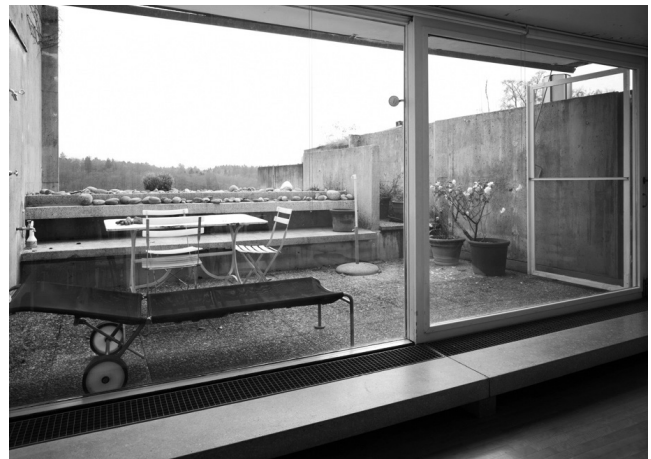
10 Solarium of the broader type of houses. The room behind the solarium opens wide to the outside with a concrete step that hides the convection heater and sliding windows with very slim frames. Towards the south a trough with plants forms a limit to the solarium, a sort of recess permits an overview of the Estate and the landscape. In accordance with the guidelines, covering of the solarium is not allowed anymore. © Archive *Atelier 5*. Photo by Nikolaus Schletterer, 1960s.
