JOURNAL OF THE CSXT® HISTORICAL SOCIETY

_____ Volume 7 Number 3 _____

BLUE DIAMOND COAL MINE

BLUE DIAMOND COAL COMPANY LEATHERWOOD, KENTUCKY MINE

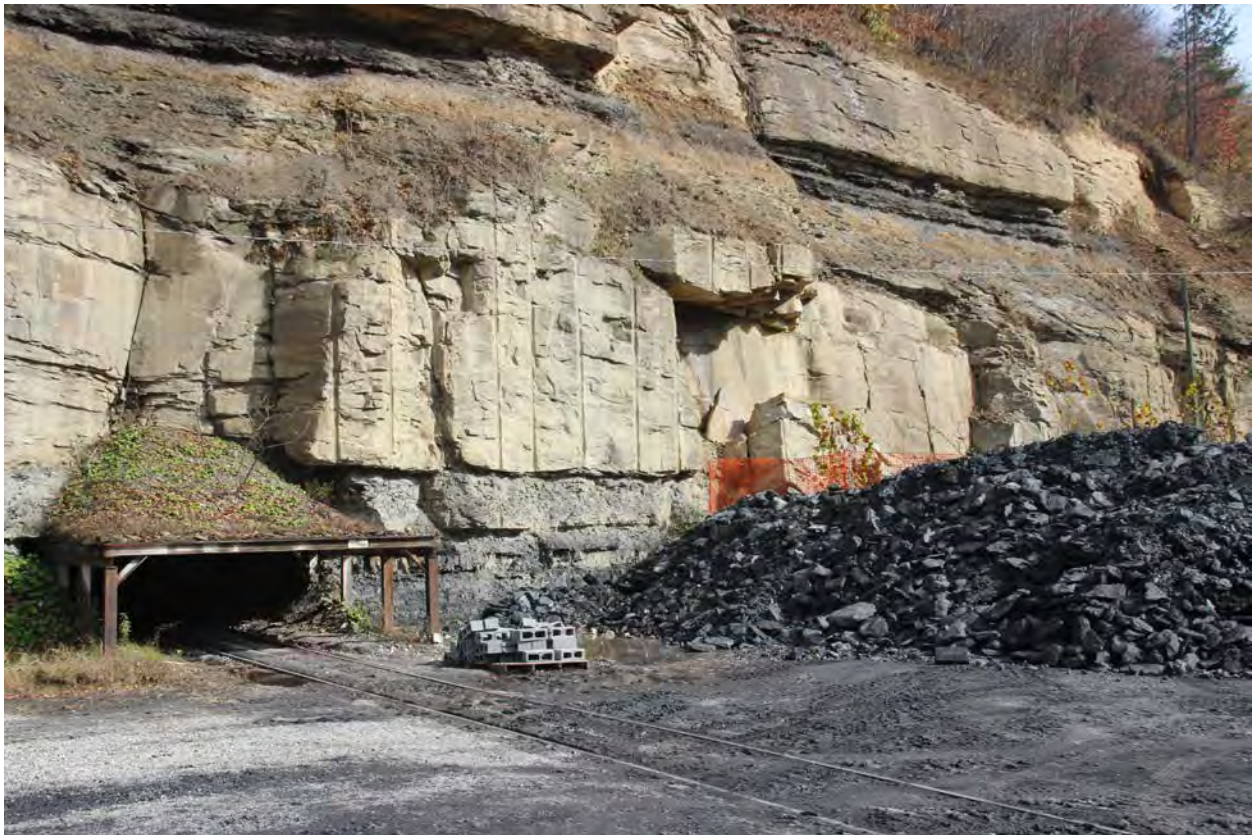
The entrance portal to Blue Diamond Mine. The track seen in the foreground carries electrically powered carts that bring the miners to their work site. Coal leaves the mine via an electrical driven belt from another mine portal. The coal on the right was part of a stockpile brought in by truck.

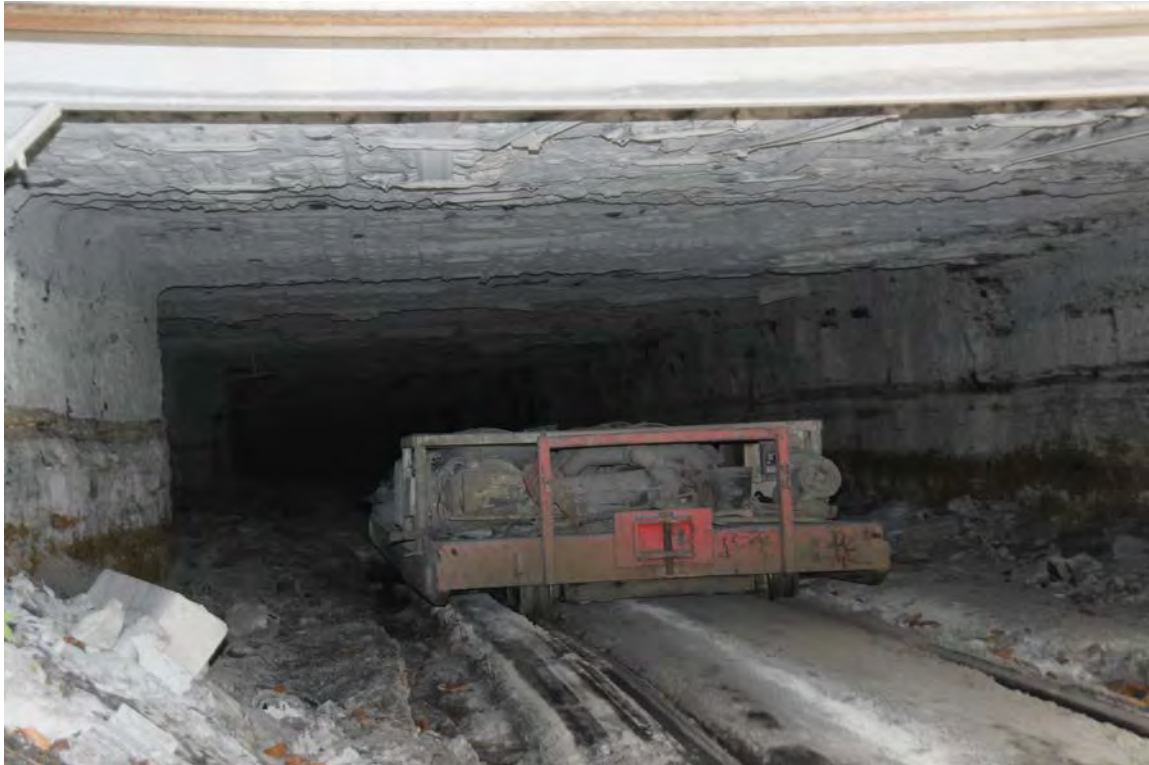
The mine cart that delivers the miners to the coal face. The tunnel is 40-inches high and ten-feet wide.

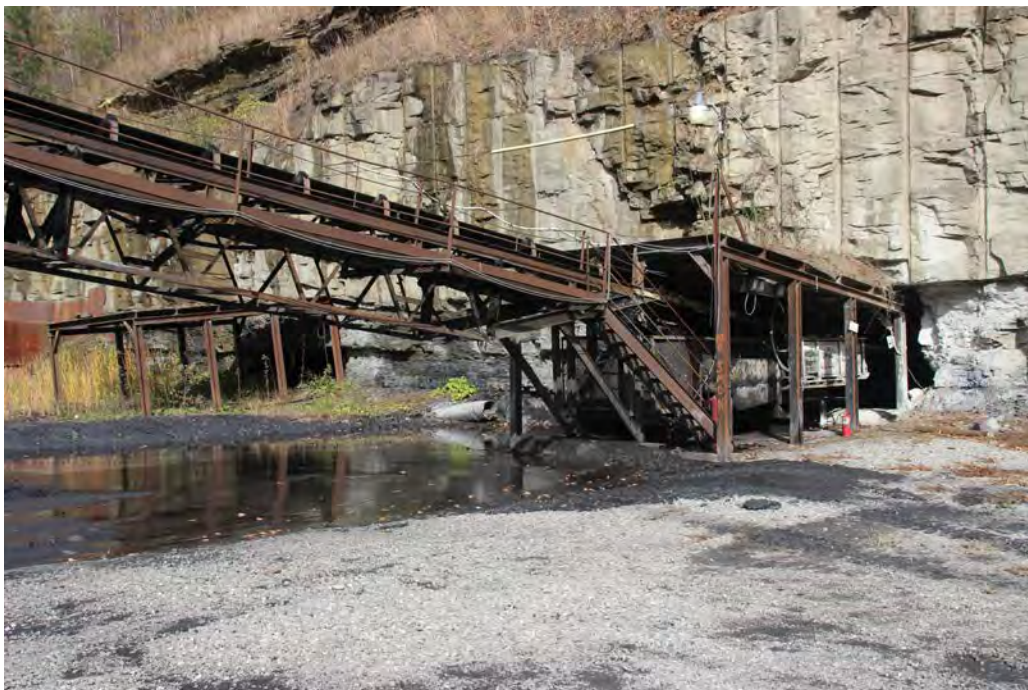
The conveyor belt that carries the coal mined from inside the mine to the wash plant. The open iron skeleton shed in the background was the previous site from which the conveyer belt exited the mine.

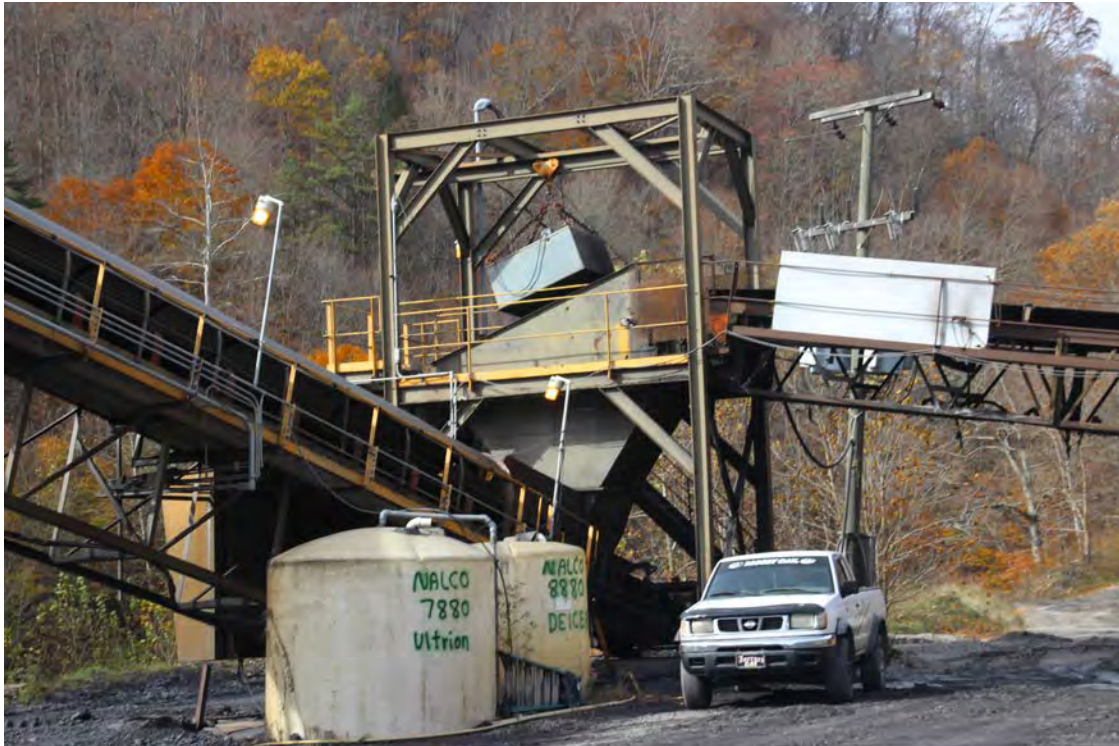
The conveyor belt on the right leads from the mine to this hopper which re-directs the coal into a conveyor belt running at a 90-degree angle from the mine.

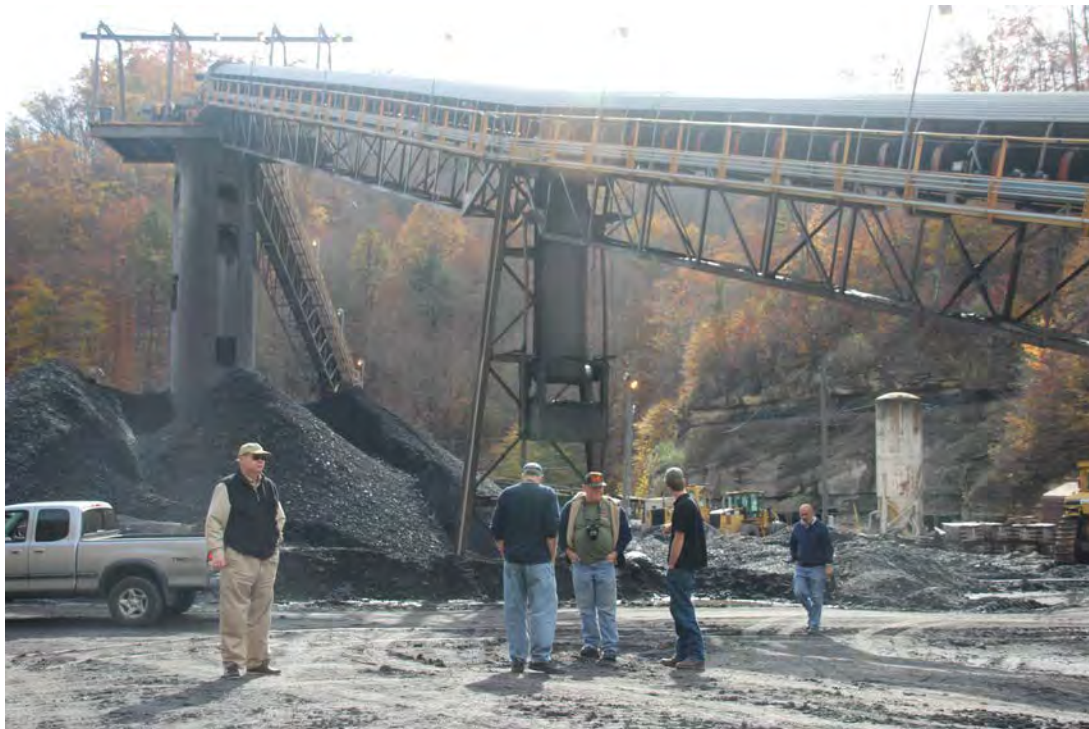
The above conveyor belt carries the newly mined coal to this stockpile area. From here the coal is sent to the wash plant. The ground is black mud.

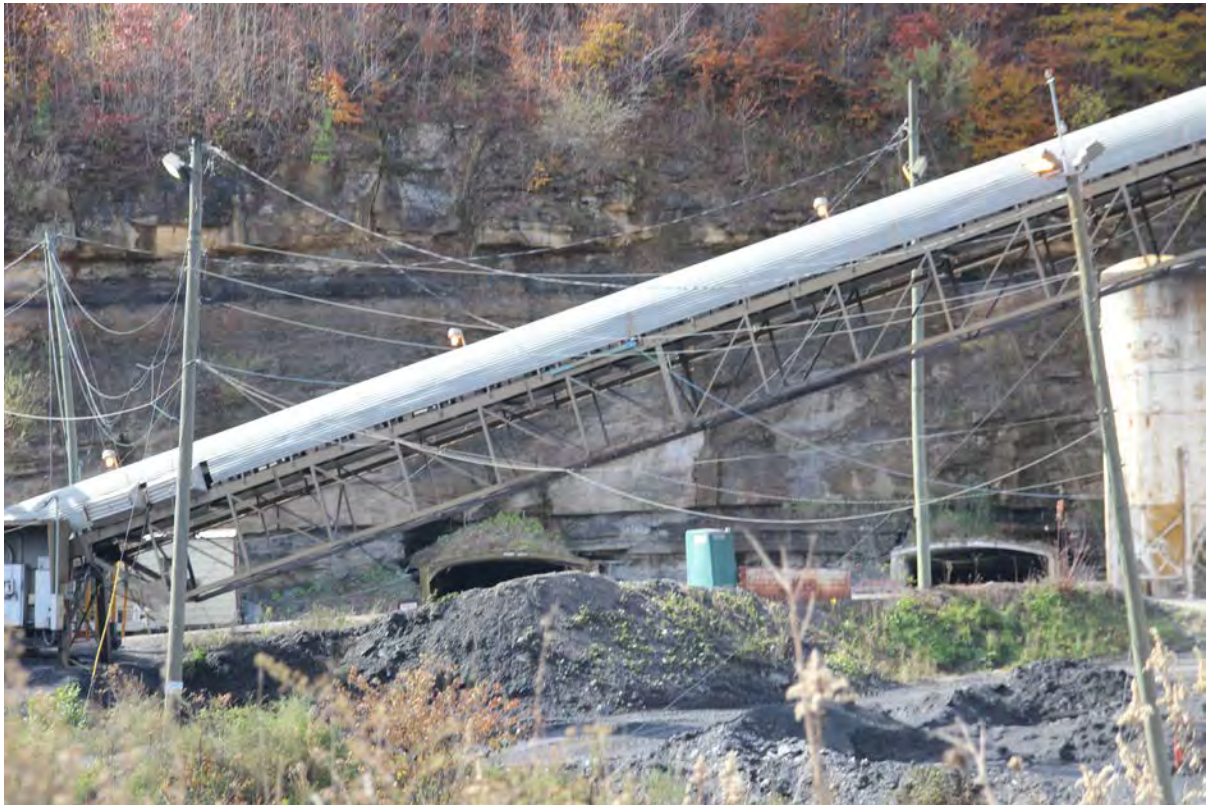
Beyond the conveyor belt are two additional entrances to the mine. These were not being used as the area was mined out. Only the coal pillars remained to be harvested.

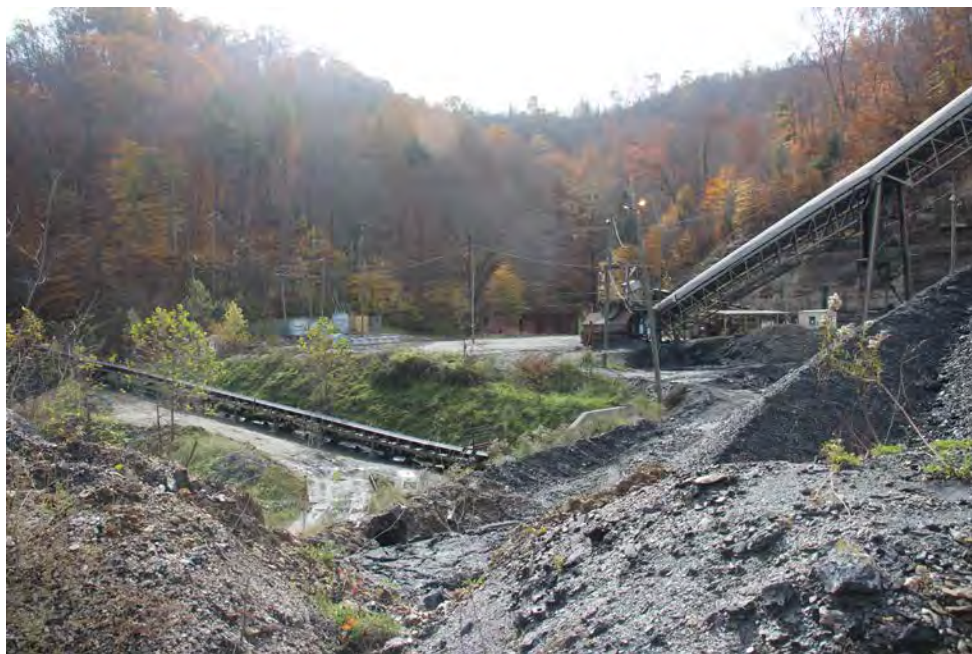
Conveyor belts snake through the property carrying coal to the wash plant from various coal veins that are being worked on the property.

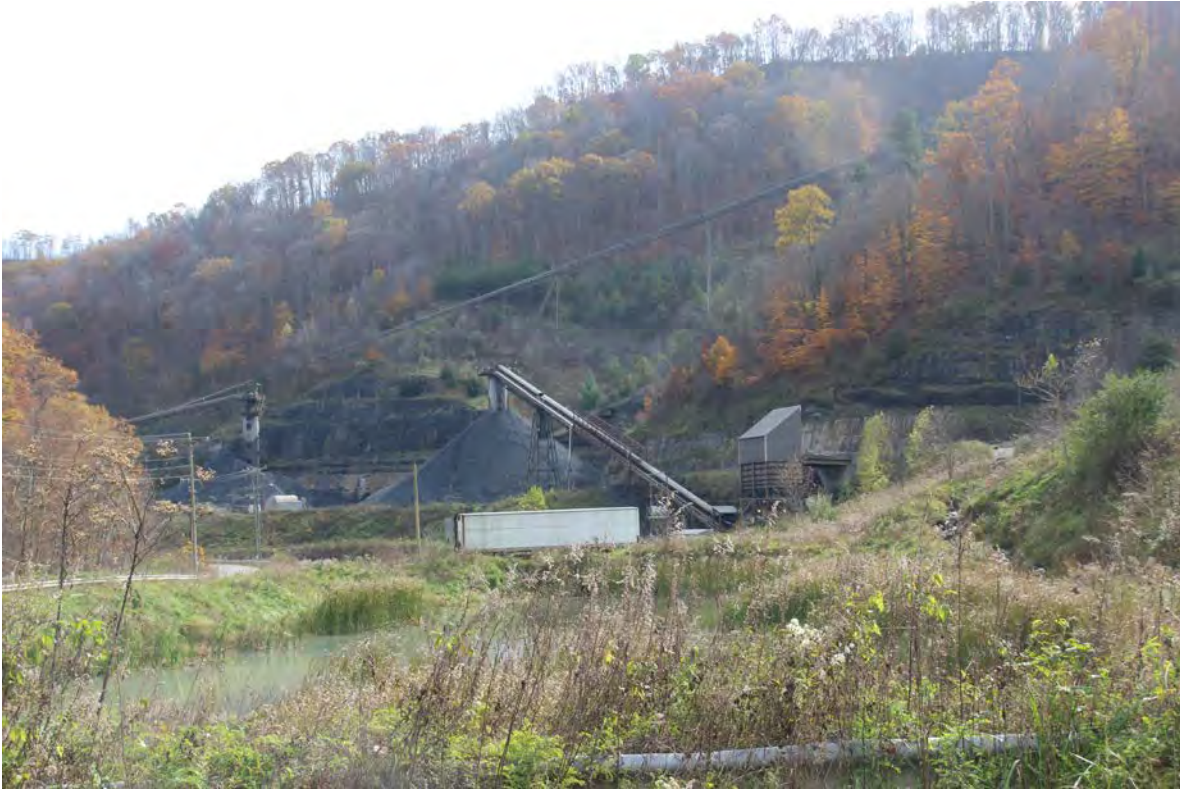
Just visible high on the hillside, running from right to left, is a conveyor belt carrying coal from a strip mine on top of the mountain. The conveyer belt, running from right to left, is carrying coal from another portal from which a drift runs back into the mountain following the coal seam. Most coal seams are three to four feet in thickness. Seams smaller than 3-feet are mined by auger or, if close enough to the surface, by strip mining.

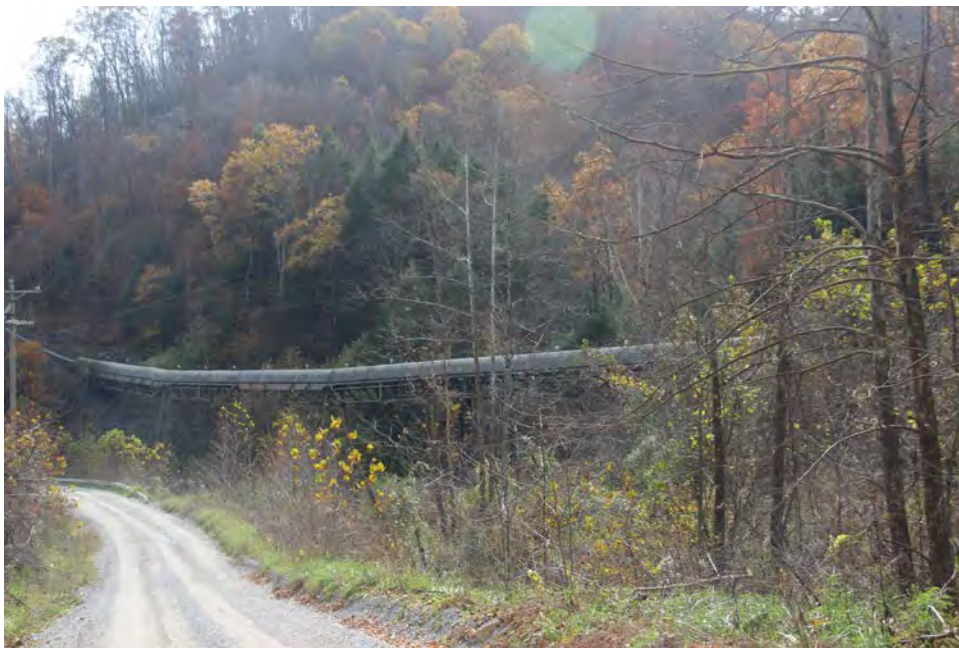
The conveyor belt from the top of the mountain, with its aluminum cap to keep coal from falling off the belt, follows a mine road toward the wash plant.

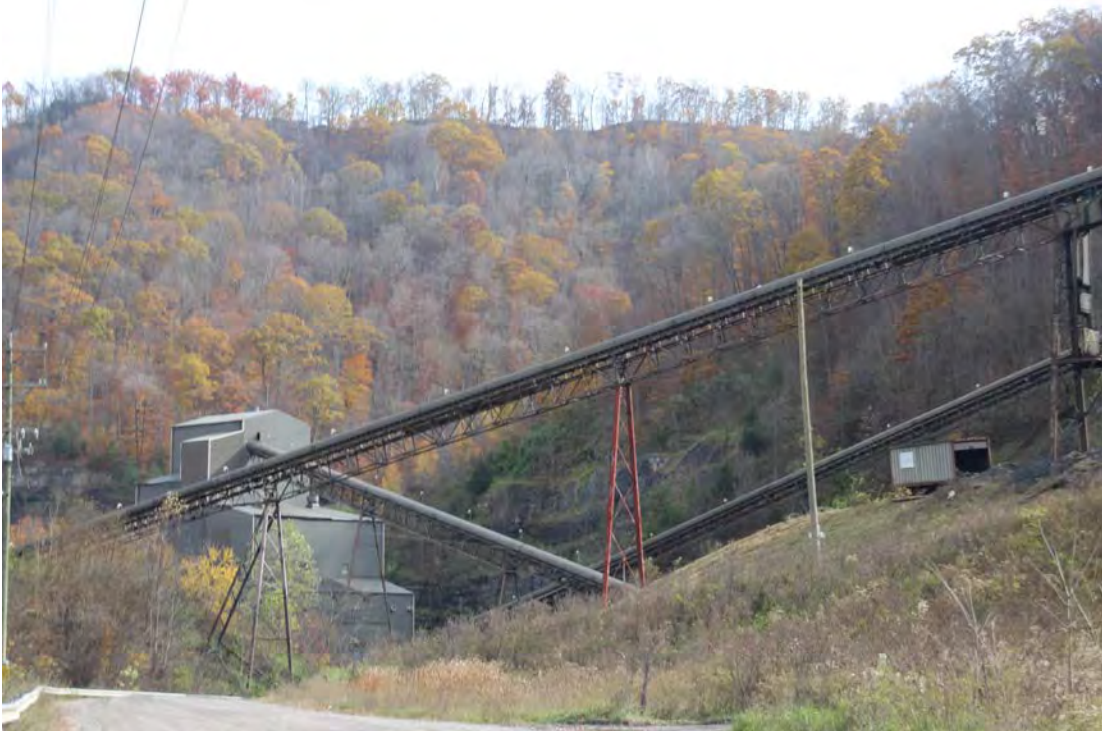
The conveyor belt is nearing the end of its journey, for the wash plant is visible in the lower left. The view is toward the southside of the wash plant.

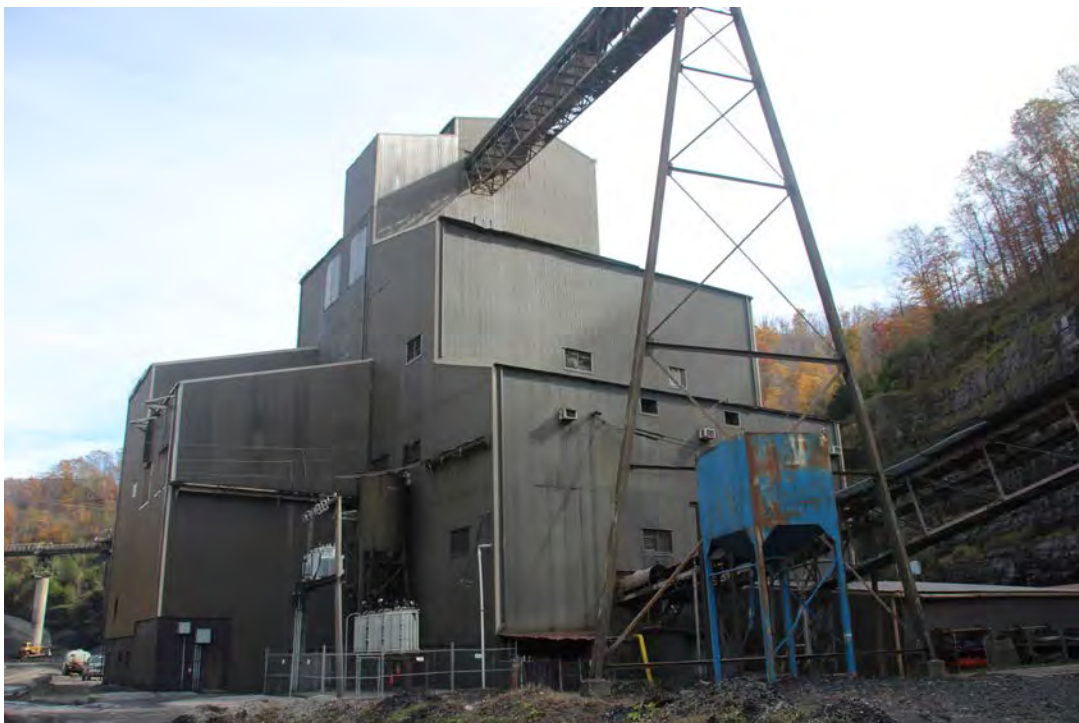
A close-up of the wash plant. Here the coal is floated in water to remove impurities, for the power plant contract calls for coal of a certain BTU with less than .05 percent non-burnable material mixed in with the coal.

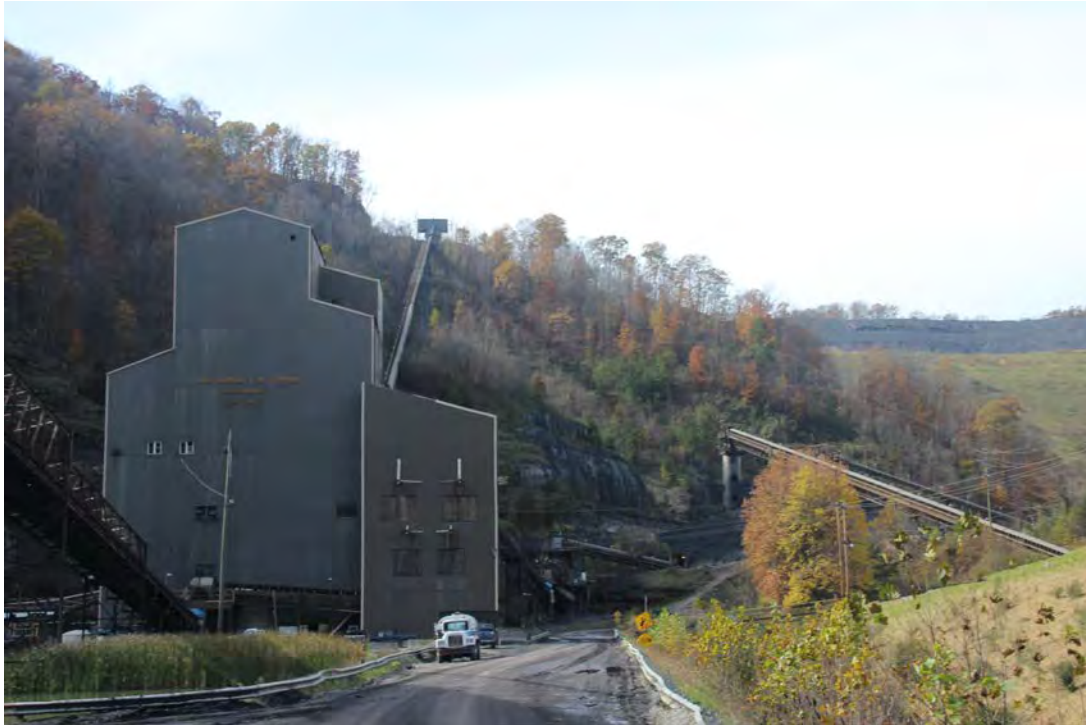
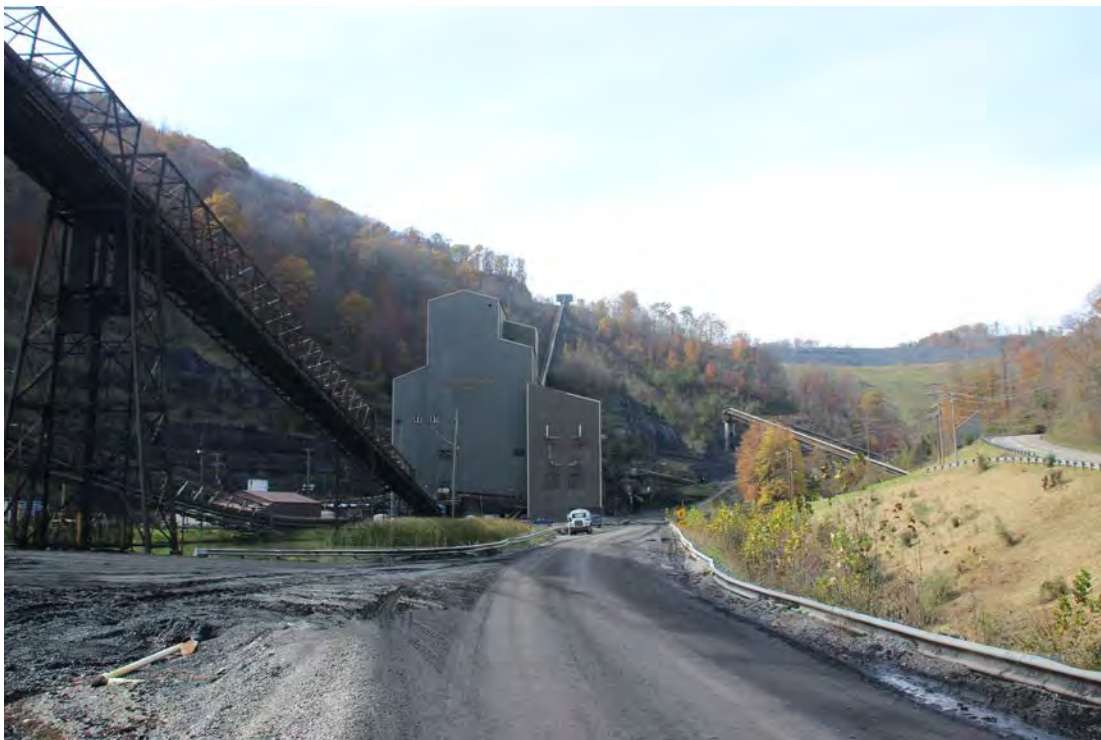
Above and below are views of the wash plant looking at its north side. The conveyer belts are carrying washed coal from the plant to the storage area.

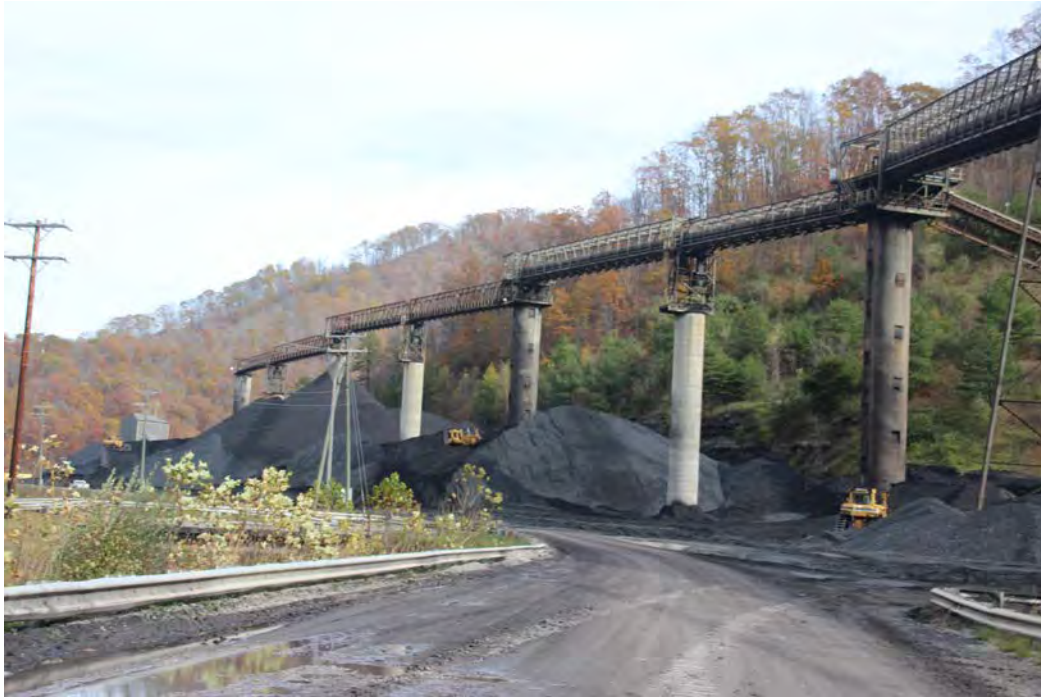
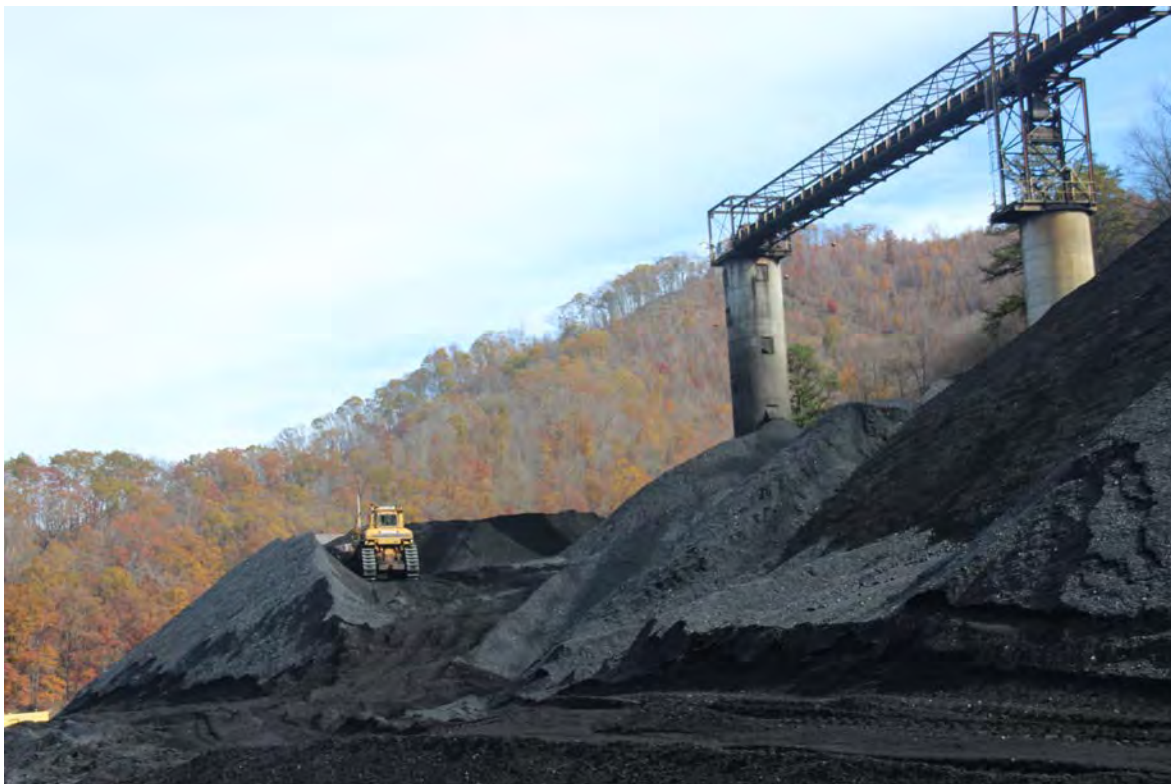
Above and below is the coal storage area. Underground augers carry the coal from here to a conveyor belt that leads to the train flood loading tippie. Note in the photo below the D9 bulldozer working the coal pile. Coal is dumped into the top of the cylinders and falls out to the storage area through window cut in the cylinder walls.

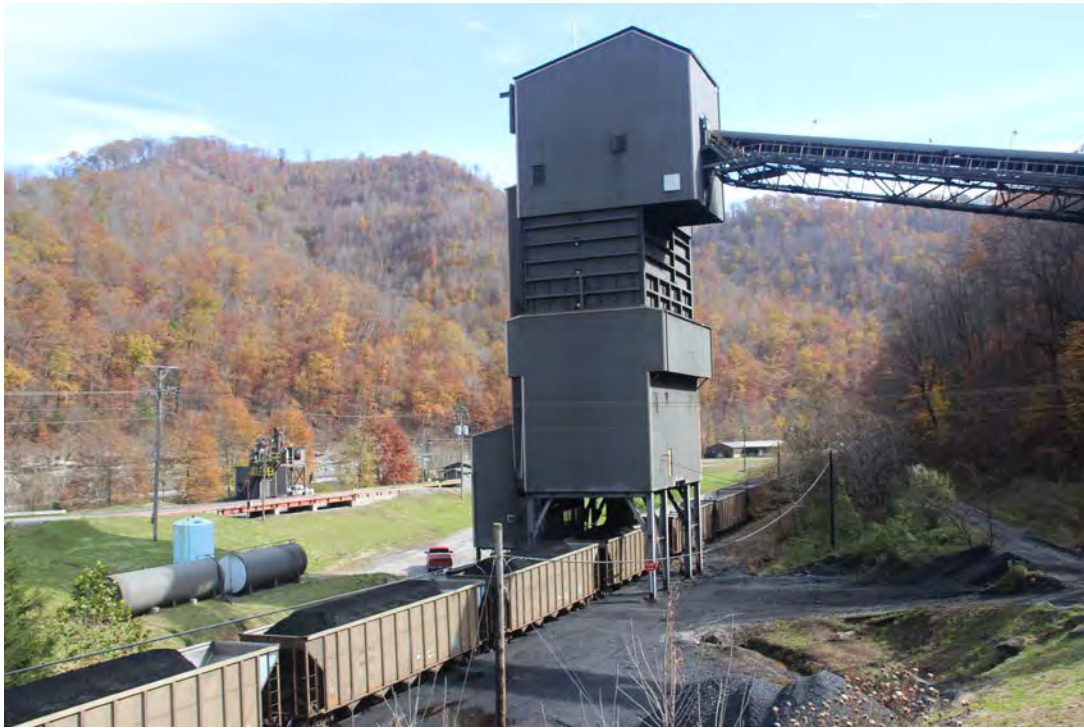
A view of the flood loader. A balloon track leads to the flood loader from the CSXT track. One leg of the balloon track can be seen up against the cliff wall beyond the telephone pole.

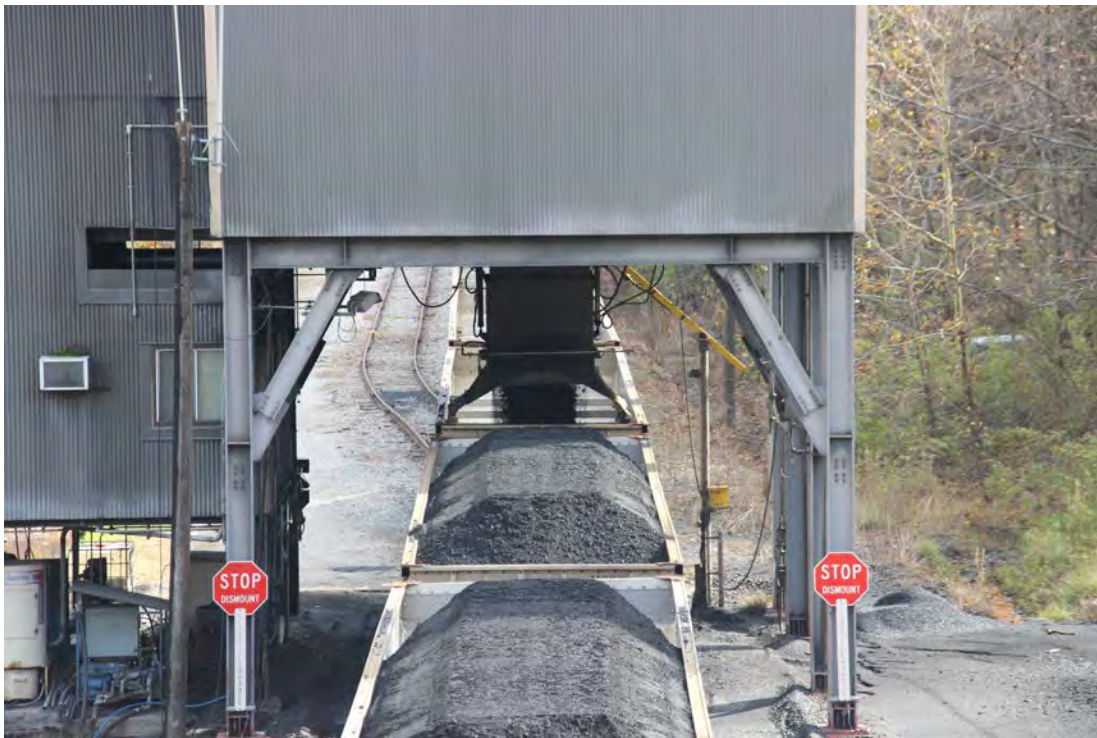
A close-up of the flood loader. The hopper is pulled through the flood loader at 2 MPH. A computer fills the hopper with the right amount of coal, forming a smooth layer of coal at the eve of the hoppers.

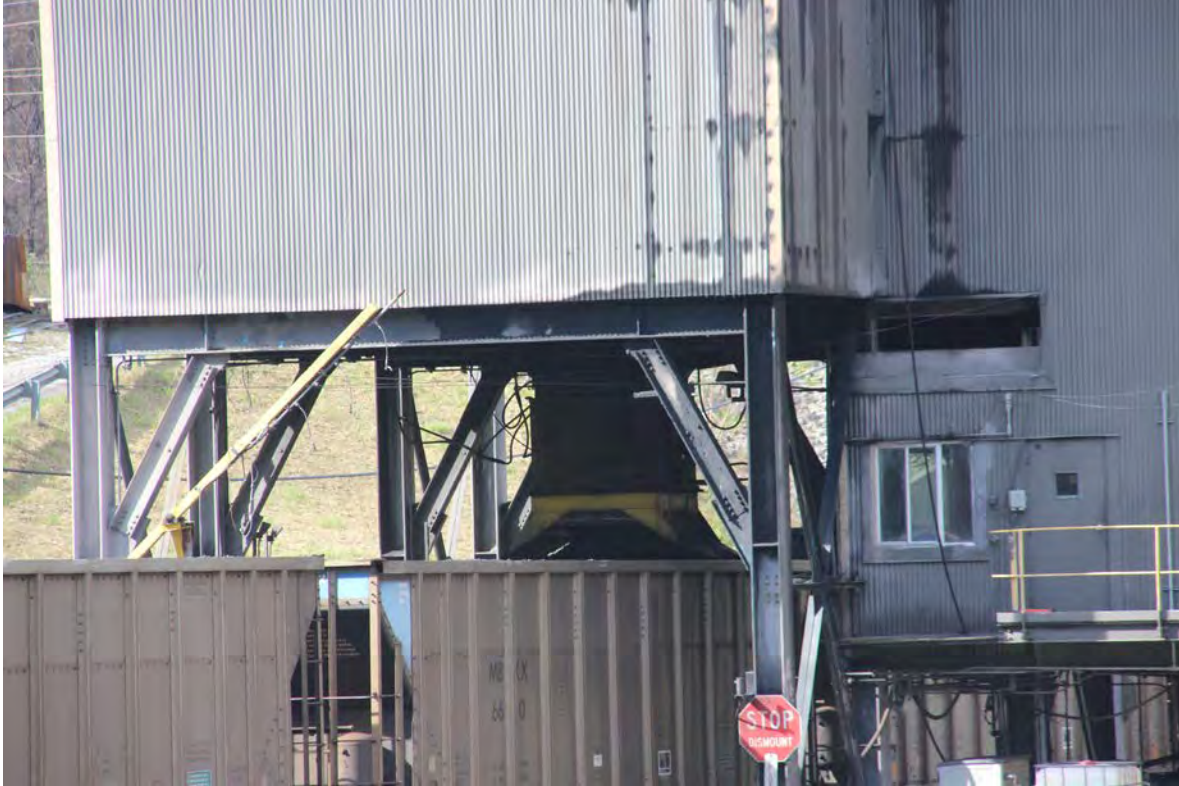
Another view of the flood loader at work. The coal is carried from the storage area to the flood loader by conveyor belts. The whole operation is controlled by a computer that ensures the right amount and type of coal is loaded into the hoppers.

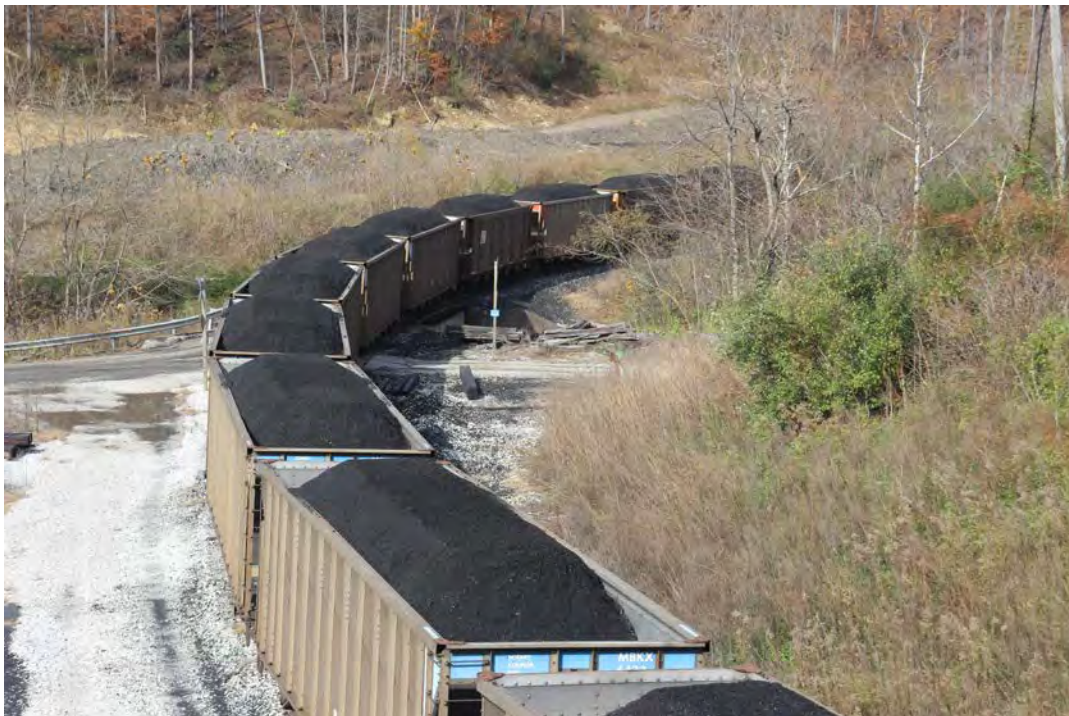
A string of loaded hoppers stretches along the balloon track toward the CSXT track. Normally a 100-car train of 100-ton hoppers can be loaded in 2 to 2.5 hours.

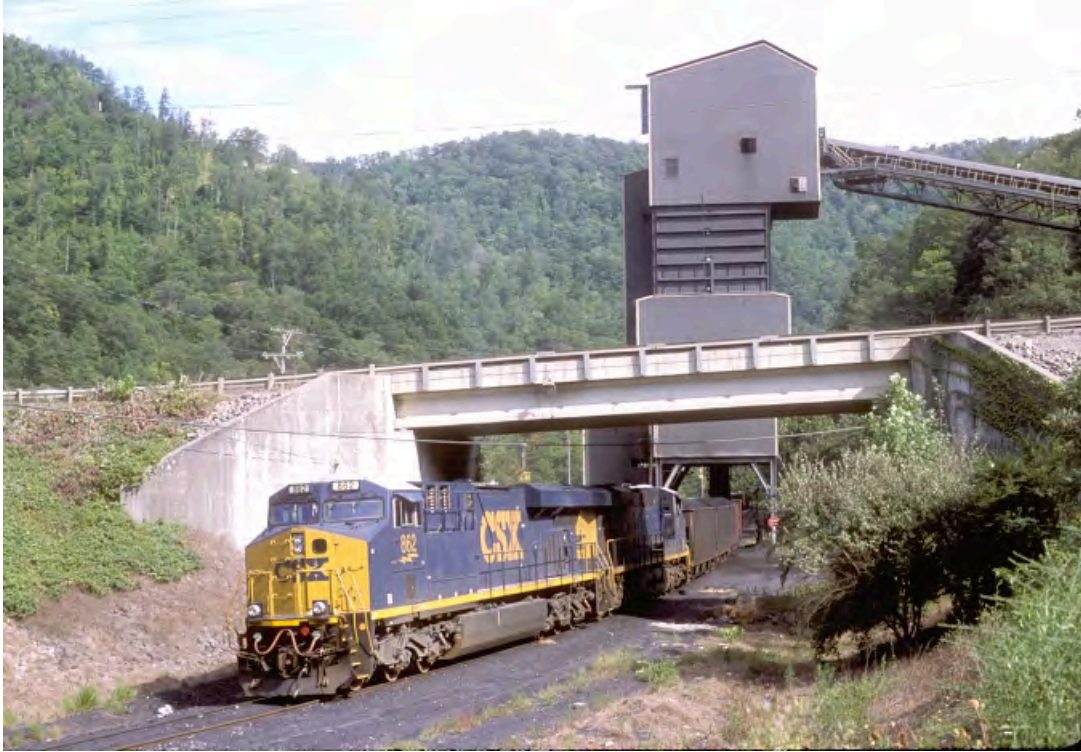
CSXT 862, a GE CW46AC/H, and a sister locomotive lead a unit train through the flood loader. The bridge carries the site's road over the track and up the hollow to the wash plant. (Blue Diamond Mine)

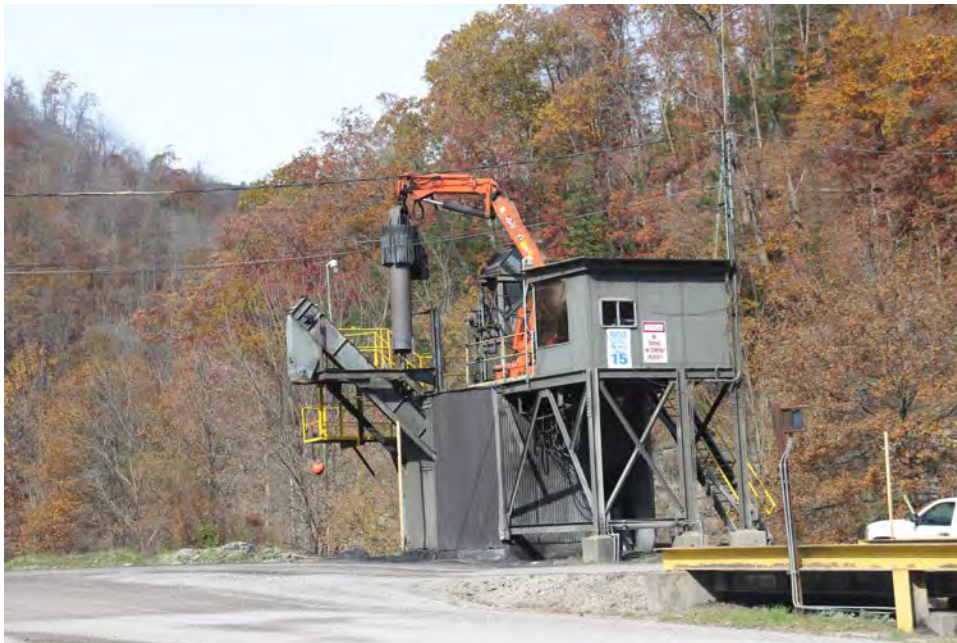
The truck scale with its coal sampler. The suction pipe is lowered down into the truck's load of coal to draw a sample to verify that it is the correct quality of coal. The conveyor belt delivers the sampled coal into a truck for removal to the coal stockpile area.

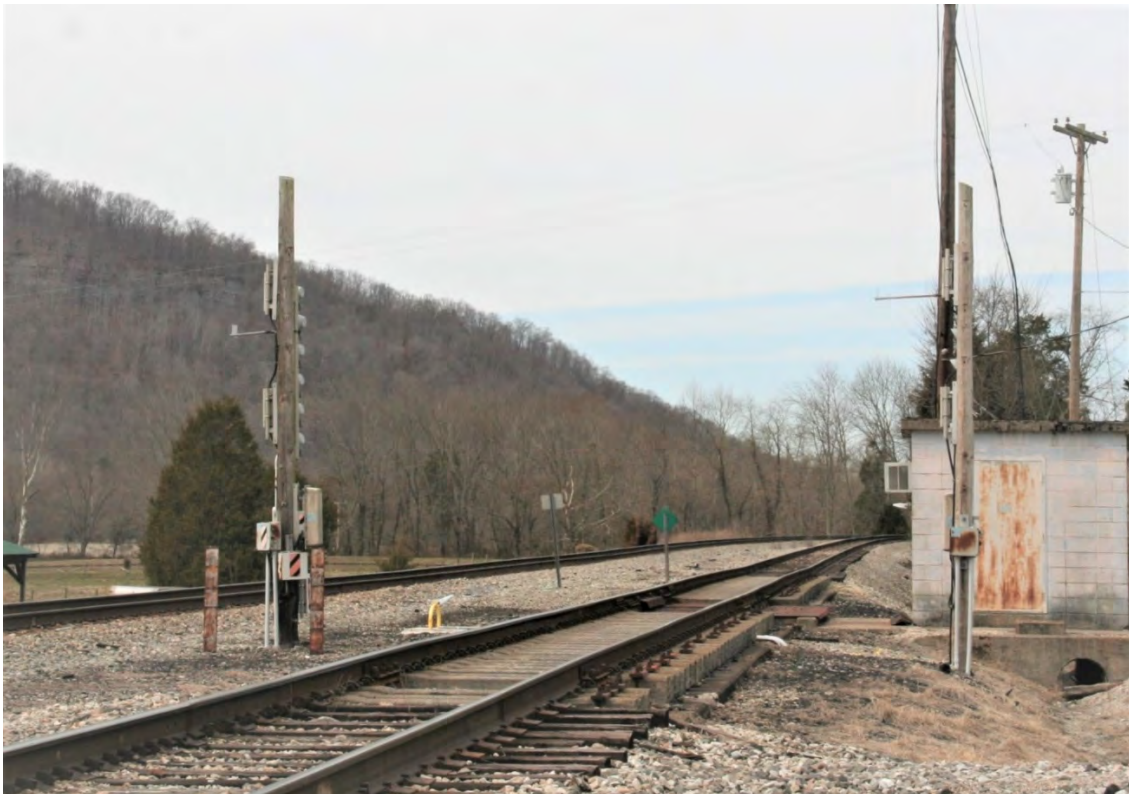
The weight in motion scale at Pryse, Kentucky

1. Scales at Pryse are designed to weigh between speeds of 4.5 MPH and 7.5 MPH and will be turned on by sensors 200 feet from the scales in each direction. The scales are equipped with computer voice instructions that advise condition of weighing, via Channel 084. Accurate weighing speed must be maintained between 4.5 MPH and 7.5 MPH with all brakes released avoiding slack action and stops on scales, during which voice instructions will transmit speed of train every 5 cars in tenths.

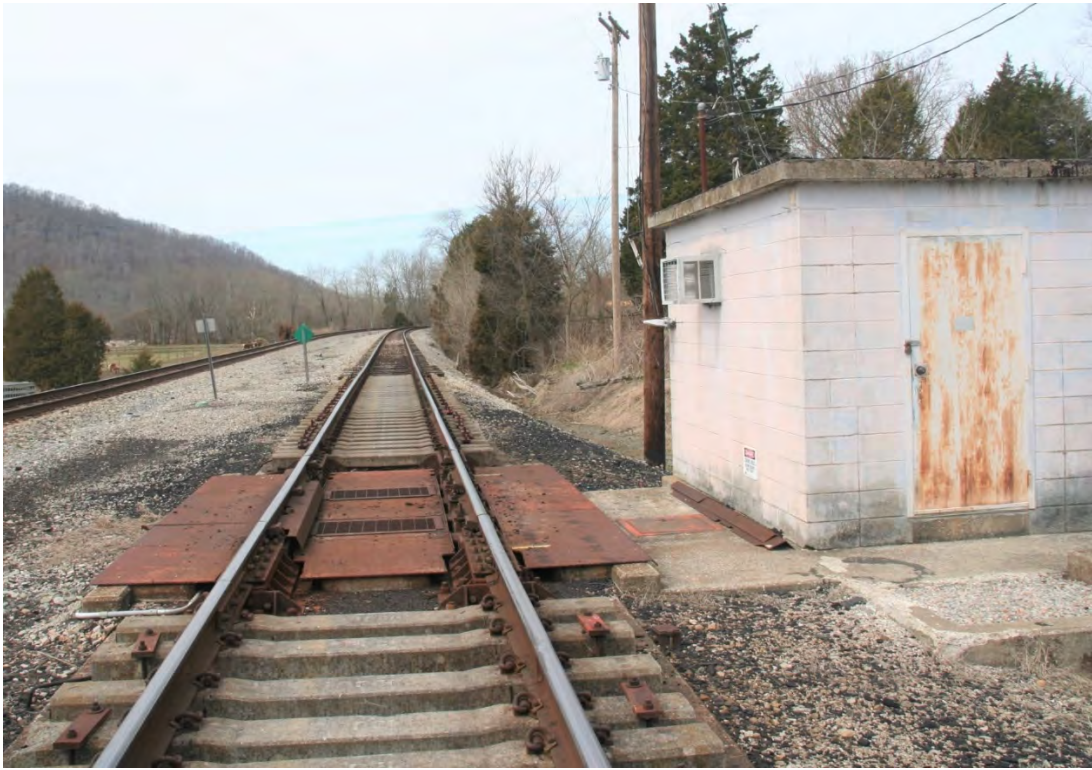
A view down the track toward Ravenna. The weight scale house on the right.

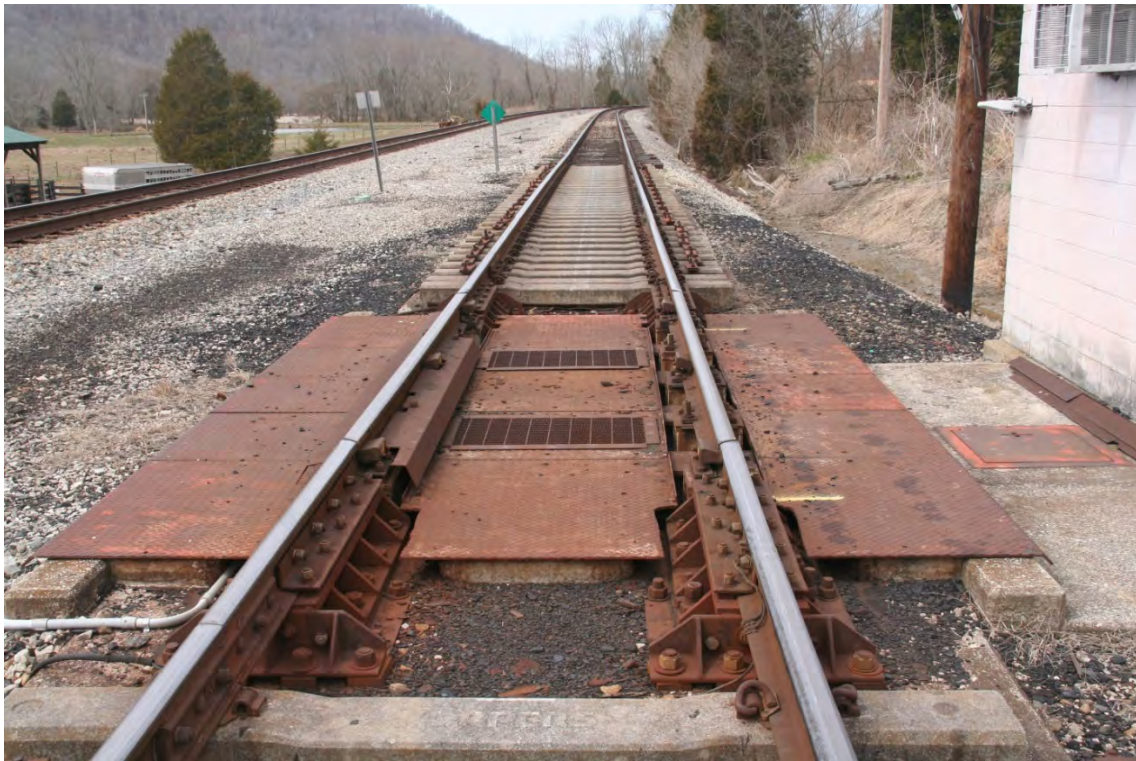
A close-up of the weight scale

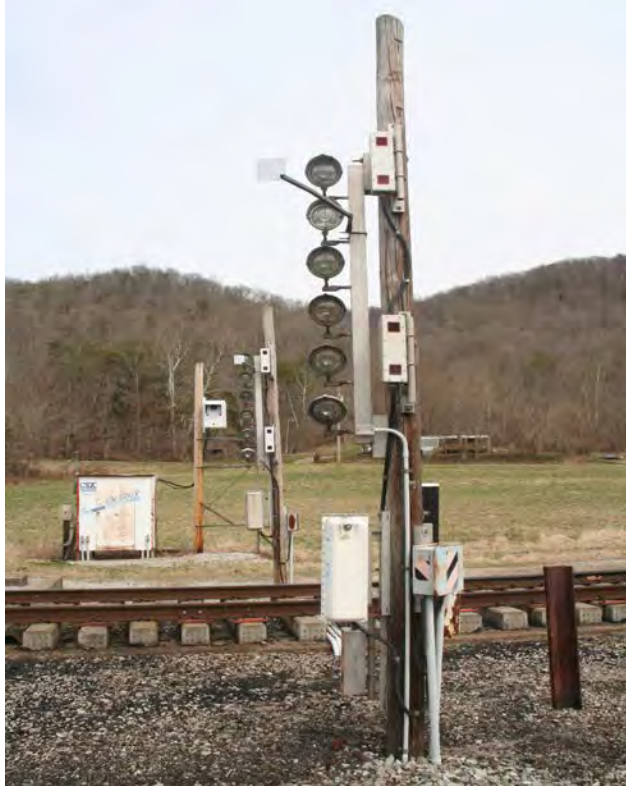
Lights for lighting up the car's reporting marks as it rolls over the scale and the video cameras that transmit the image to the Jacksonville Operation Center

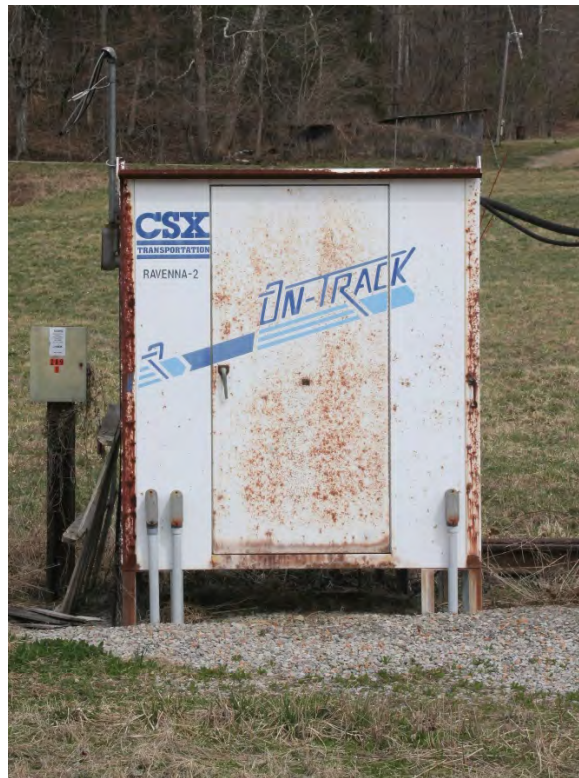
The signal box that controls the weight in motion scale
