JOURNAL OF THE CSXT® HISTORICAL SOCIETY

_____ Volume 7 Number 3 _____

BLUE DIAMOND COAL MINE

BLUE DIAMOND COAL COMPANY LEATHERWOOD, KENTUCKY MINE

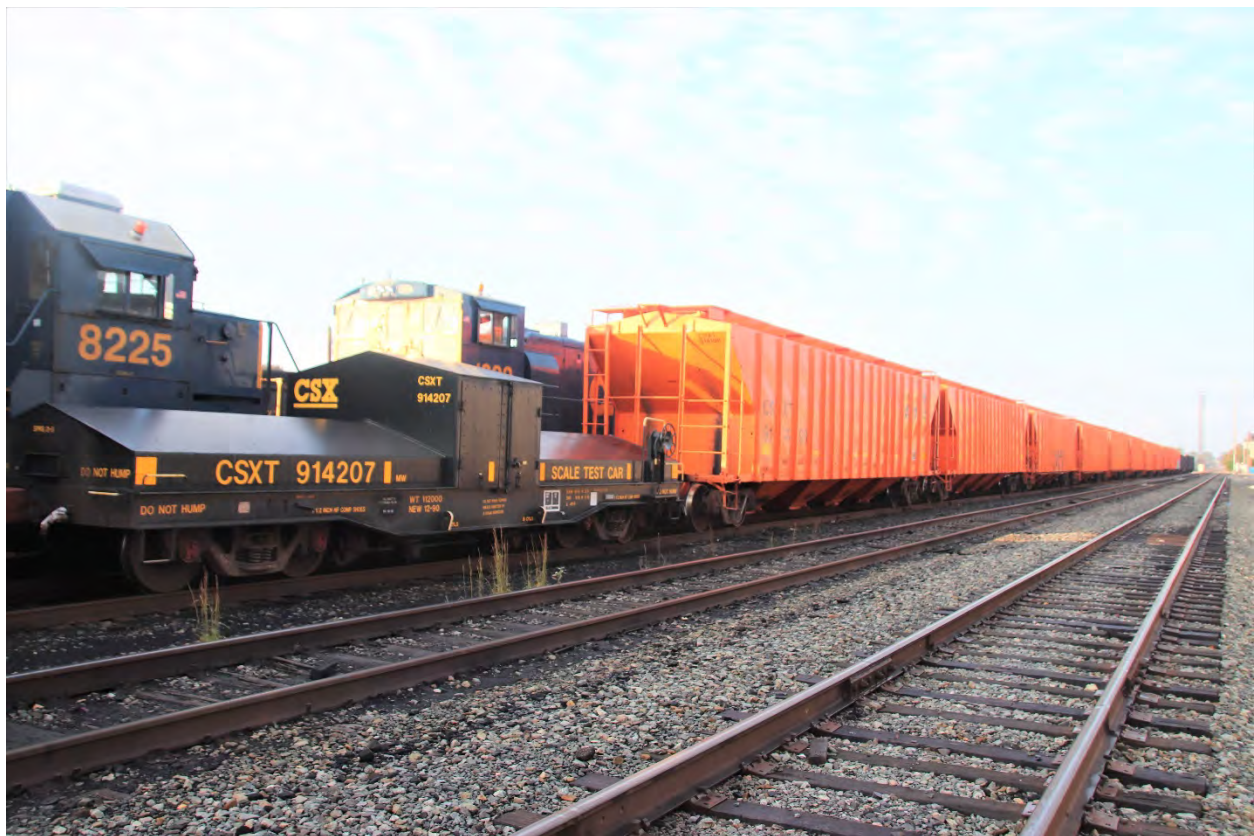
The scale weight in motion test train as encountered at Huntington, West Virginia

To verify that the weight in motion scale is working accurately, CSXT periodically runs a test weight in motion train over the scale to insure its accuracy. The test weight in motion train consists of a standard scale test car and ten test scale cars converted from covered hoppers. These covered hoppers are each loaded with a load that varies by 50 to a 100 pounds of the loads on the other cars. In October 2018, I encountered a test weight in motion train at Huntington, West Virginia. It consisted of standard scale test car CSXT 914207 and ten covered hopper scale test weight cars. I only obtained the reporting numbers of the first six covered hopper test weight cars: CSXT 914192, CSXT 914195, CSXT 914198, CSXT 914199, CSXT 914201, and CSXT 914202.

The weight in motion scale test train works as follows: The standard test weight car is placed on the motion scale to calibrate the scale. Once the scale reads the same weight as the test scale car weighs, the car is removed. It is then returned to the scale to verify that the scale is still reading the weight of the standard test weight car correctly. Once the scale is certified as in compliance, the ten covered hopper test weight cars are pulled over the scale. The scale weighs each car and reports each car's weight to the Jacksonville Operation Center. Since the exact weight of each car in the test train is known, the car's actual weight can be compared to what the weight reported by the weight in motion scale is reading and reporting accurately.

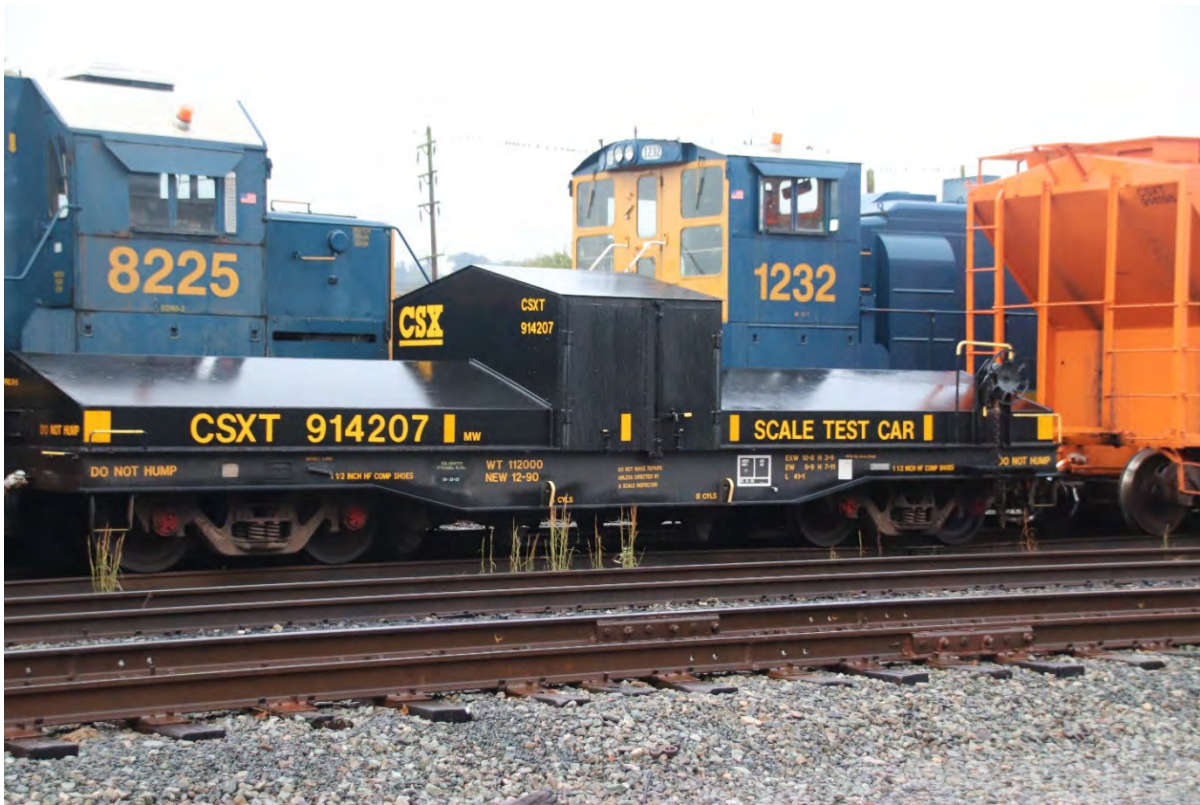
A close-up of Scale Test Car CSXT 914207

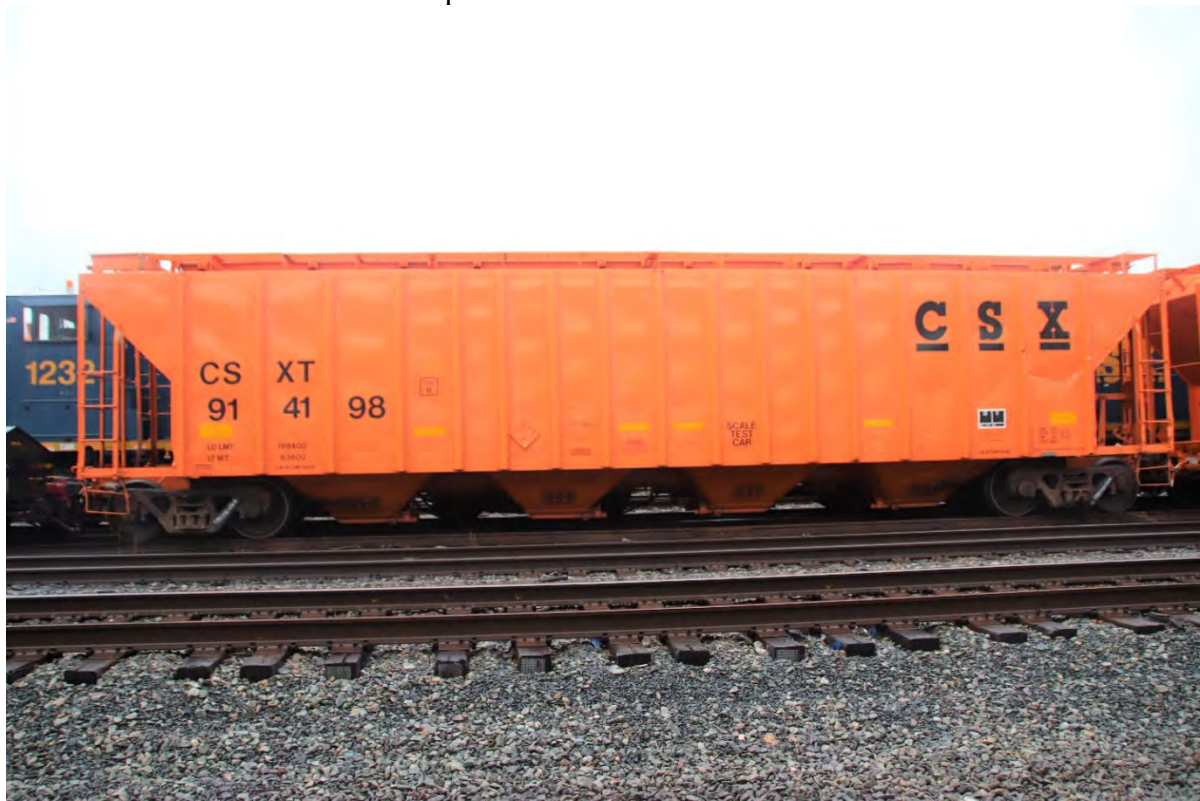
Scale Test Car CSXT 914198 is a converted cover hopper.

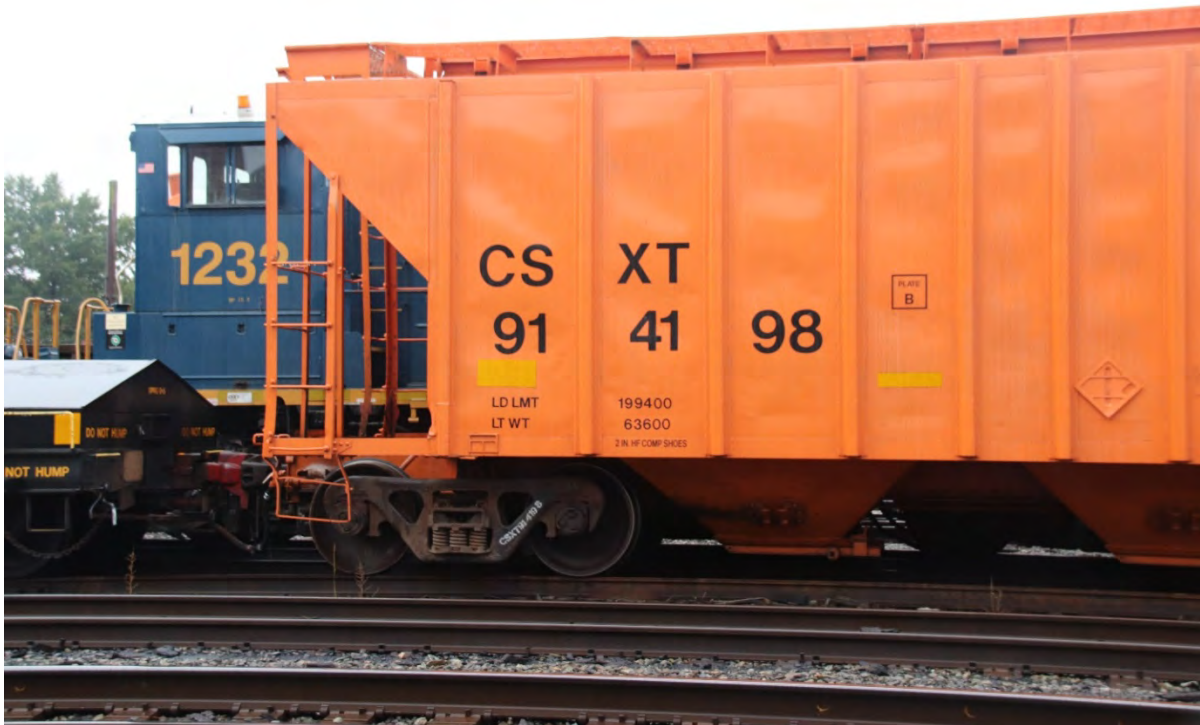
A close-up of CSXT 914198 “A” End showing her reporting marks. Note she carries Plate B markings and her LT WT is given as 63,600 and her LD LMT weight as 199,400.

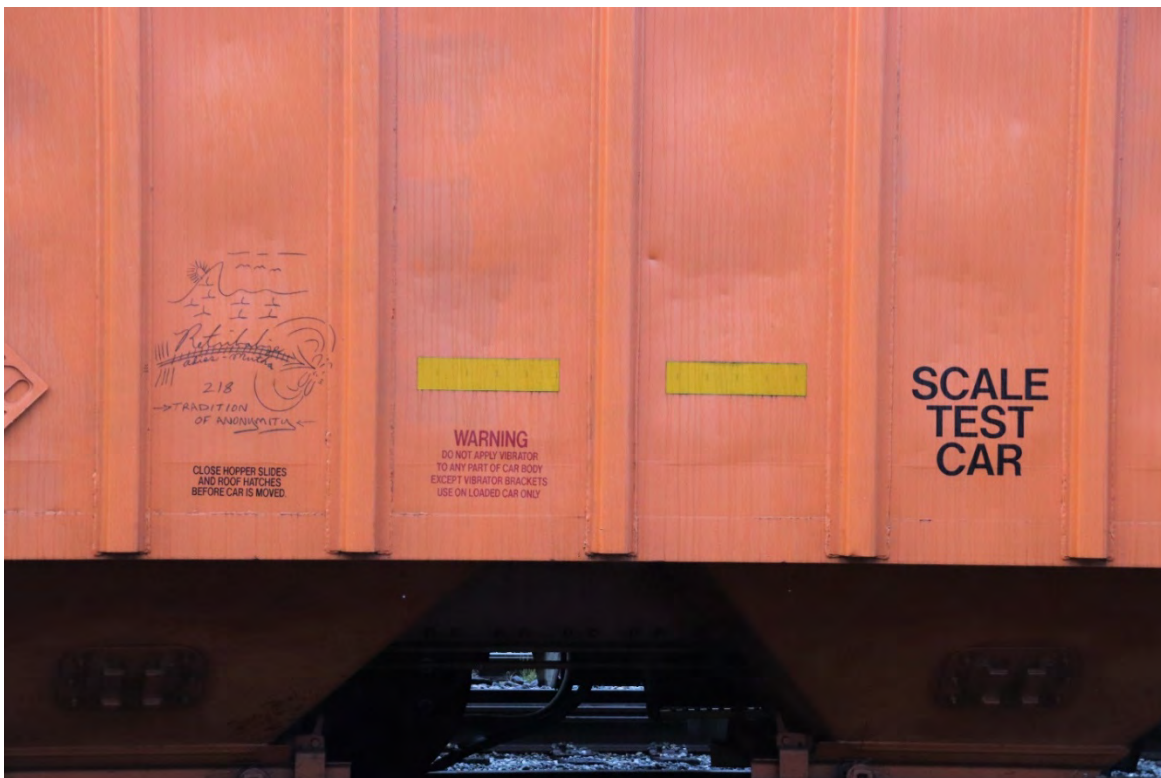
A view of the center section of CSXT 914198

She was built in November 1969 and repainted in February 2017 at Fruit Grower Express by Davis Frost. She has 2-inch High Friction Composite Brake Shoes. She has an interior of 4,899 cubic feet. Her width at the top of the car, 13-feet 1-inch off the ground, is 10-feet 1-inch wide. Her extreme width, however, is located 3-feet 5-inches off the ground where her width is 10-feet 7-inches. Her extreme height, to the top of the walkway, is 14-feet 7-inches. A portion of the mandated FRA reflecting tape is visible above her extreme height mark, and her computer reporting chip is located below her cubic feet marking.

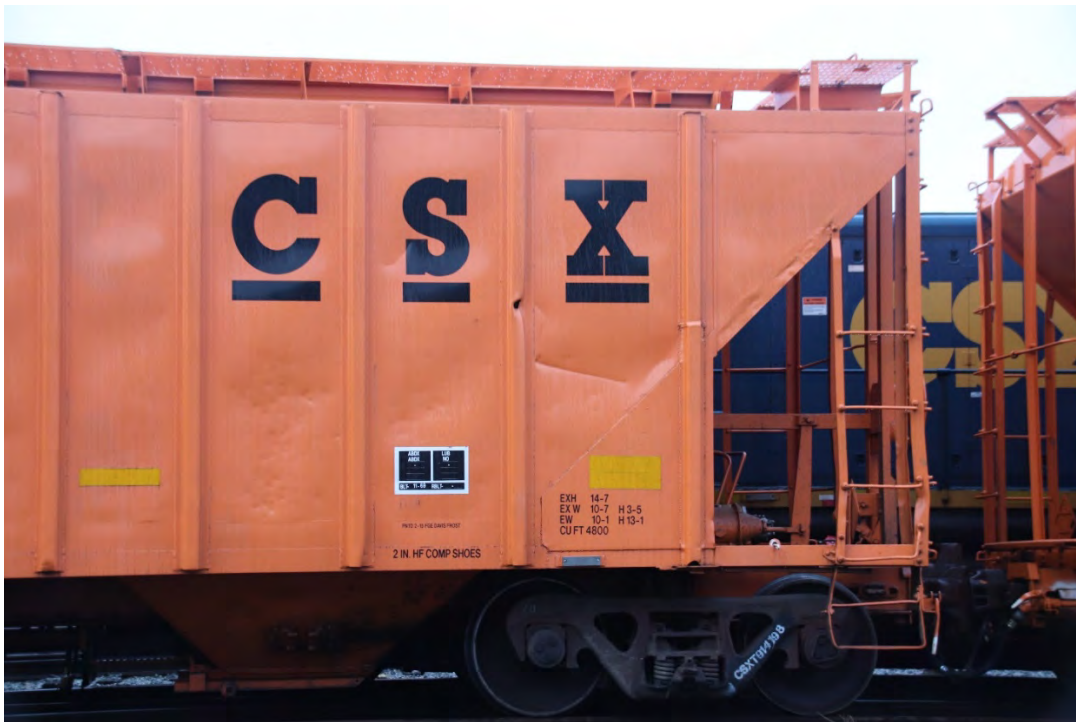
A view of the B End of CSXT 914198

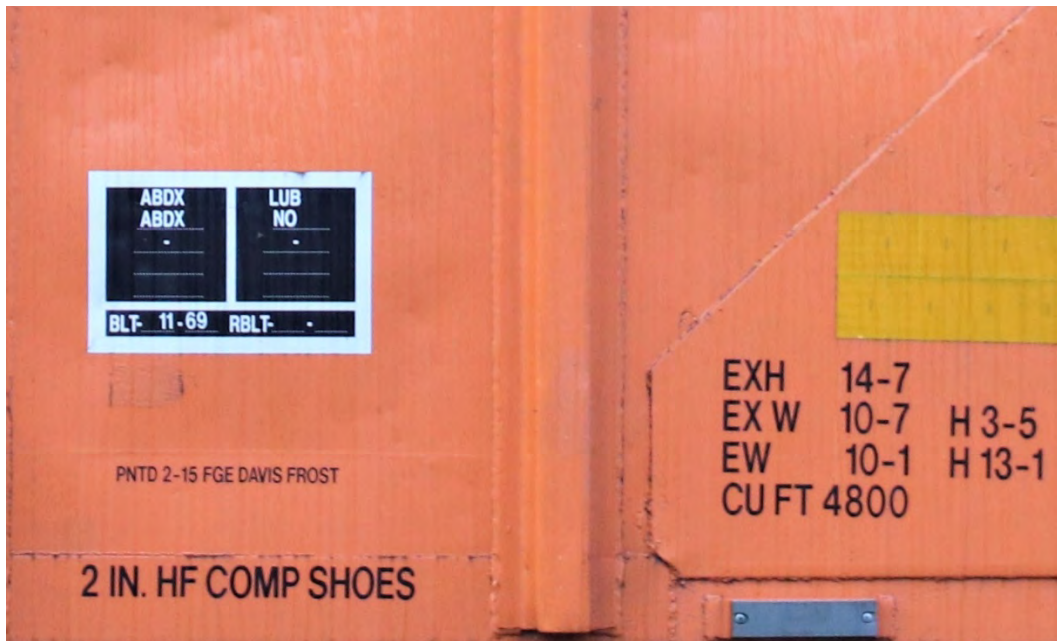
A close-up of building information and size information carried at the B End of CSXT 914198.

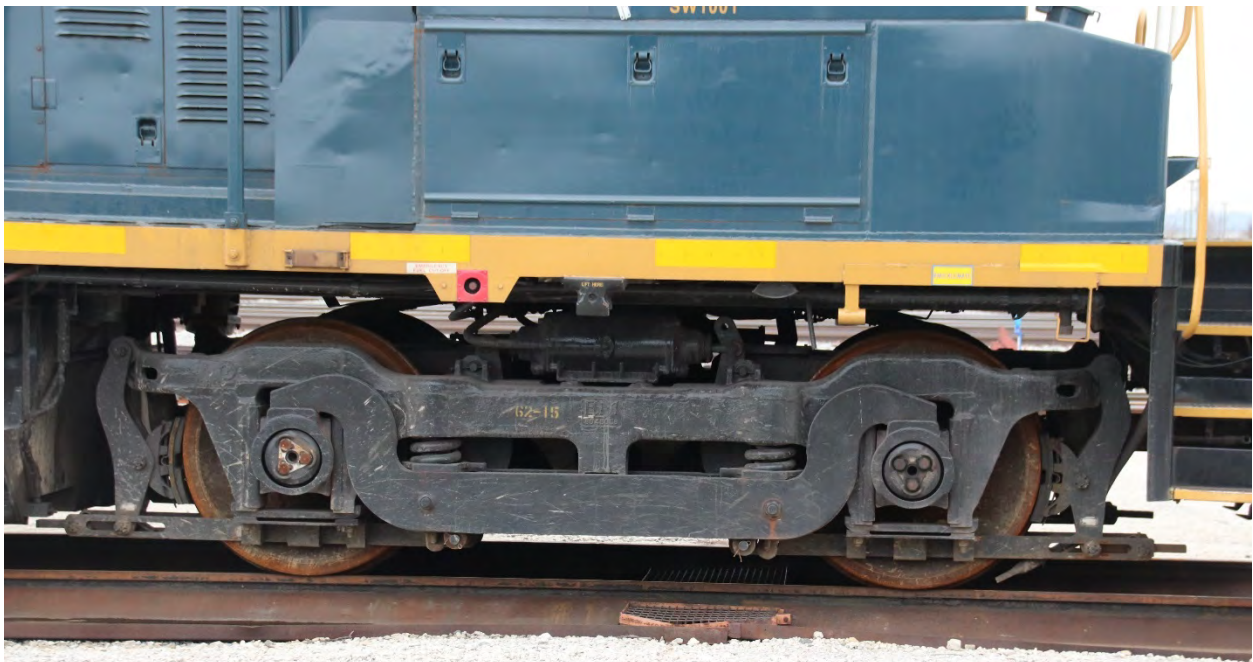
A close-up of the trucks under the cab

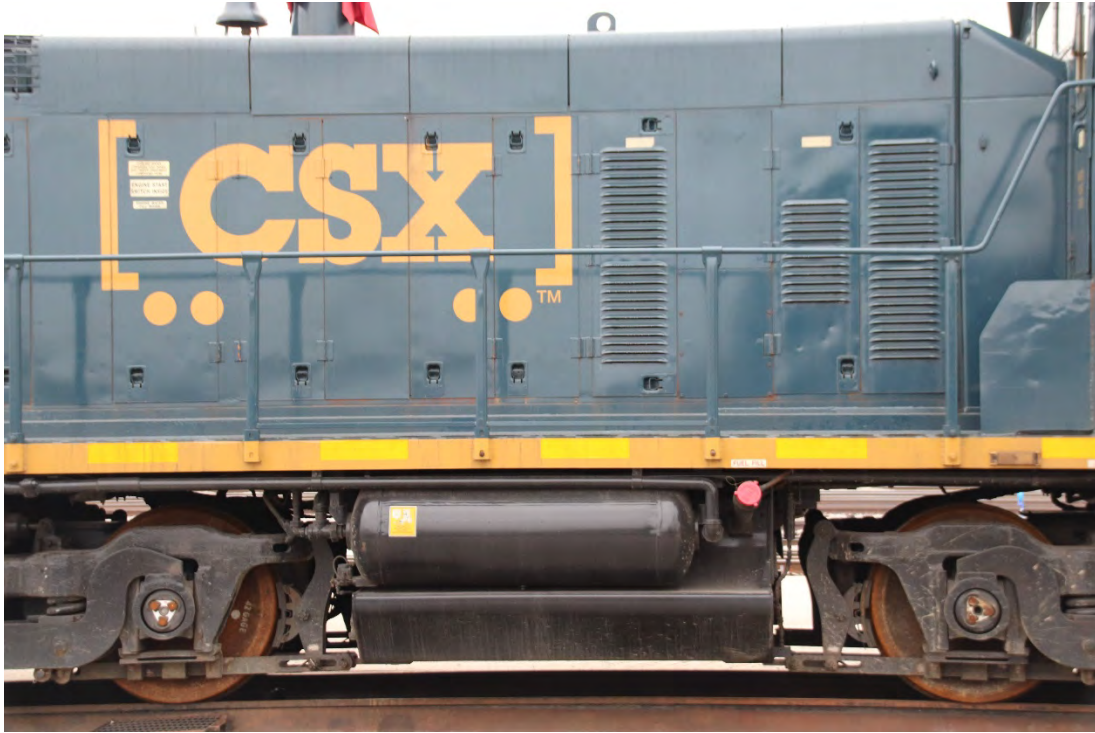
A view of the right-side fuel tank and air reservoir

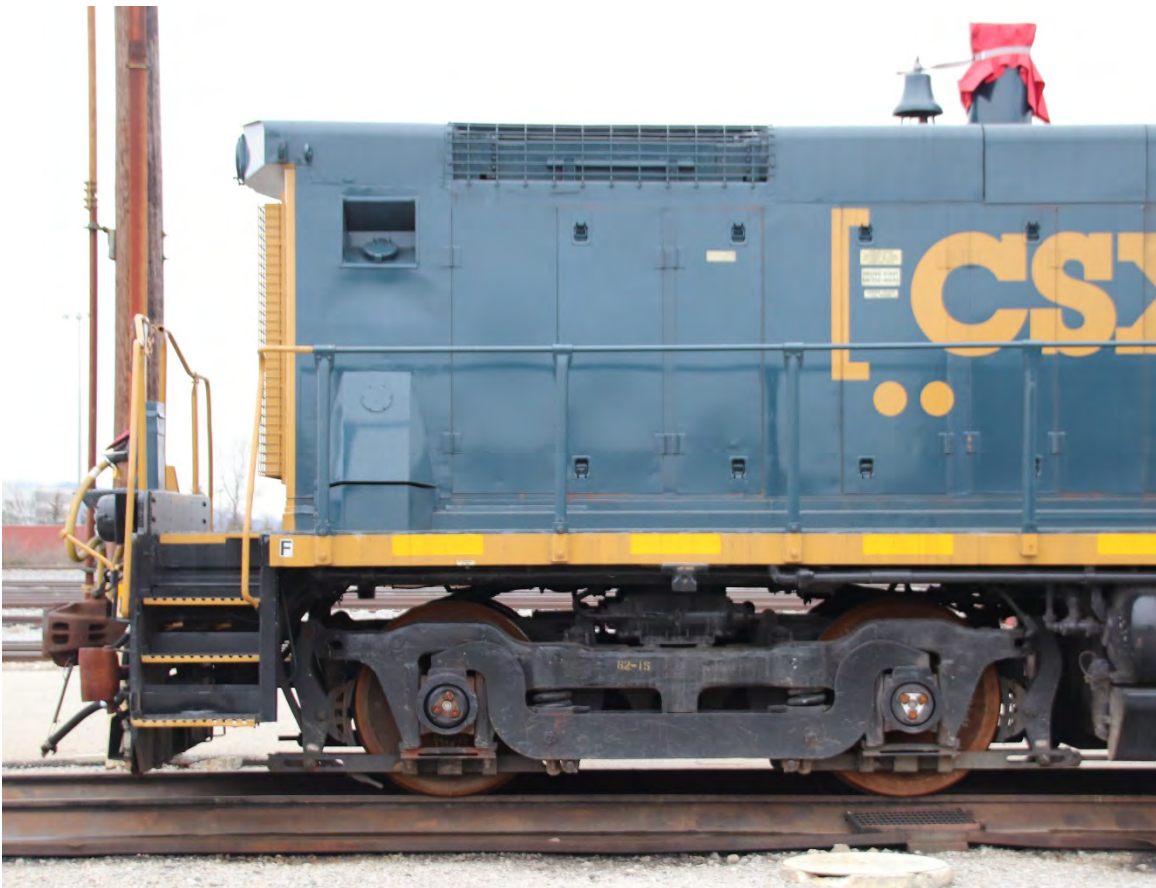
A close-up of the right-side front of CSXT 1127. Note the "F" next to the steps.

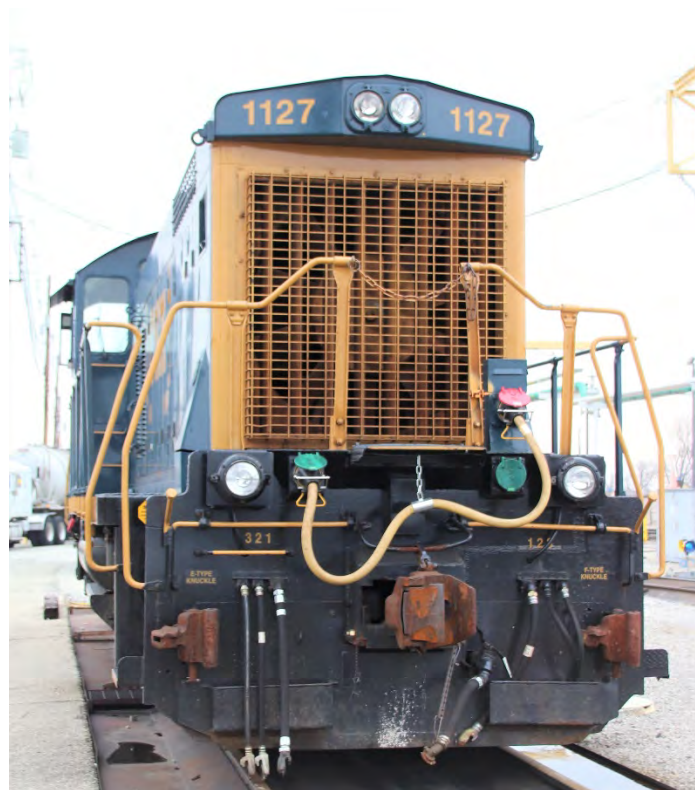
A view of the front of CSXT 1127 showing the radiator vent and her MU cable and replacement knuckles

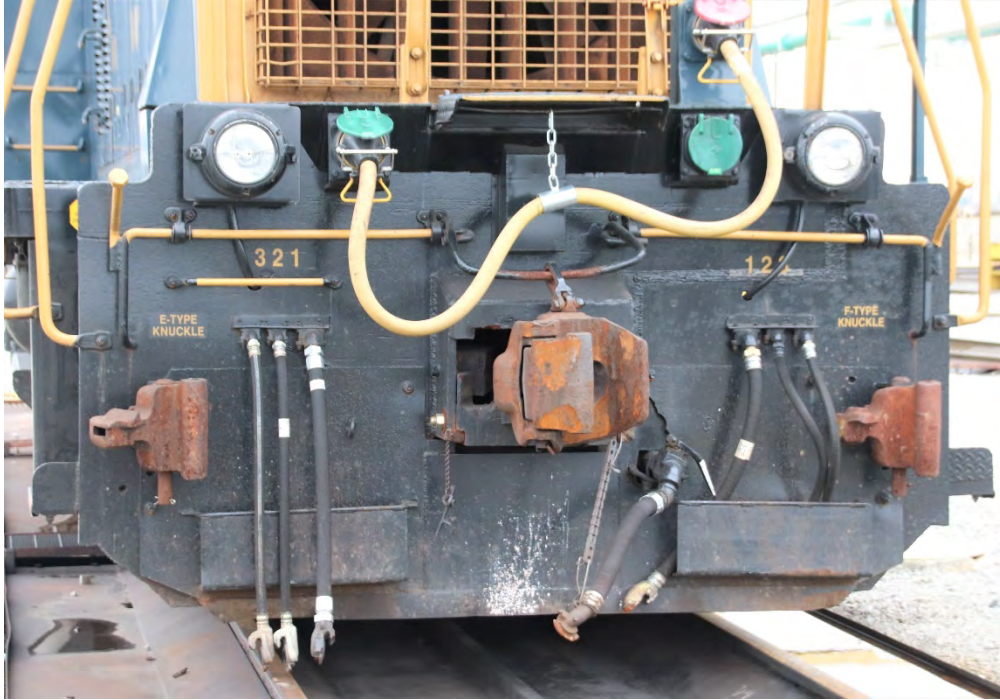
A close-up of CSXT 1127 snow plow. On the right she carries a spare F knuckle and on the left a spare E Type Knuckle

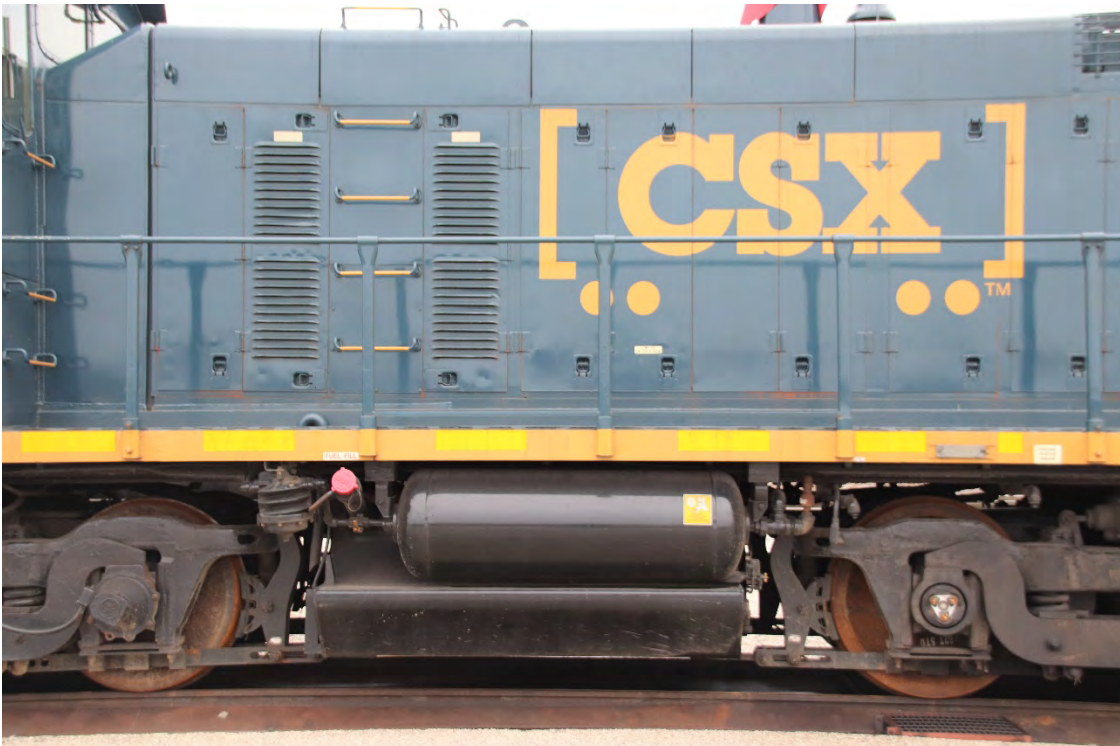
A view of the left side fuel tank with the air reservoir on top of the fuel tank

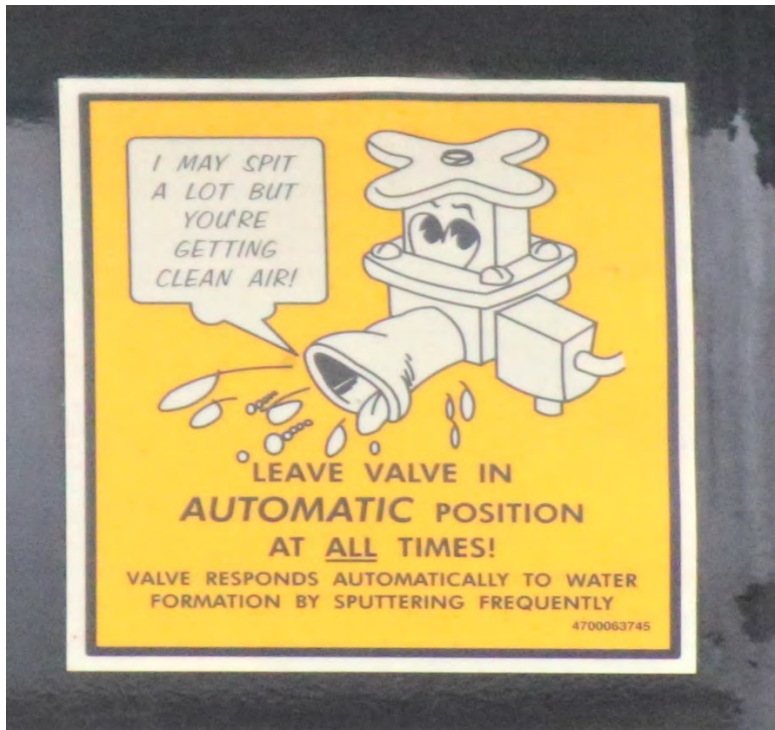
A close-up of the sticker on the air tank telling one and all that it is OK that the air tank randomly squirts moisture into the air as it is just purging its tank of water.

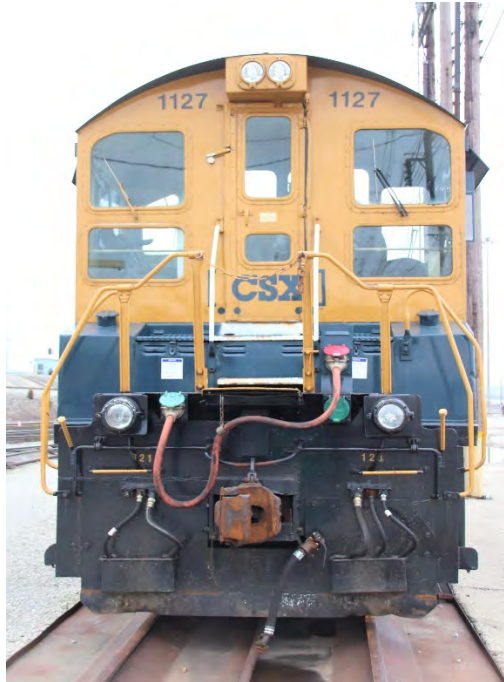
A view of the rear of CSXT 1127 showing the entrance to the locomotive cab. Most railroads, in ordering SW1001 diesel switchers, set them up to run hood forward, like a steam locomotive, negating the excellent visibility the cab provided for the engineer when facing away from the hood.

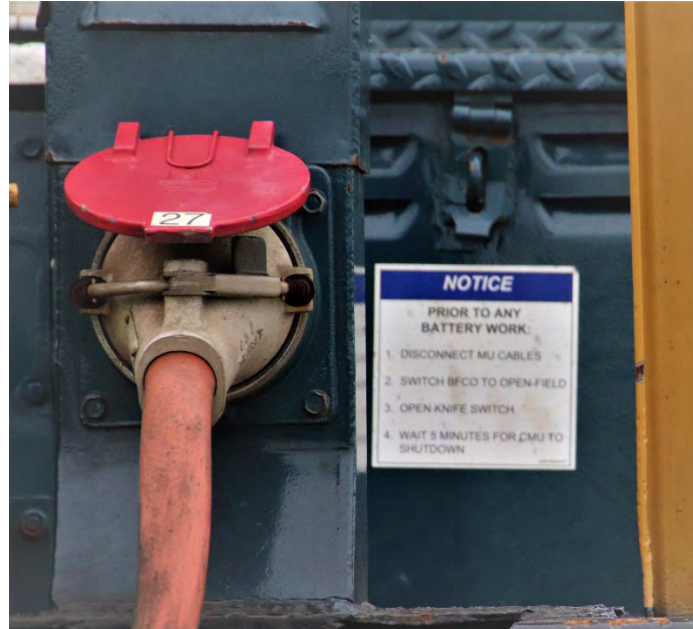
The sign reads “NOTICE – PRIOR TO ANY BATTERY WORK

1. Disconnect MU Cable
2. Switch BFCO to open field
3. Open knife switch
4. Wait 5 minutes for CMU to shutdown”

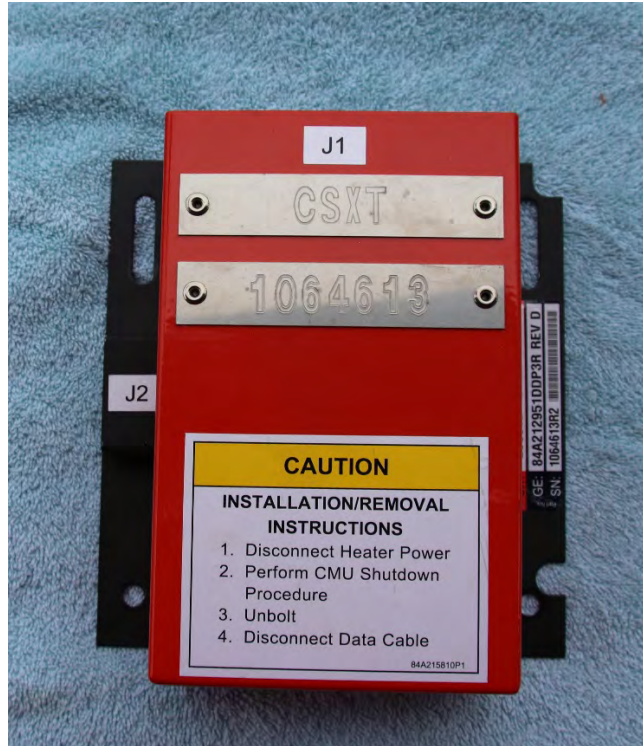
The locomotive event recorder box

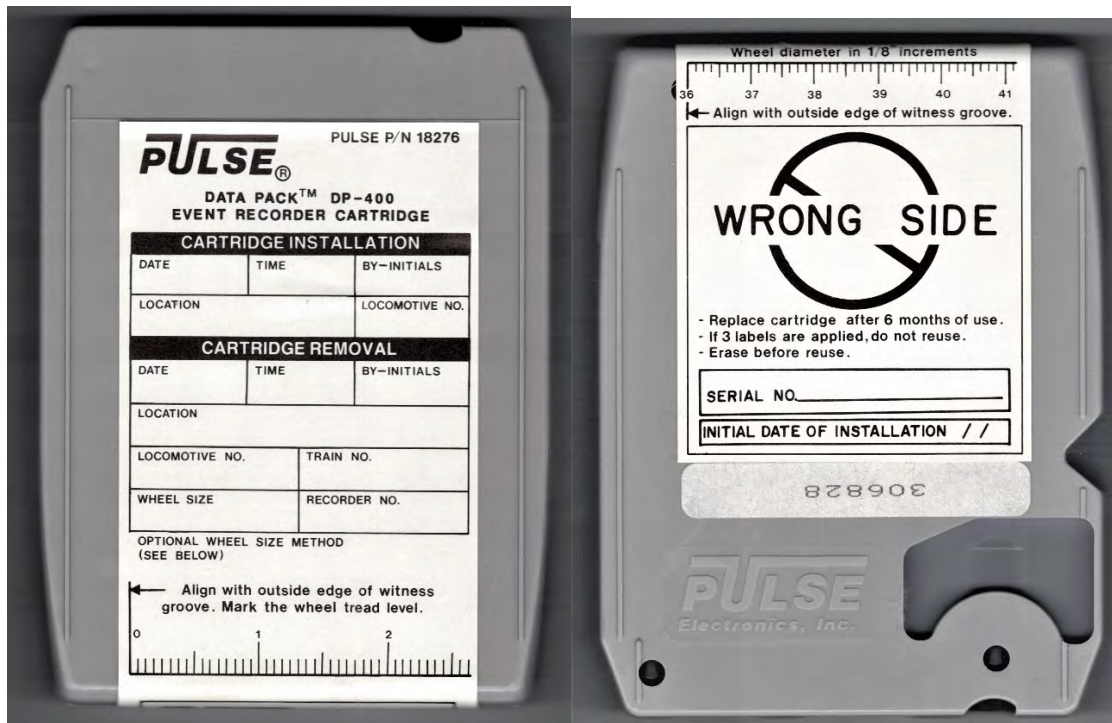
The tape cartridge used in the locomotive event recorder. The tape cartridge is similar to the old 8 track music tape.
