The paper was published in the proceedings of the 10th International Conference on Scour and Erosion and was edited by John Rice, Xiaofeng Liu, Inthuorn Sasanakul, Martin McIlroy and Ming Xiao. The conference was originally scheduled to be held in Arlington, Virginia, USA, in November 2020, but due to the COVID-19 pandemic, it was held online from October 18th to October 21st 2021.

Effects of River Dredging as Mitigation for Lahar Accumulation Downstream of the Santo Tomas River

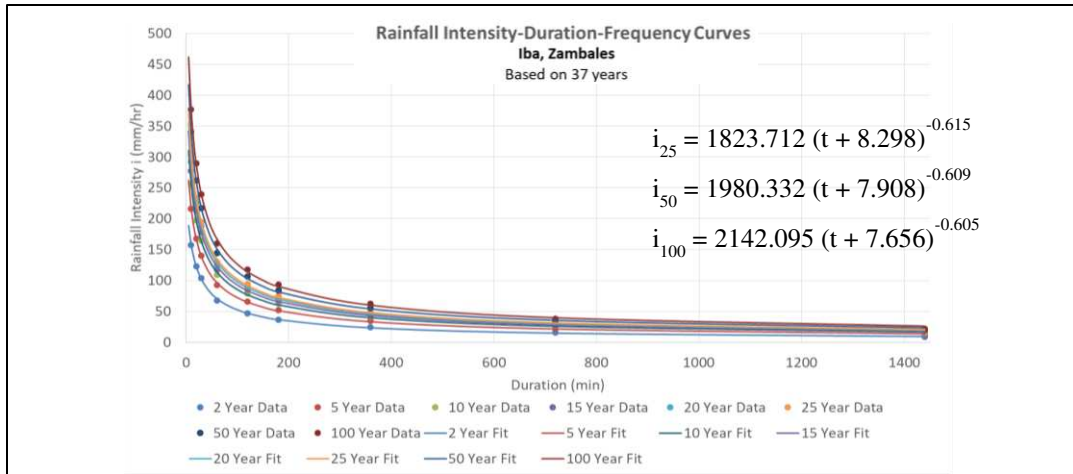
Figure 3. Rainfall Intensity Duration Frequency (RIDF) Curves for Iba, Zambales

For this study, the Rainfall Intensity Duration Frequency (RIDF) data from Iba, Zambales Rainfall Station, which is approximately 33.5 km north of the study area, served as the basis for the design frequency storm used in the hydrologic analysis. Figure 3 shows the RIDF curves generated from the actual rainfall data based on 37 years of record, as well as the equations for rainfall intensities for different return periods.

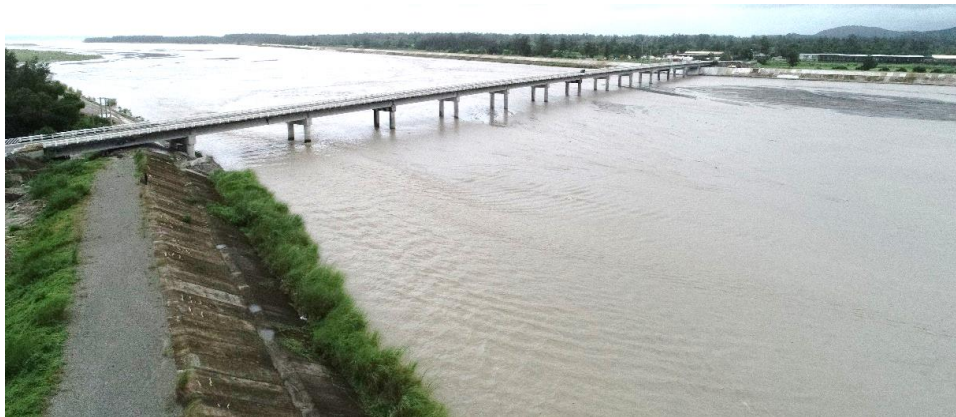
Figure 4. Existing condition of the Santo Tomas River (photo taken on August 9, 2019)

During an inspection conducted last August 9, 2019, Santo Tomas River had rapidly flowing water due to monsoon rains enhanced by Typhoon Lekima, known in the Philippines as Typhoon Hanna. Parts of the lahar deposit riverbed were still above water at the time of observation. Concrete dikes are built along the riverbanks for flood protection. Vegetation can also be found on some portions of the riverbank. The surrounding area of the river is relatively flat and occupied with green fields except for portions with small houses and truck terminals.

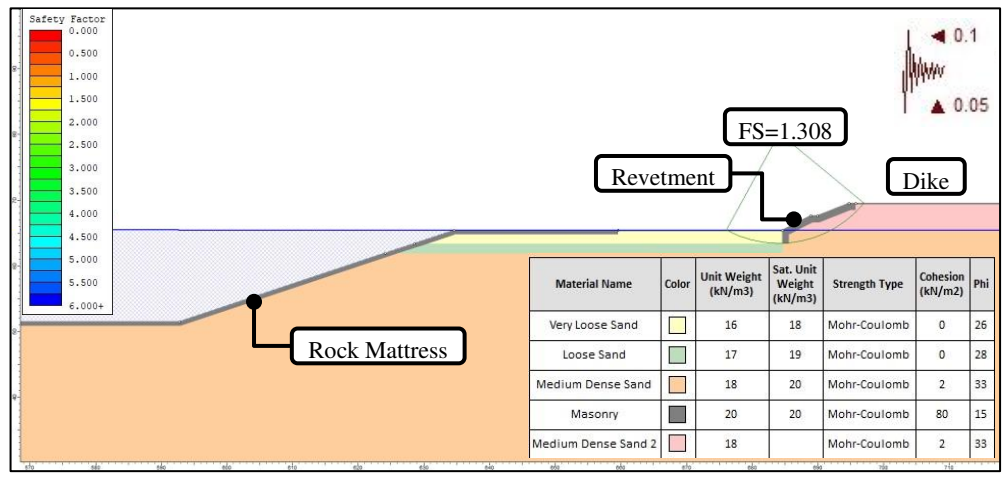
Figure 11. Scheme 4 with rock mattress at south bank (seismic loading condition)

The rock mattress, extending all throughout the dredged section as well as the existing riverbed at both sides, was incorporated in the model. The resulting factors of safety for all sections are greater than 1.2 (for static) and 1.1 (for seismic), showing that the use of rock mattresses as protection helped address the erosion on the dredged scheme (Figure 10 and Figure 11).

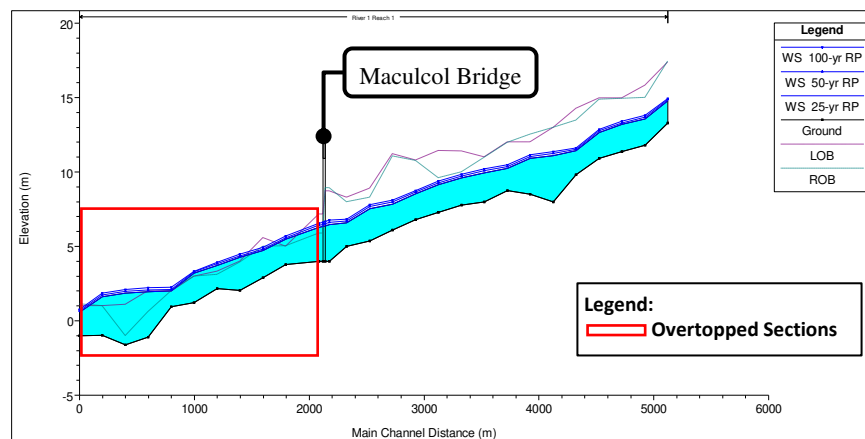
Figure 13. Profile view of the river bed and flood levels (pre-dredging)

The estimated peak runoff flows were used to perform water surface profile calculations for the various return periods, and the resulting flood levels show that the water within the river overtops the banks at ten (10) stations downstream of the bridge (Figure 13). Figure 14 shows a sample section of the river with banks overtopped by 0.3 m of flood.

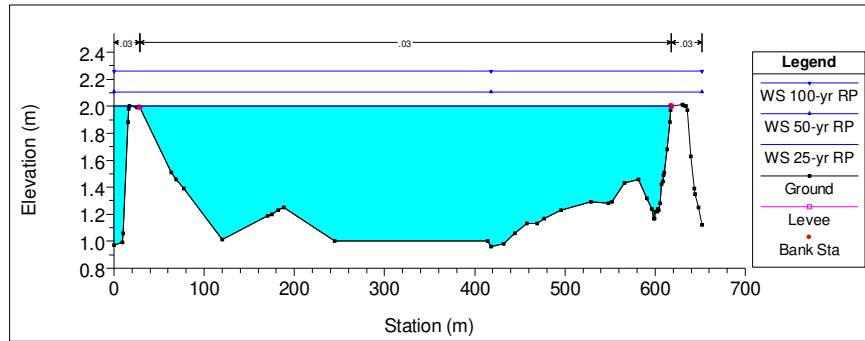
Figure 14. Overtopped banks at Station 0+800 (pre-dredging)

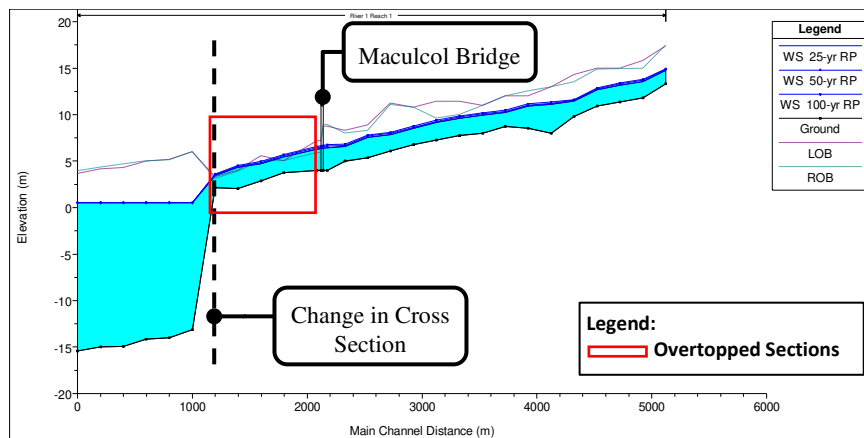
Figure 16. Profile view of the river bed and flood levels (Scheme 4)

The following figure shows the profile view of the Santo Tomas River at post-dredging condition considering Scheme 4. The flood levels show that the water within the river no longer overtops the banks at the first six (6) stations from the mouth of the river. However, upstream of the dredged section towards Maculcol Bridge still resulted in overtopping (Figure 16). Scheme 4 resulted in the lowest flood levels and least overtopped sections.
