HERITAGE ASSESSMENT OF HISTORIC FARM DWELLING KURUMAN (NORTHERN CAPE PROVINCE)

Date: February 2013 Report: April 2013

Project by: M. Naudé

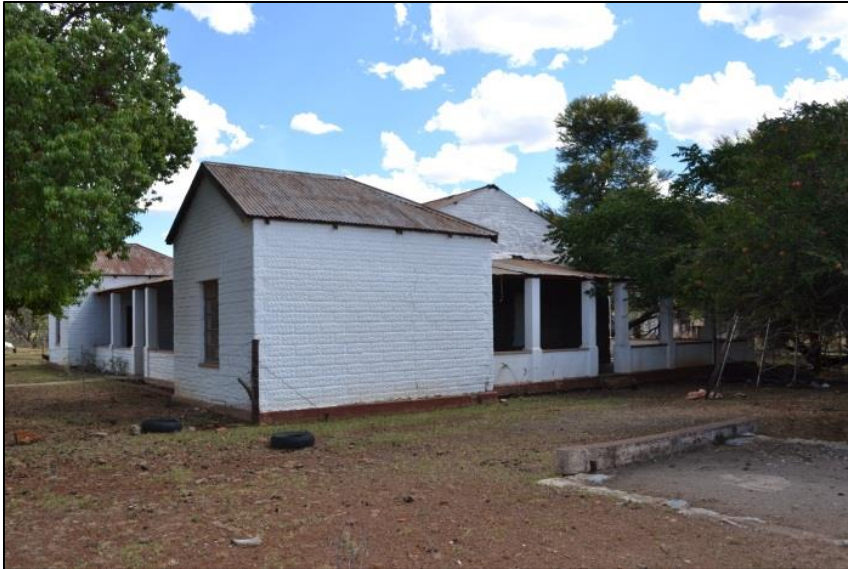
Figure 1. Side elevation of the dwelling with stoepkammer in the centre and verandahs on both sides

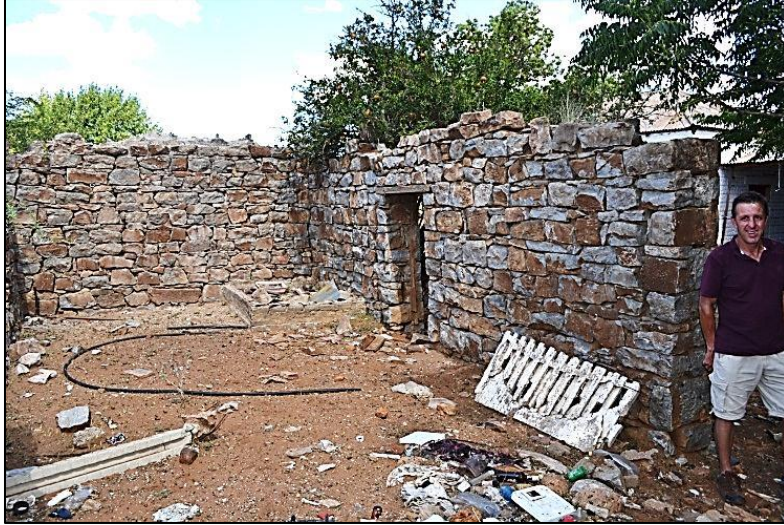
Figure 3. Interior of dolomite stone outbuilding

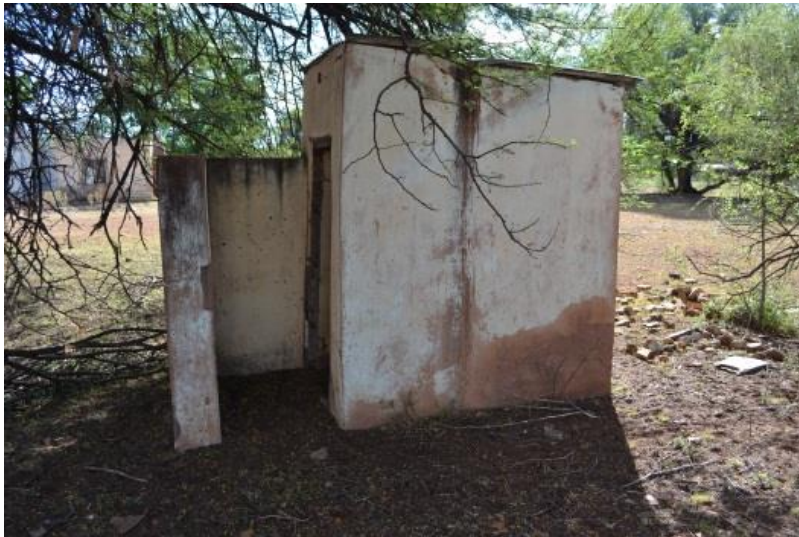
A single outdoor privy occurs on the site at the back of the dwelling. Typical of urban or serviced outdoor privies it functioned as a 'bucket-system' and not as a 'longdrop'.

Figure 4. Detached outdoor privy located at the back of the dwelling

The outdoor privy, dolomite ruin, workers dwelling and cement brick ruin may be demolished. If the water furrow is still in use or must be retained for serving the property with water according to municipal regulations, it must be re-aligned to serve its new purpose. All other infra structural elements may be removed.

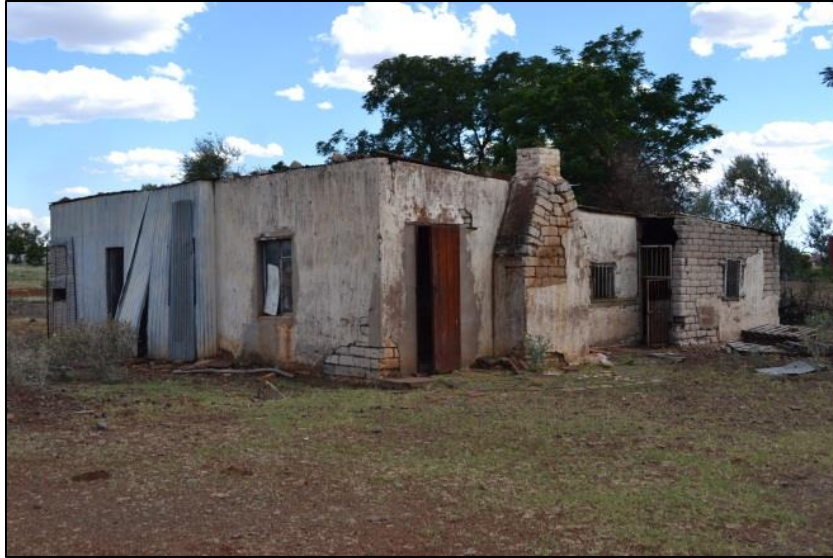
This is the second dwelling on the site and it is assumed that this was where the servants serving the principal dwelling, lived.

Figure 5. Separate workers dwelling in the backyard

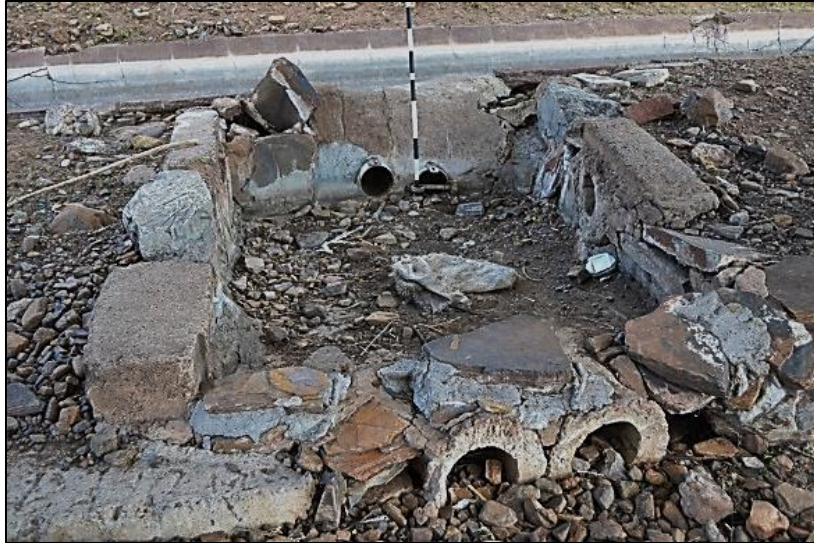
Figure 7. Furrow distributor dam adjacent to the dam from where water was irrigated into the gardens and orchard (photograph: M. Naude 2013)

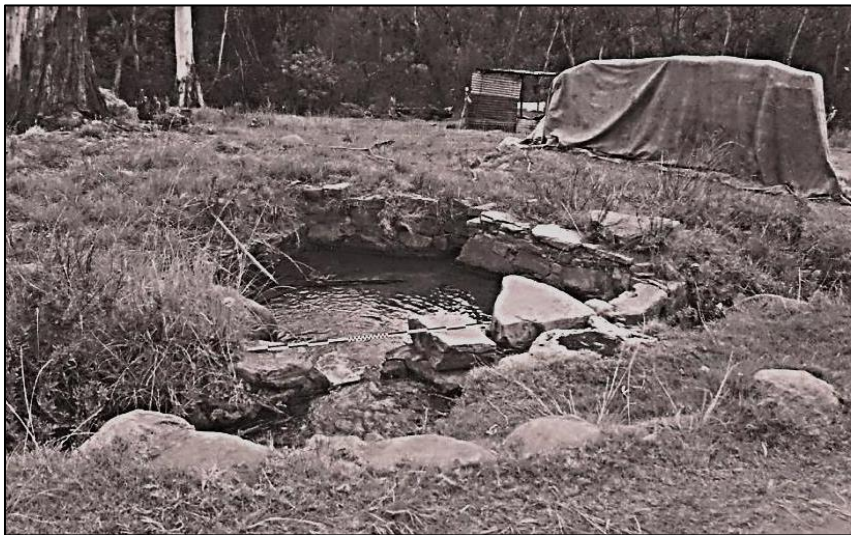
Figure 8. Simple water furrow distributor dam constructed with stone walling

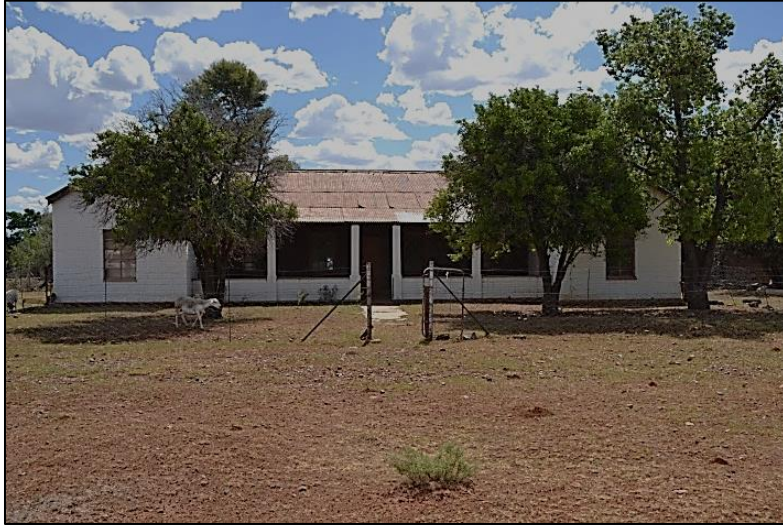
Figure 11. Front elevation of the principal dwelling - view from the street

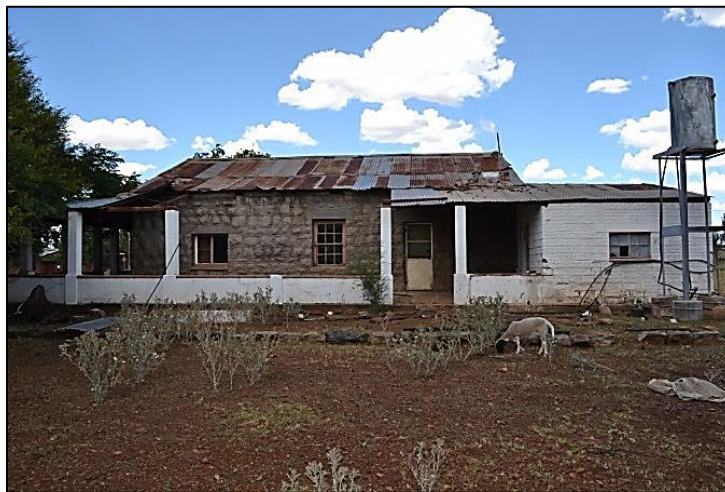
Figure 12. Back elevation of the dwelling indicating the location of the core dwelling (grey dolomite stone) and bath room stoepkamer (white-washed room)

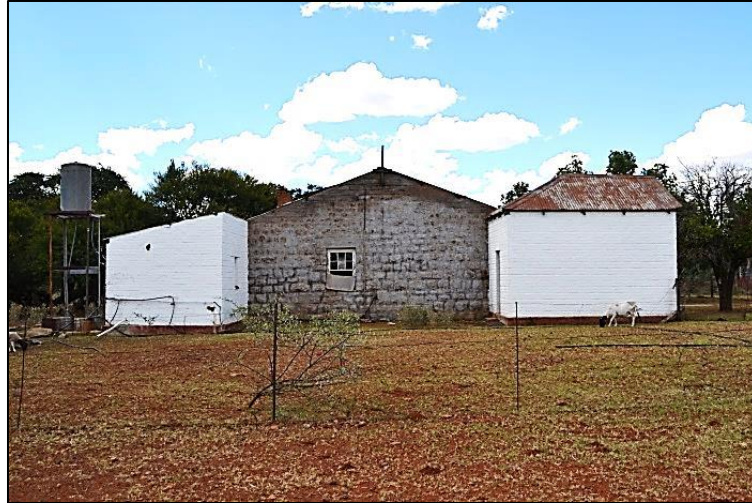
Figure 23. Side elevation with exposed dolomite gable end and two stoepkamer additions (Photograph: M. Naude 2013)

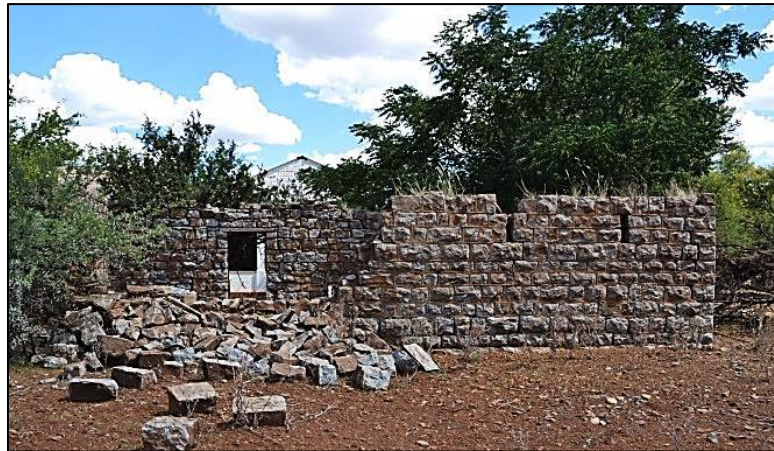
Figure 3. Side elevation of the dolomite ruin located adjacent to the dwelling but without any indication of the original function of the building (Photograph: M. Naude 2013)

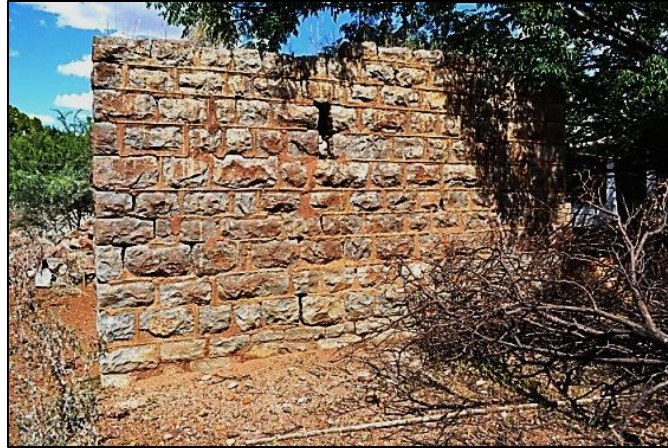
Figure 4. Gable end of the dolomite structure without roof (Photograph: M. Naude 2013)

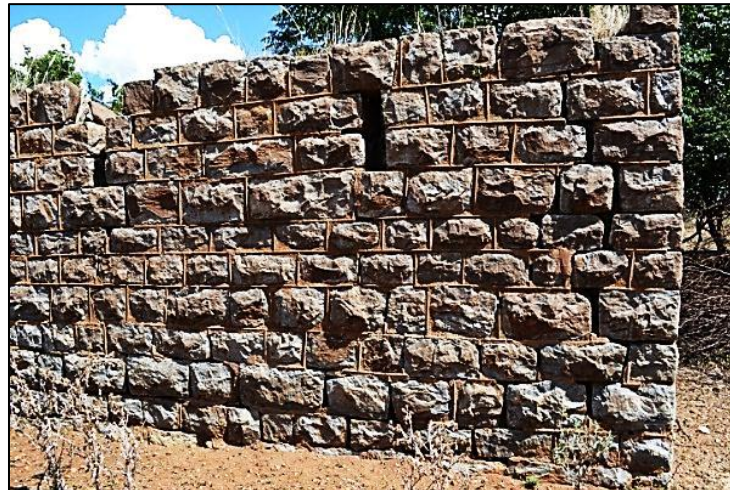
Figure 5. Detail of stone masonry work on the dolomite outbuilding (Photograph: M. Naude 2013)

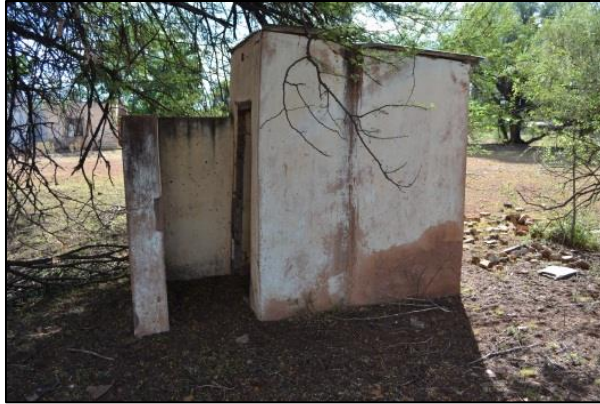
Figure 6. Side elevation of the detached outdoor privy (Photograph: M. Naude 2013)

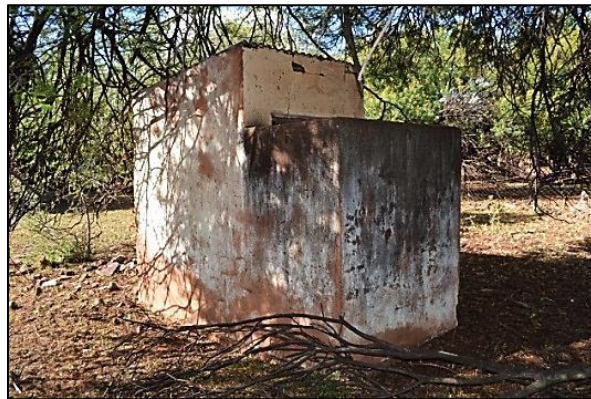
Figure 7. Protecting wall of semi-open outdoor privy (photograph: M. Naude 2013)

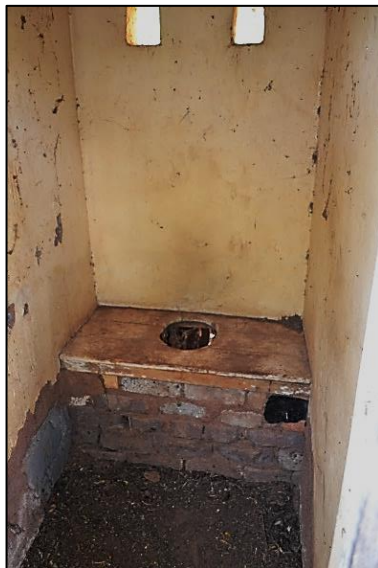
Figure 8. Simple seat arrangement of interior of the outdoor privy (photograph: M. Naude 2013)

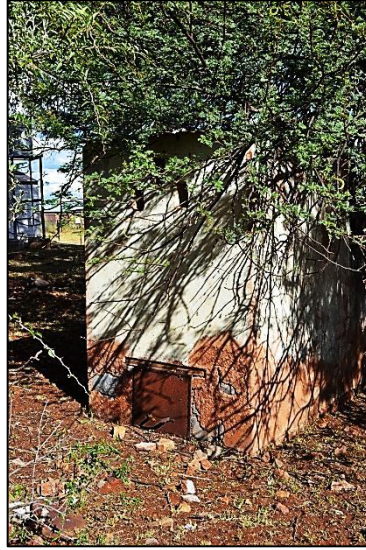
Figure 9. Back of the outdoor privy indicating where the bucket is removed at the lower end of the wall (photograph: M. Naude 2013)

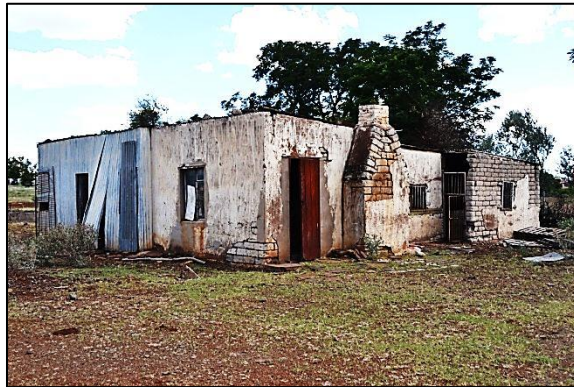
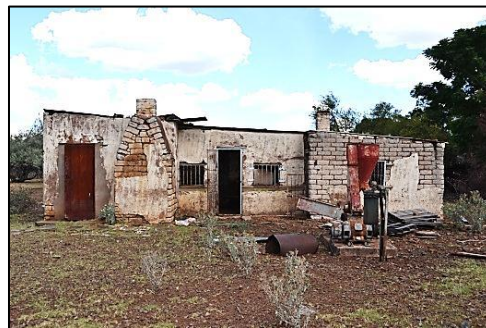
Figure 10. Workers dwelling adjacent to the main dwelling (photograph: M. Naude 2013)

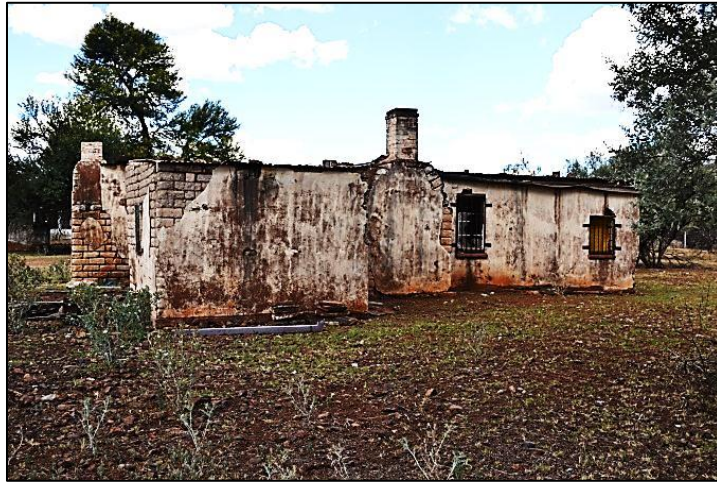
Figure 11. Back of workers dwelling (photograph: M. Naude 2013)

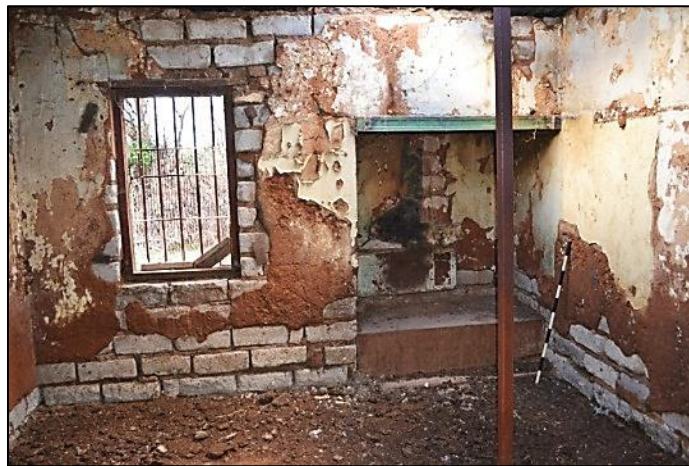
Figure 12. Hearth in the kitchen of the workers dwelling (photograph: M. Naude 2013)

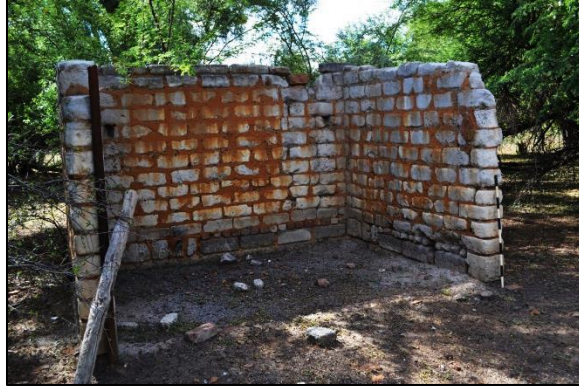
This structure is constructed with homemade sand and cement bricks, laid on top of a foundation of cement bricks similar to those used for the additions and stoepkamers of the principal dwelling. What this structure was used for remains unknown and it contains no architectural elements to guide the investigation towards any possible uses.

Figure 13. Ruin of unknown origin at the back of the dwelling in the backyard (photograph: M. Naude 2013)

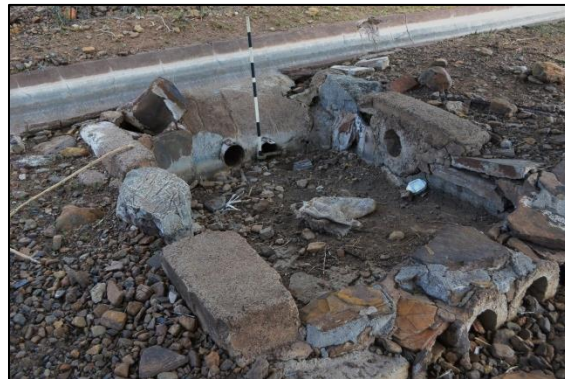
Figure 14. Water furrow distributor dam with furrow at the back and various outlet pipes in front (Photograph: M. Naude 2013)

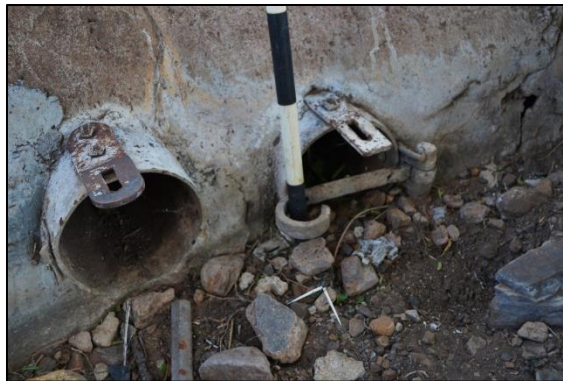
Figure 15. Pipes letting water from the principal water furrow into secondary furrows (photograph: M. Naude 2013)

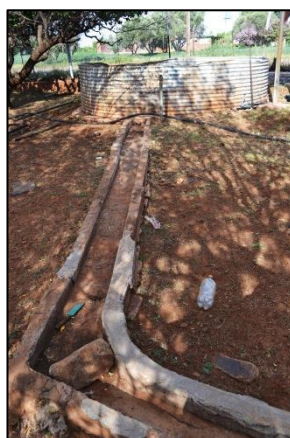
Figure 16. Open water furrow leading directly from the corrugated iron water reservoir (photograph: M. Naude 2013)

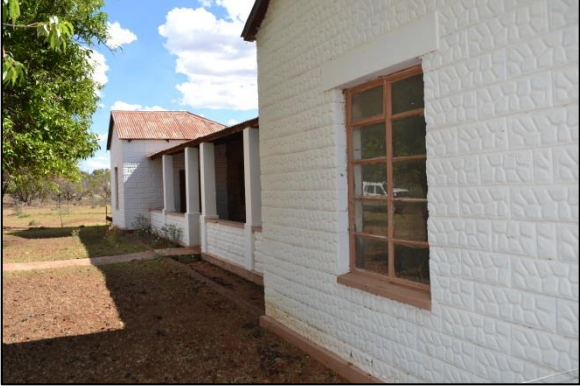
<p>Figure 17. Front facade of the dwelling indicating the impact of the stoepkamers and stoep that is slightly set back (Photograph: M. Naude 2013)</p> <p><u>Building 2: dolomite outbuilding</u> The use of dolomite for any building seems to have been the norm in the region. However, this is not the norm anymore and the use of other materials of a more standard and pre-fabricated origin is now common.</p> <p><u>Building 3: outdoor privy</u> Outdoor privies used to be a common occurrence on farms. However this site is located on the [periphery of the town where privies were also common during a previous era. What makes this privy special is its bucket system which was associated with an earlier period and development in the history of sewage removal in urban centres.</p> <p><u>Building 4: workers dwelling</u> The size and scale of this workers dwelling suggest that it was more than a standard laborers dwelling as it contain more rooms and other elements typical of laborers dwellings. It may have been used by an entire family who lived on the site almost as ‘bywoners’. This makes the little dwelling significant.</p> <p><u>Building 5: clay brick ruin</u> As the use of this structure is unknown it is difficult to determine its significance</p>	<p>High</p> <p>Medium</p> <p>Low</p> <p>Medium</p> <p>low</p>

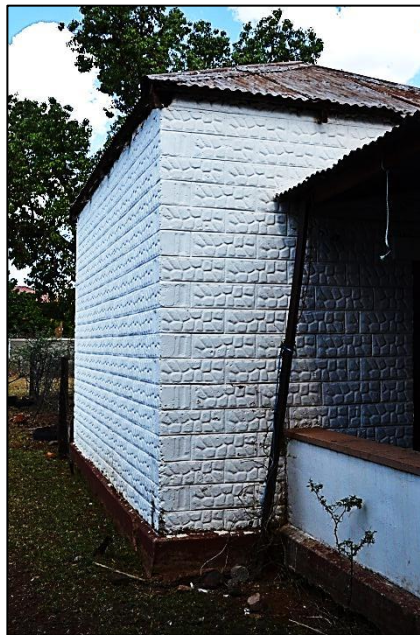
Figure 18. Prefabricated cement bricks mimicking the texture of stone, used for all the later additions and stoepkamers (Photograph: M. Naude 2013)

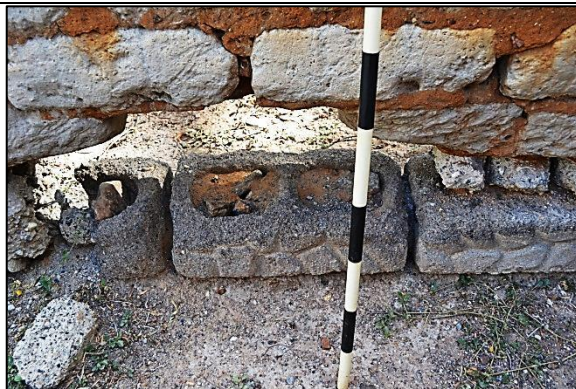
Figure 19. At the base of the structure some of the prefabricated cement bricks used for the additions to the dwelling are exposed where they have been used as foundation material for this structure (Photograph: M. Naude 2013)

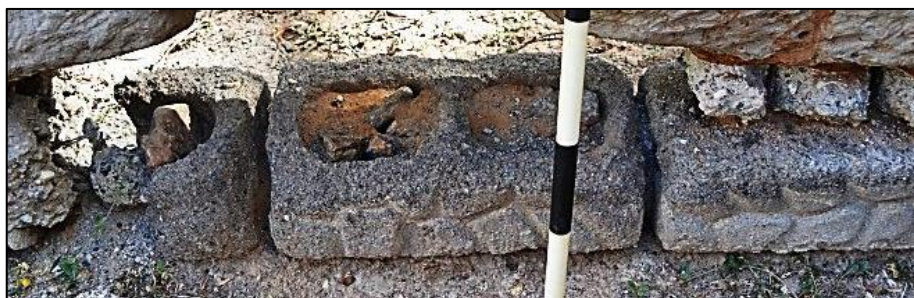
Figure 20. Detail of prefabricated cement bricks used for the foundation of the structure (photograph: M. Naude 2013).

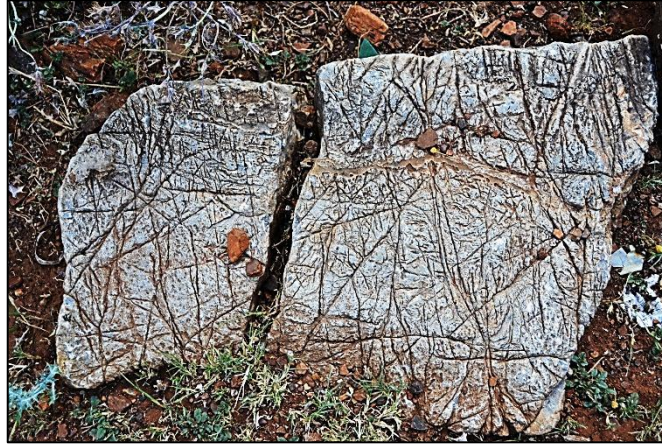
Figure 21. 'Raw' dolomite stone chunks similar to those used for the construction of the core section of the dwelling and the adjacent annex (Photograph: M. Naude 2013)

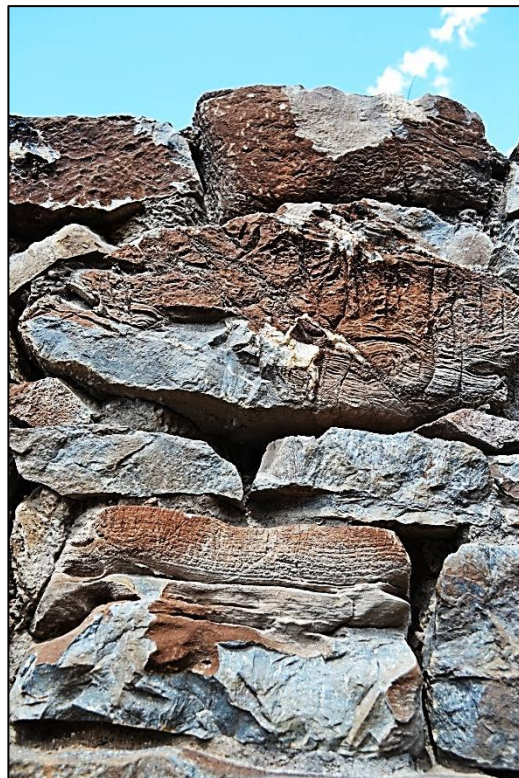
Figure 22. Interior of the wall exposing dolomite stone used for the construction of the annex to the dwelling (photograph: M. Naude 2013)

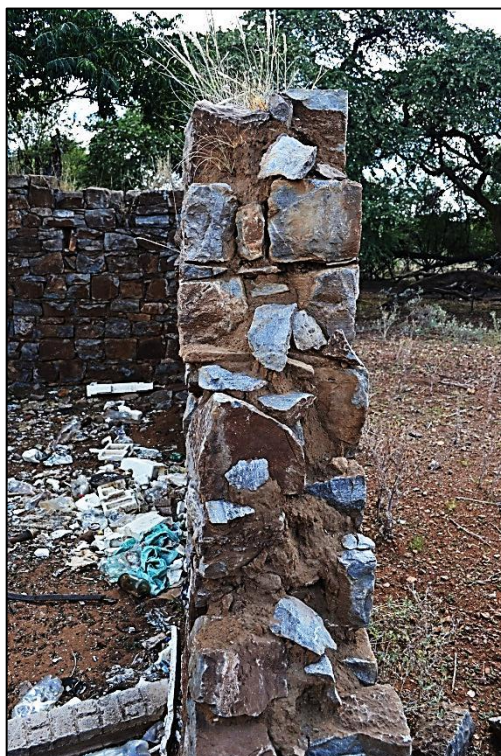
Figure 23. Section through the dolomite wall construction of the annex indicating the use of clay mortar with the stone (photograph: M. Naude 2013)

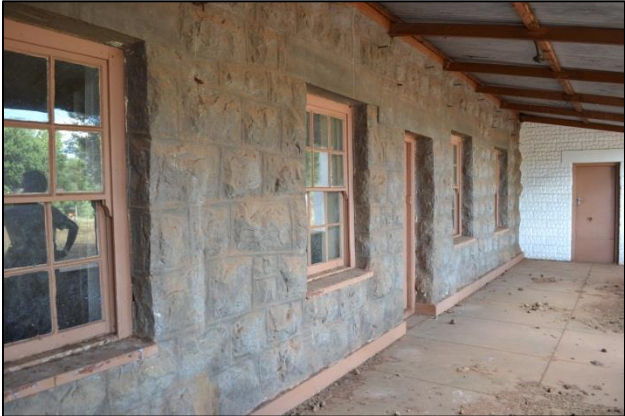
<p data-bbox="321 1234 1065 1352">Figure 24. View of the main entrance and facade protected by the verandah indicating the use of unplastered dolomite wall construction and timber frame windows (Photograph: M. Naude 2013)</p>

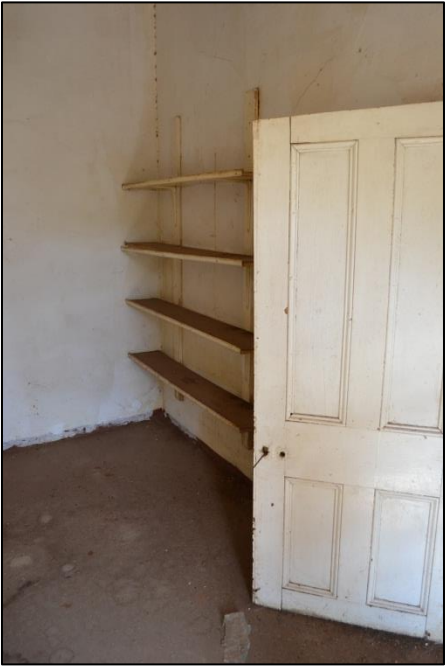
<p>Figure 26. Remains of the pantry with some of the shelving in position (photograph: M. Naude 2013)</p> <p>Original wooden sash windows on the front stoep (front elevation and principal façade) and similar windows at the back have remained intact. In some rooms the curtain pelmets have remained.</p>	<p>Rating</p> <p><i>medium</i></p>

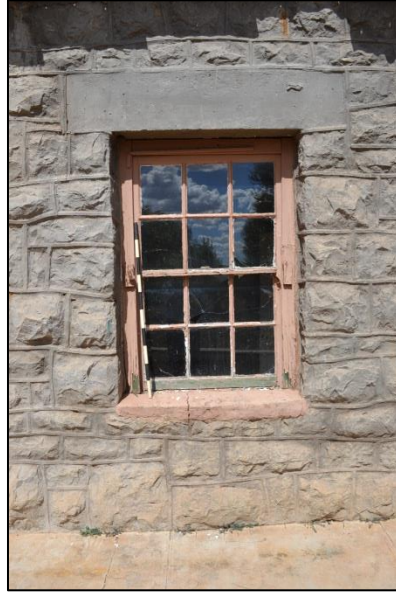
Figure 27. Small wooden frame sash window similar to those still installed on the front stoep (photograph: M. Naude 2013)

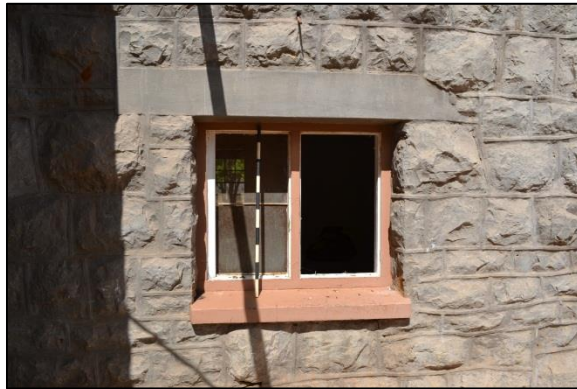
Figure 28. Small window with wide and over-designed cement lintel (Photograph: M. Naude 2013)

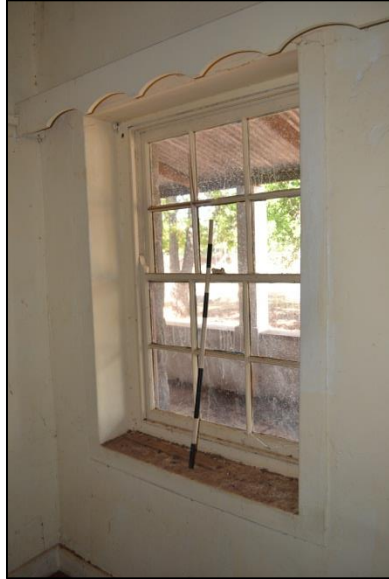
**Figure 29. Interior of wooden sash window with curtain pelmit
(photograph: M. Naude 2013)**

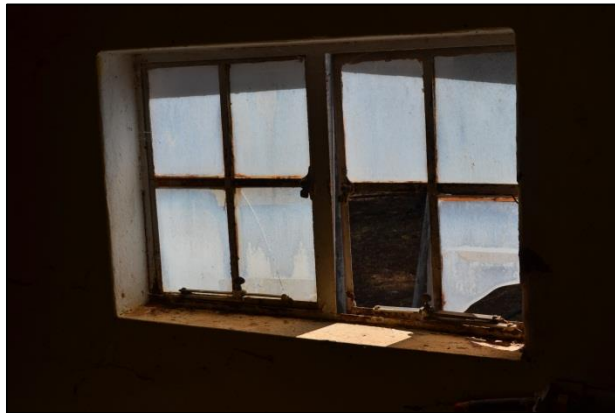
All the windows in the extensions are mounted steel frames of a later date (probably between 1920 and 1930).

**Figure 30. Interior of steel frame window in bath room (photograph:
M. Naude 2013)**

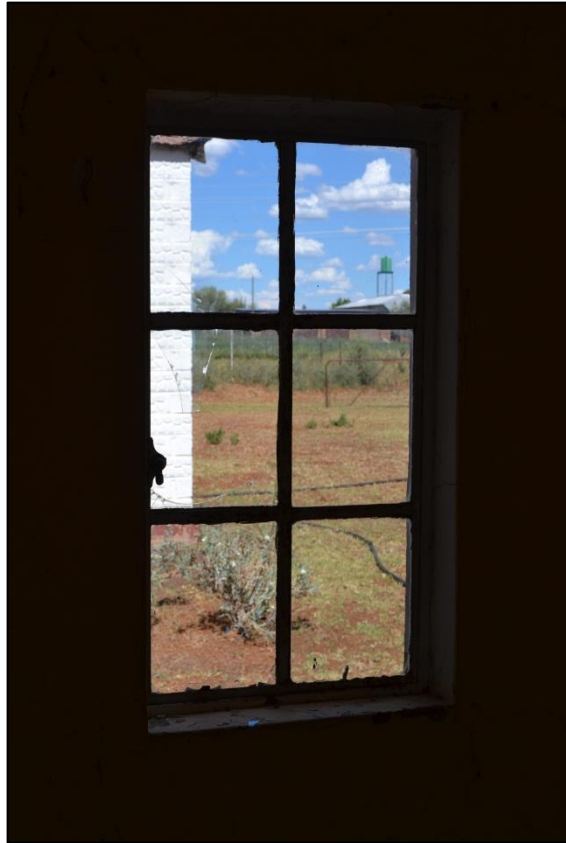
Figure 31. Steel frame window (Photograph: M. Naude 2013)

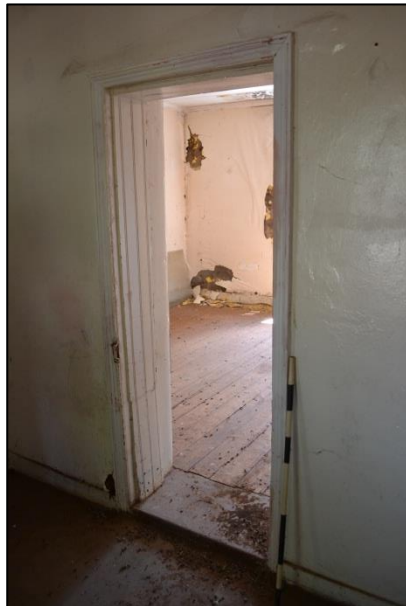
Simple unpretentious wooden architraves and skirtings occur throughout the dwelling and the front door is equally simple.

Figure 32. Timber frame interior door with simple undecorated wooden architraves and skirting boards (Photograph: M. Naude 2013)

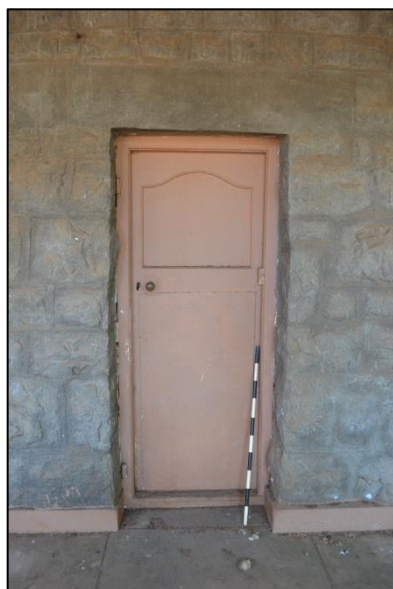
Figure 33. Timber frame front door with glass at the top (Photograph: M. Naude 2013)

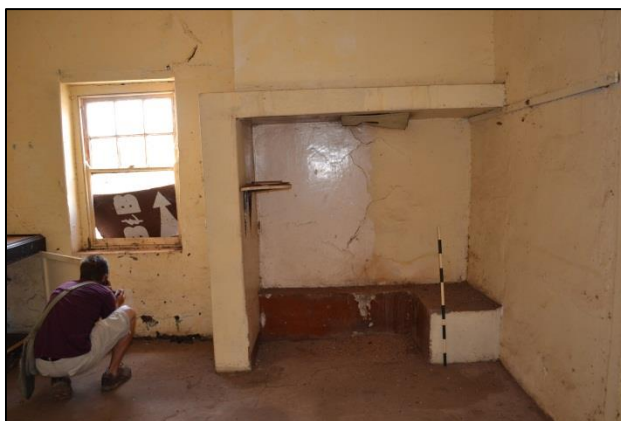
Figure 38. Alcove of the first hearth - in the kitchen - which was later altered to accommodate a coal stove (Photograph: M. Naude 2013)

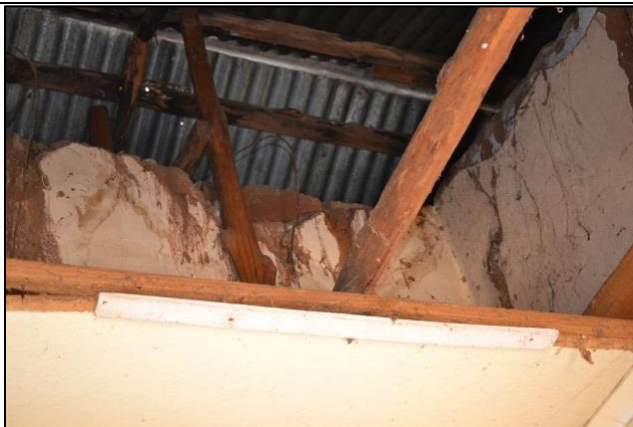
Figure 40. The interior walls were also elevated and the roof structure was replaced over time (Photograph: M. Naude 2013)

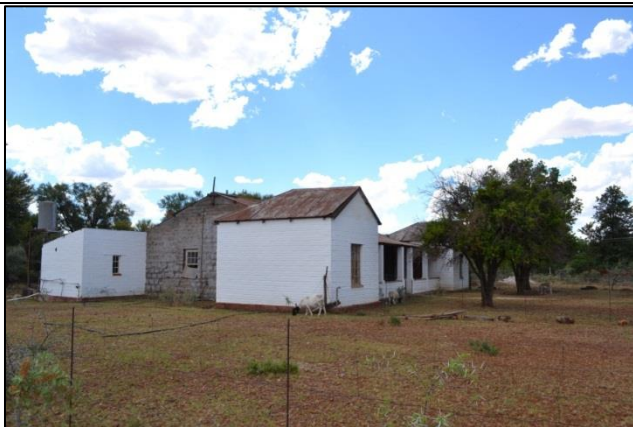
The original dwelling – the core section – was constructed with neatly dressed dolomite chunks. When the building was extended it was done with prefabricated cement bricks with a false stone face. The latter material was probably preferred in order to imitate the dressed stone texture of the original walling resulting in all the later additions now clearly distinguishable from the original dwelling. All the latter additions can be identified as these are the only sections that were painted - white washed – whilst the original dolomite dwelling remained unpainted.

Figure 41. The later additions and extensions are clearly defined by the whitewashed rooms and supporting columns of the front verandah (Photograph: M. Naude 2013)

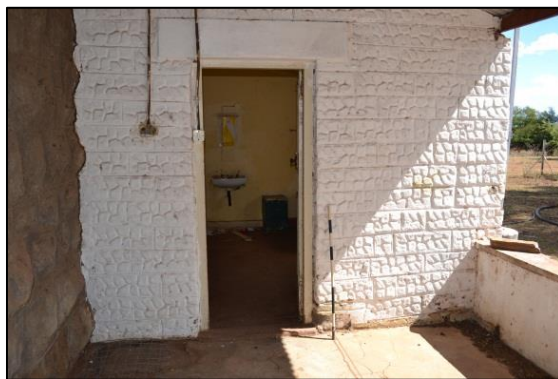
Figure 42. One of the stoepkamers on the back verandah that was later added that differs from the original core dwelling constructed with stone masonry (left) (Photograph: M. Naude 2013)

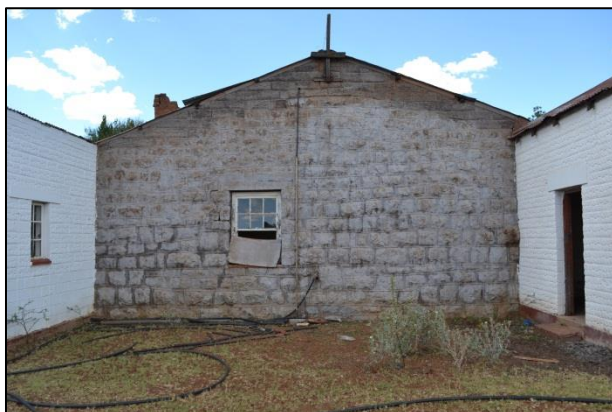
Figure 43. Side gable of the original dwelling and the two stoepkamers added to the back and sides of the core section of the dwelling (photograph: M. Naude 2013)
