KELSALE

Conservation Area Appraisal

Supplementary Planning Document

June 2018

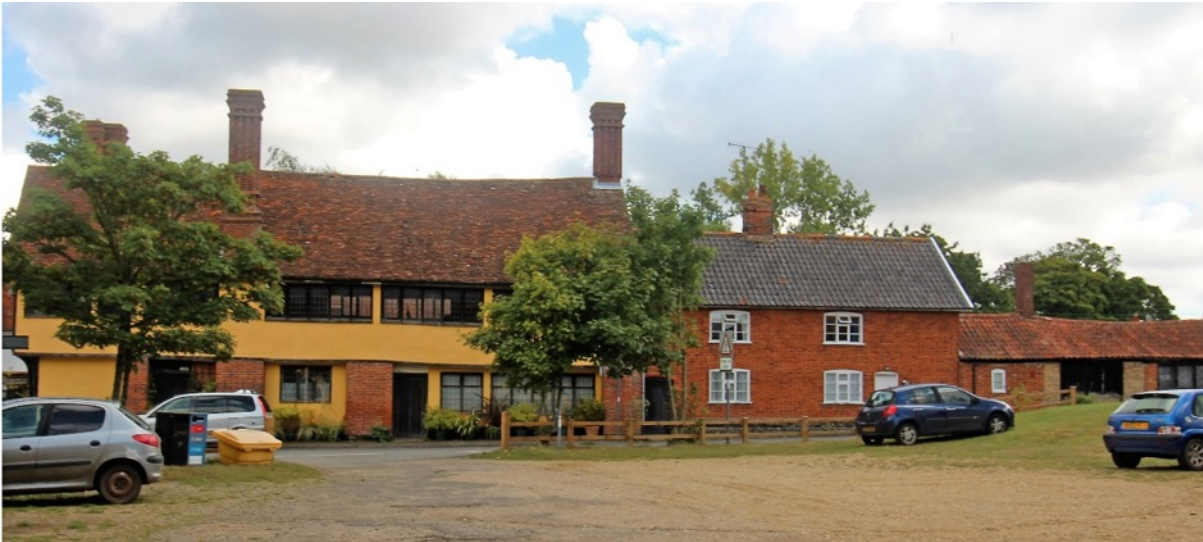
The Old Guildhall, Trust Cottage, and former Smithy on Low Road; a memorable group of historic buildings at the entrance to the Conservation Area

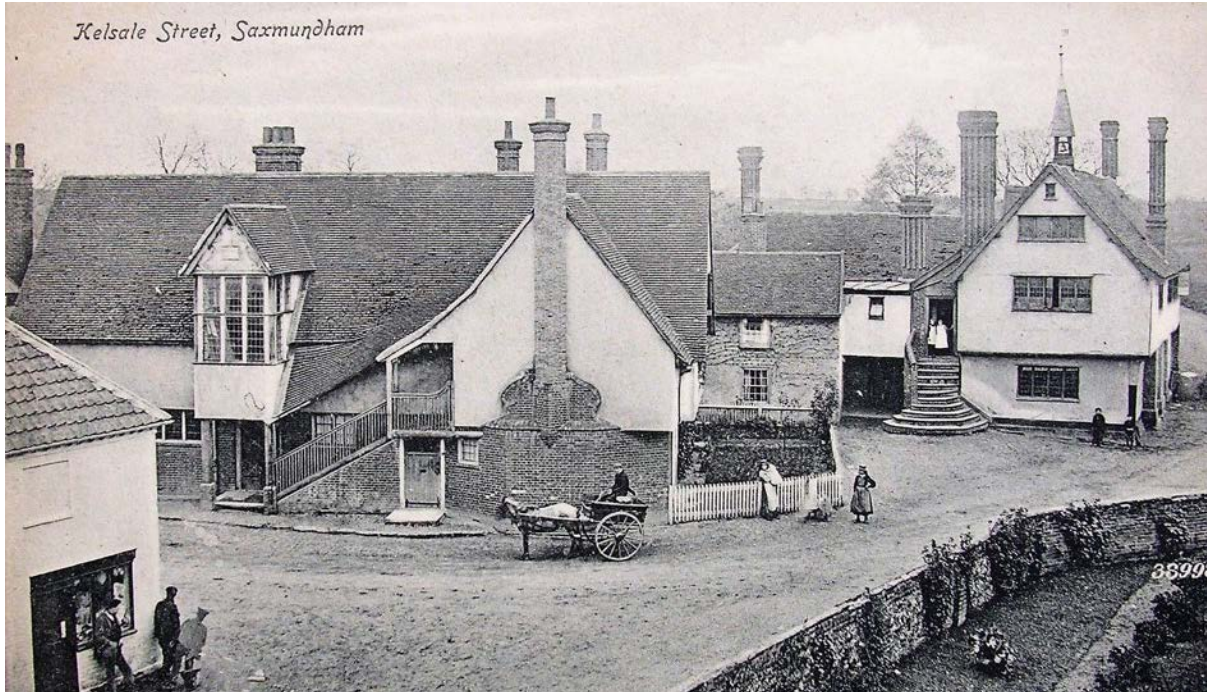
Kelsale Social Club, The Old Guildhall and Corner Cottage c1910. Richard Norman Shaw's bellcote on the Guildhall roof has since been removed and the porch of the Social Club has lost some of its pargetted decoration

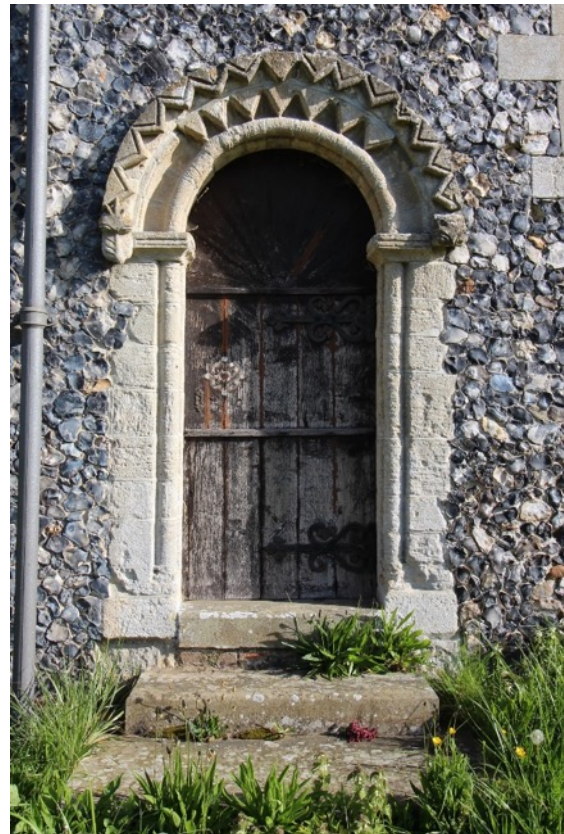
A reset twelfth century doorway at Saint Mary and Saint Peter's Church. The church was rendered until the late nineteenth century

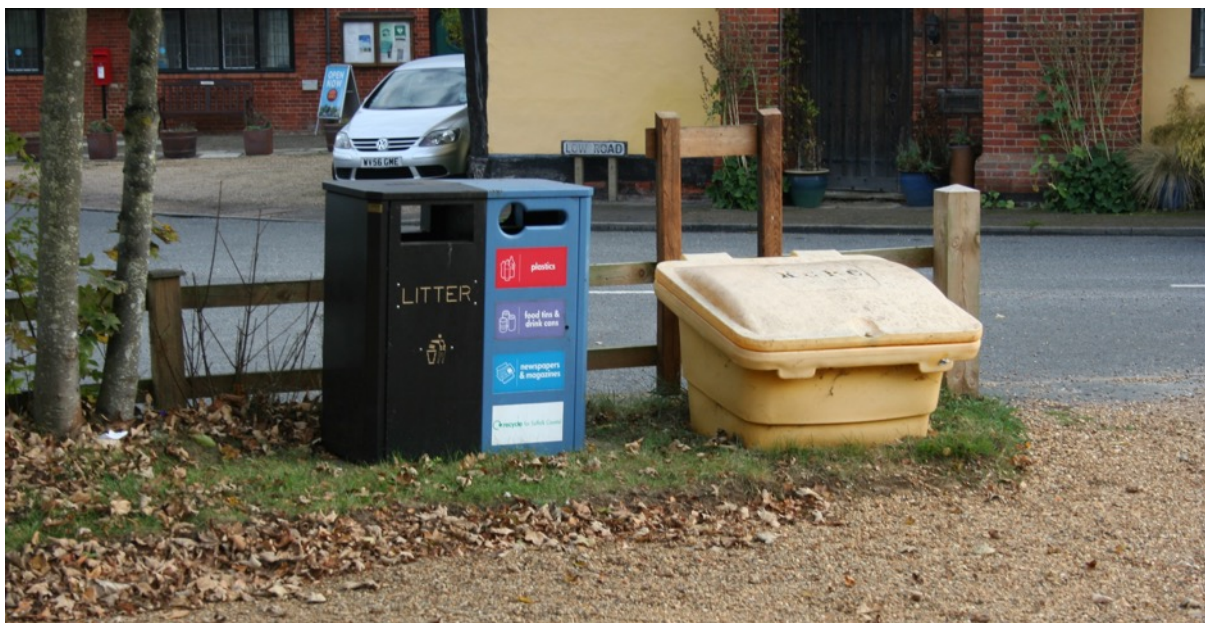
Street furniture close to listed buildings on Low Road, illustrating the need for careful positioning of such items

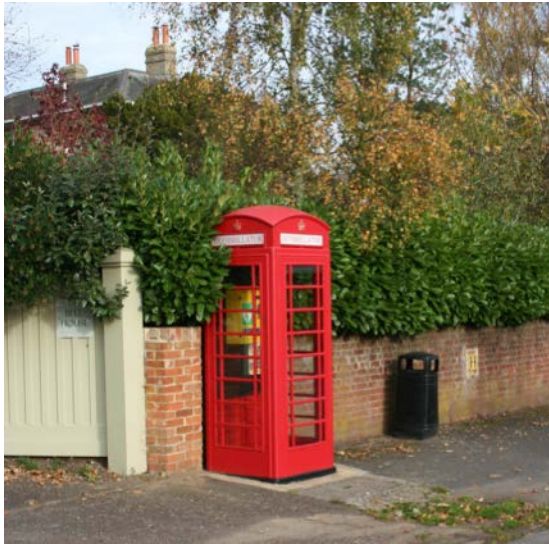
A K6 telephone kiosk to the north side of the junction of Church Lane and Low Road. Installed c2015 and used to house a defibrillator

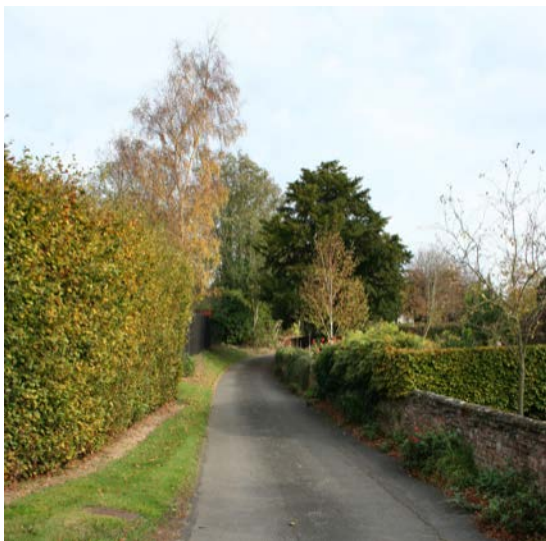
The attractive, rural and understated quality of Church Lane is enhanced by its grass verges and a lack of kerbs, road markings and street furniture

The hardening of an area through the introduction of pavements and kerbs is subtle but evident, and where possible grass verges without raised kerbs should be retained to avoid creating a suburban character.

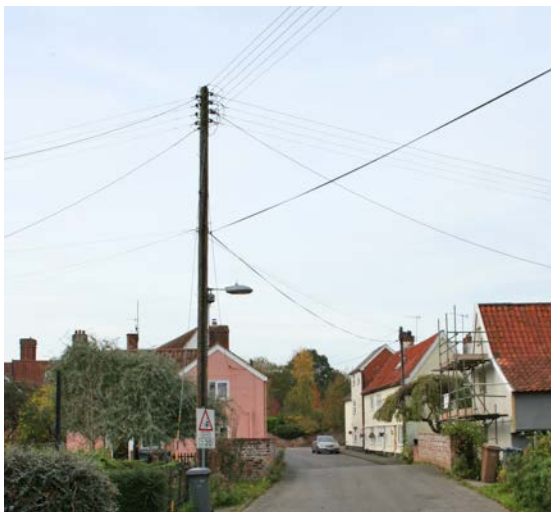
Telegraph pole, street light and associated cables, Bridge Street

Telegraph poles and overhead cables are features commonly found in both urban and rural settings. Unless the number of poles and cables is high then such features rarely detract from the special character of a Conservation Area.

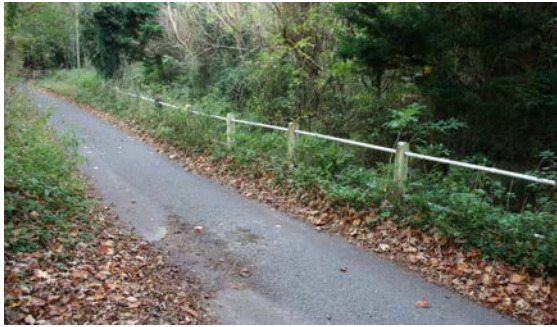
Concrete posts and iron guard rail on Tiggins Lane, providing a safety barrier between the road and stream

Other railings, of mid twentieth century date, have a more utilitarian appearance but usefully guard the public from a ditch or watercourse. The retention and maintenance of these low-key features is important on safety grounds. While not intrinsically of historic merit, if replaced any future item should adopt the low-key appearance and simplicity of design as the extant items.

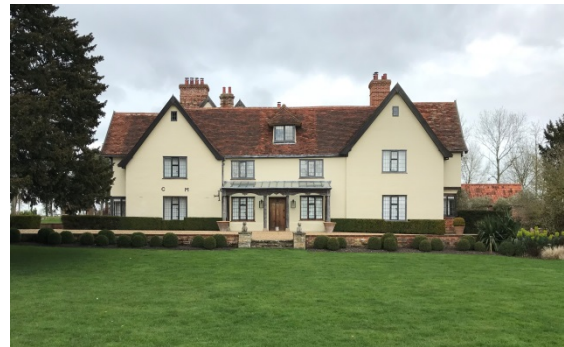
Old Manor House, Bridge Street (Grade II)

A substantial detached house standing close to the parish church, on a site which also contains a late medieval drainage moat. The house is set back a considerable distance from the road upon the crest of a gently sloping hill. Fragments of thirteenth and fourteenth century pottery were found here during excavations in 2009.

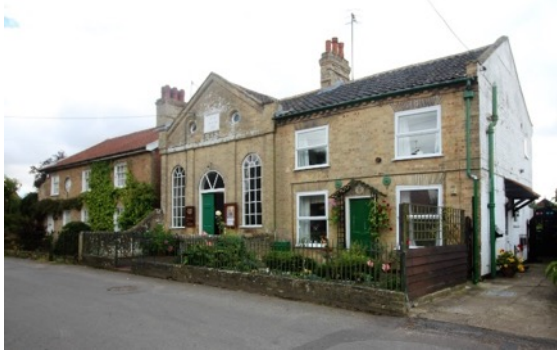
Chapel Cottage and The Methodist Chapel, Bridge Street

Chapel Cottage, Bridge Street A two storey cottage faced in gault brick with a dentilled eaves cornice which is attached to the chapel's western wall. It was originally built as the manse to the adjoining chapel and probably dates from c1851. The window joinery was replaced in the late twentieth century but original openings with wedged-shaped lintels are preserved. Central, nineteenth century four panelled door beneath a wedge-shaped lintel. Late twentieth century trellised wooden porch. Pan tile roof and gault brick stack to the eastern gable. The western gabled return elevation is now painted.

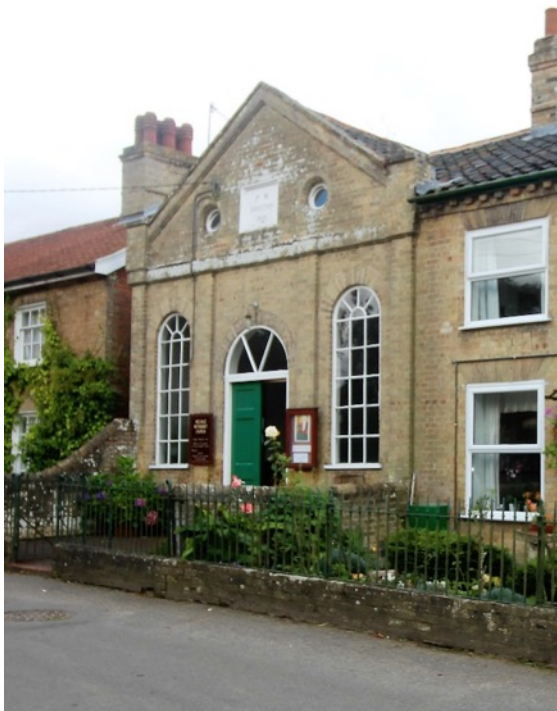
Methodist Chapel, Bridge Street

Methodist Chapel and railings to front
Originally built in 1851 as a Primitive Methodist Chapel, reputedly at a cost of £120. A meeting room was added to the rear (or southern) elevation c1871. A small classical gault brick façaded building with a pediment on the northern or Bridge Street elevation, and a black pan tile roof. Red brick return elevations. Street frontage of a single storey and three bays. Central arched doorway with a replaced radial fanlight and two centrally opening three panelled doors. The original radial fanlight was of a far more elaborate design. The doorway is flanked by tall arched small pane casement windows. Each bay of the façade is separated by pilasters and there is a central date stone above the doorway flanked to each side by an oculus. Interior retains original furnishings (2016) but the original ceilings now underdrawn. Simple iron railings on dwarf gault brick wall to front. Joseph Arch of the National Agricultural Labourers Union spoke in the meeting room at the rear of the chapel in 1874, permission for his speech being recorded in the chapel minute book. Kelsale was one of a small number of Suffolk and Norfolk chapels to defy national guidance and allow early agricultural trade union activity within its premises. Scotland, N, *Primary Sources for Nineteenth Century Agricultural Trade Unionism* in - Dymond, D (Ed) *The Local Historian* Volume 13 No.5 (1979).

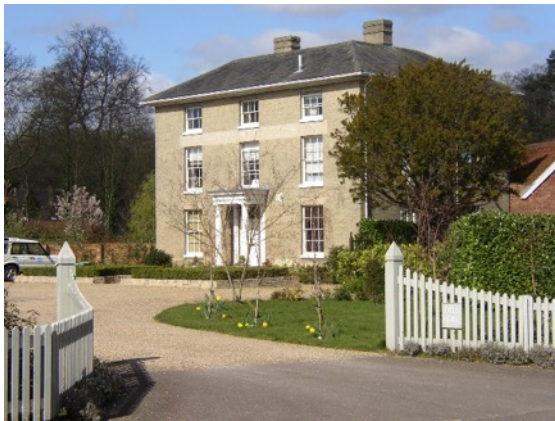
Bell House, Church Lane (grade II) A distinguished classical building of early to mid-nineteenth century date with a sixteenth-seventeenth century wing to the rear facing Church Lane. It forms part of a memorable group with Rectory Cottages and is prominently located. Formerly a public house, and shown as the Eight Bells Inn on the 1884 1: 2,500 Ordnance Survey map. It is also recorded as a public house in White's 1855 Directory. The pub closed in 1987 and is now a dwelling. The columned porch is a late twentieth century replacement for the heavy late nineteenth century hood on ornamental cast iron brackets which is recorded in the listing description. This late nineteenth century porch had itself replaced an earlier portico.

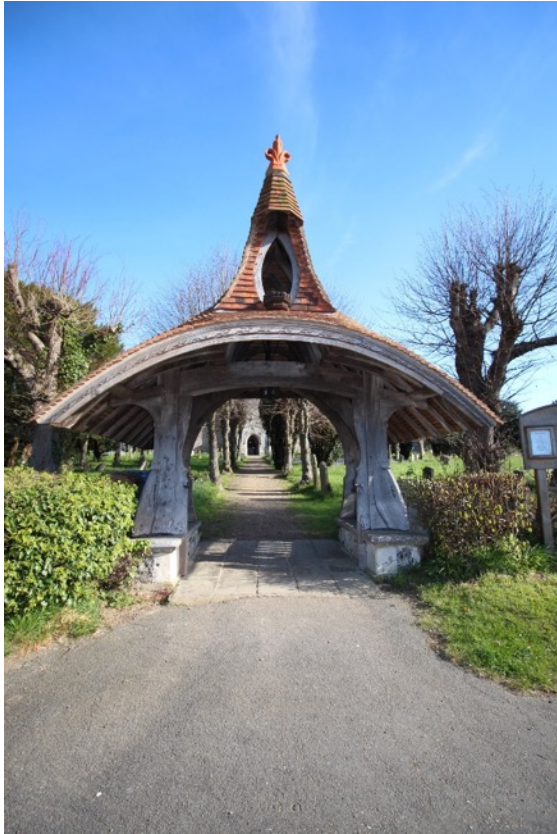
Lych Gate to Saint Mary and Saint Peter's Church (grade II*). Lych gate. 1890 by Edward S. Prior for the then rector The Reverend George Irving Davies as a memorial to his wife. Timber framed on a stone and flint plinth, plain tiled roof. The uprights each side of the entrance have buttresses carved in the manner of medieval crown posts; shallow arched tie beam carved with the words 'Come unto me ye weary and I will give you rest'. The roof has a sweeping curve over the entrance front with a tall pointed section enclosing a niche which is now empty; carved fascia board; the rear of the roof is half hipped. The original wooden gates with heavy iron hinges have sadly been removed. Davies had wanted the niche to contain a statue of his late wife, but this was forbidden by the bishop. Bettley, J, and Pevsner, N, *The Buildings of England, Suffolk: East* (London, 2015) p.380. Cook, M.G *Edward Prior, Arts and Crafts Architect* (Marlborough, 2015) p68-69. Walker, L.B, *ES Prior 1852-1932* (London, 1978).

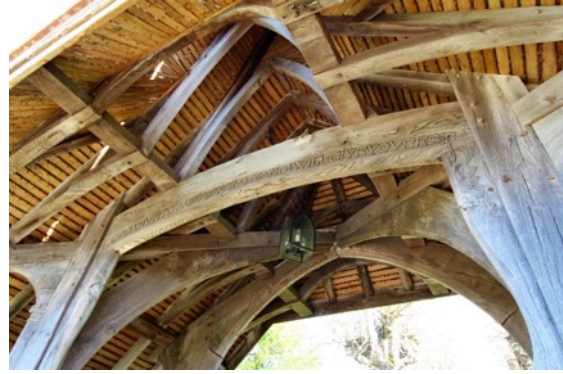
Roof structure of the Lych Gate to Saint Mary and Saint Peter's Church

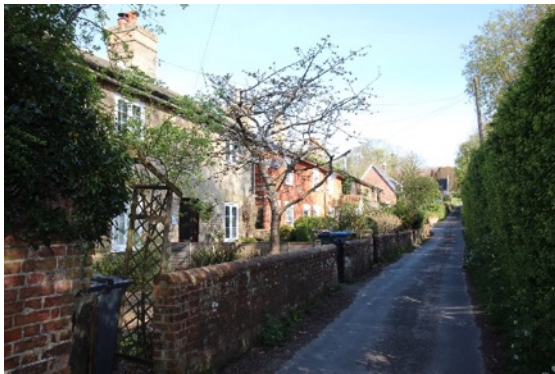
Nos. 1 & 2 Denny's Lane

Adams Cottage No. 1 & No.2 Denny's Lane and boundary wall to front. A semi-detached, early to mid-nineteenth century pair of cottages with a gault brick faced façade to Denny's Lane. Shallow pitched Welsh slate roof. Denny's Lane façade has replaced casement windows within original openings and wedge-shaped gault brick lintels to the openings. Both houses have replaced, partially glazed front doors. Adams Cottage with single storey late twentieth century conservatory addition. Red brick garden wall to Denny's Lane possibly of later nineteenth century date. These cottages were reputedly constructed by Samuel Clouting who presented them to the parish. Used as a girls' school in the nineteenth century. They were sold by the church in 1984. A c1900 postcard of No.1 labelled 'Nurses Cottage' is reproduced in Neave, D *A Second Look at Saxmundham and area* (Saxmundham, n.d.) p26. This shows the house with centrally opening casement windows, each panel divided into three lights.

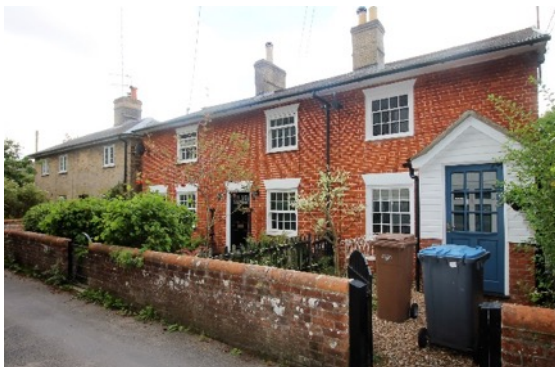
Nos. 3-5 (cons) Denny's Lane and boundary wall to front A terrace of three early to mid-nineteenth century red brick cottages, probably built in two stages; a straight joint being evident between No.3 and the mirrored pair of cottages which form Nos.4 & 5. Shallow pitched Welsh slate roof with gault brick ridge stacks and overhanging eaves. Original window and door openings with wedge-shaped brick lintels retained. No.5 now however, has a late twentieth century gabled porch of painted weatherboarding on a high red brick plinth. Replaced small pane sash windows. Rear elevations considerably altered. No.4 with a two storey gabled and rendered rear addition, No.5 with a late twentieth century single storey red brick lean-to addition but retaining its original first floor window opening. Good nineteenth century red brick garden wall shared with Nos.1 & 2.

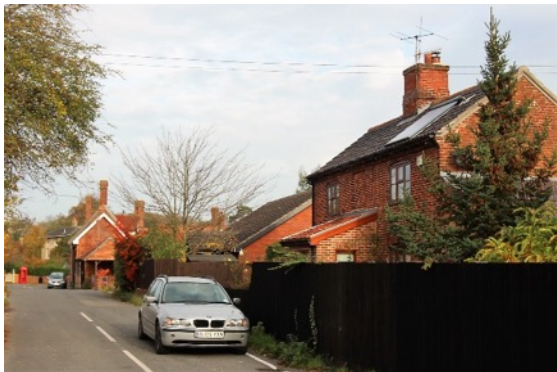
Walnut Tree House, Low Road A detached two storey red brick cottage of early to mid-nineteenth century date with a black pan tile roof and a dentilled brick eaves cornice. Substantial central red brick ridge stack with rebuilt upper section. It has symmetrical three-bay façade to Low Road, with a centrally placed early twenty-first century red brick lean-to porch with a red pan tile roof. Above the porch is an original blind recess with a stone sill. The casement windows within this façade are c2000 replacements,

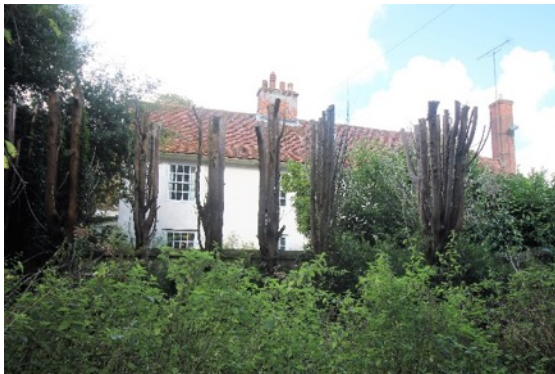
Kelsale Manor from Tiggin's Lane

Kelsale Manor, Tiggin's Lane (grade II*) A substantial timber framed farmhouse with an early sixteenth century (or possibly earlier) core, and early eighteenth century rendered façades. Formerly called Manor Farm, in the nineteenth century it belonged to the Bence Lambert family of Thorington Hall but in the mid eighteenth century it was the property of the wealthy Ketts. In the early 1920s a door knocker with the Kett crest was noted at the house. In 1921 LM Kett described the house as *"an Elizabethan house with two wings and an old oak staircase, panelled rooms, quaint chimneys and fireplaces. The windows of the drawing room have nice bevelled glass."*

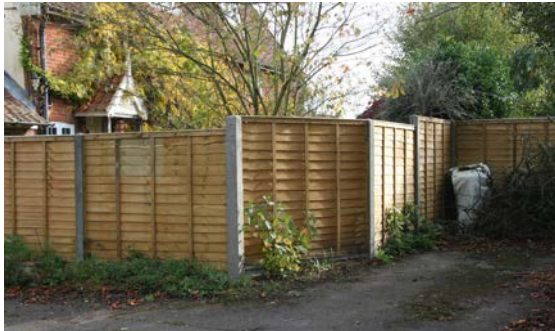
The negative visual impact of fence panels and concrete posts

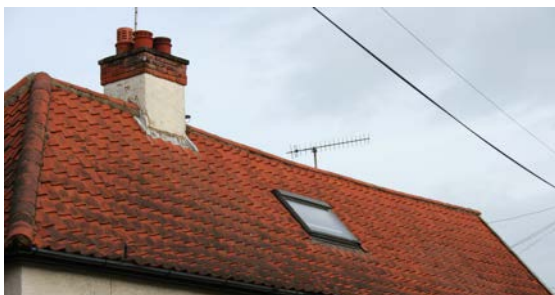
Rooflight and uPVC windows

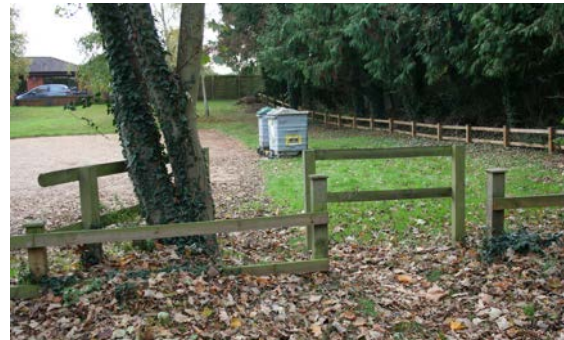
The importance of grass verges, vegetation and the loose chipping surface to the car park. The positioning of bins and street furniture needs further consideration
